Strål
säkerhets
myndigheten

Quality Assurance Review of the Swedish Nuclear Fuel and Waste Management Company's LOT Experiment (Phase S2 and A3) at the Äspö Facility in Sweden

2021:06

Authors: T.W. Hicks¹, T.D. Baldwin¹ and J.R. Scully²

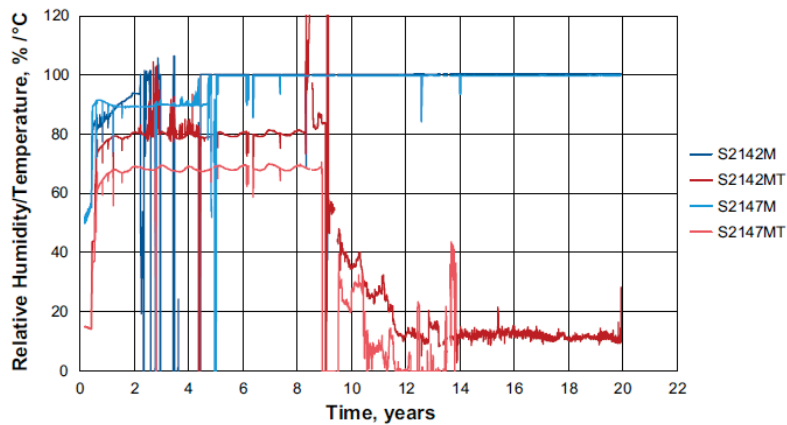
Figure 6 Relative humidity (blue) and temperature (red) as a function of time in block 14 of test parcel S2 [5]. Full saturation appears to have occurred after about four years, after which time results are not reliable.

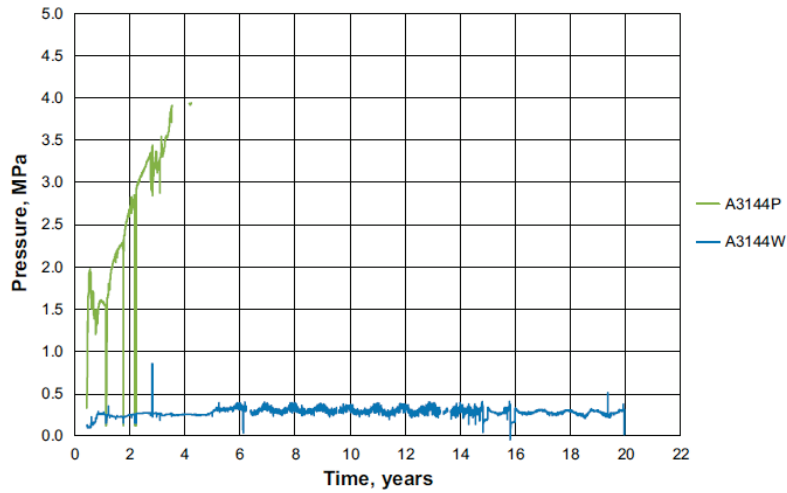
Figure 8 Total pressure, A3144P, and water pressure, A3144W, as a function of time near the centre of block 14 in test parcel A3 [5]. The pressure sensor stopped working after about four years.

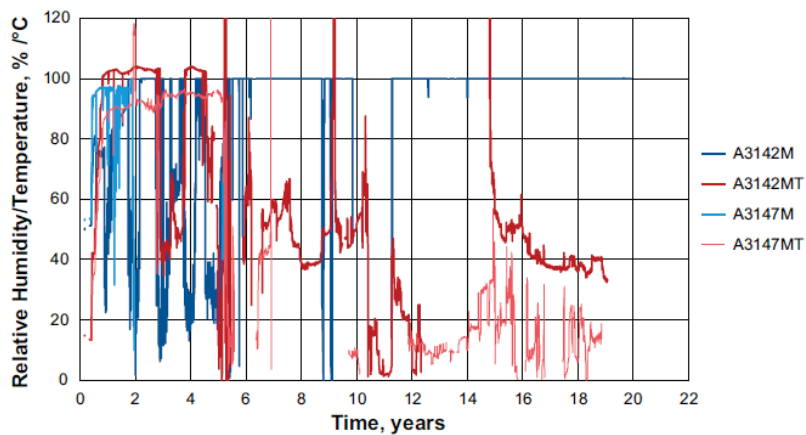
Figure 9 Relative humidity (blue) and temperature (red) as a function of time in block 14 of test parcel A3 [5]. Full saturation appears to have occurred after about two to three years, after which time results are not reliable.

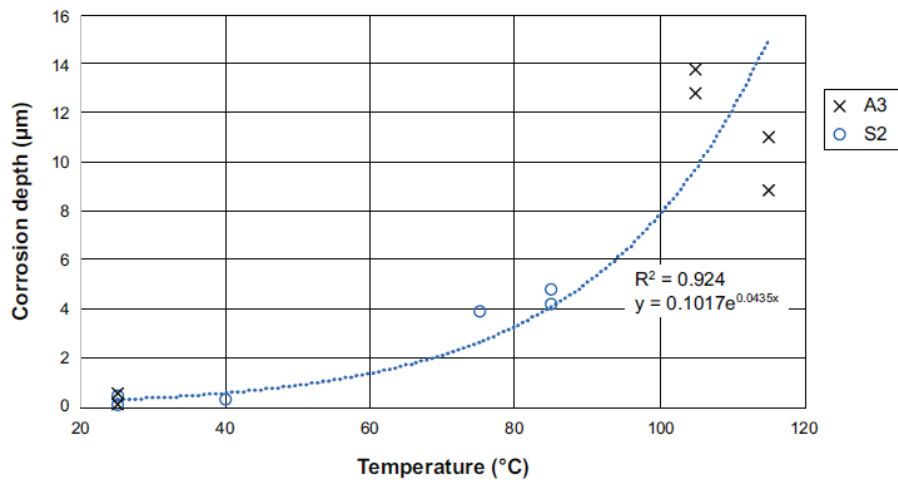
SKB suggested that the slightly deeper corrosion (13.8 μm) on the warmest parts of tube A3 than seen on the previously examined LOT tube A2 (9.6 μm) (recovered after 6 years) could have been due to the longer period of exposure of tube A3 to Cu^{2+} , although differences may otherwise be due to differences in the amounts of O_2 in the two parcels [18]. The only other oxidant available in the groundwater environment is sulphide, for which transport limitations control the long-term corrosion rate. Although sulphur was detected on the tube samples and in the bentonite, the Cu-S phase associated with the corrosion process is not clear [6, §4.1].

At the second QA review meeting [17], there was some discussion as to whether the axial thermal gradient in the experiment could have further affected the corrosion depths and rates. That is, the more rapid consumption of oxygen by corrosion in the warmer parts of the tube could draw oxygen from the cooler parts to the warmer parts, thereby enhancing corrosion in the warmer parts and reducing it in the cooler parts. It was noted that such an axial thermal gradient would not be present in the repository, where the temperature increase is caused by more uniformly emitted spent fuel residual heat rather than an electric heater that provides a more localised heat source.

Figure 11 Corrosion depth as a function of temperature for the S2 and A3 copper pipe samples [6, Figure 4-1].
