Hot-Cell Examination of a Defect Rod from IFA-597

Tord Jonsson

November 1998

Studsvik Nuclear AB
SE-611 82 Nyköping
Sweden

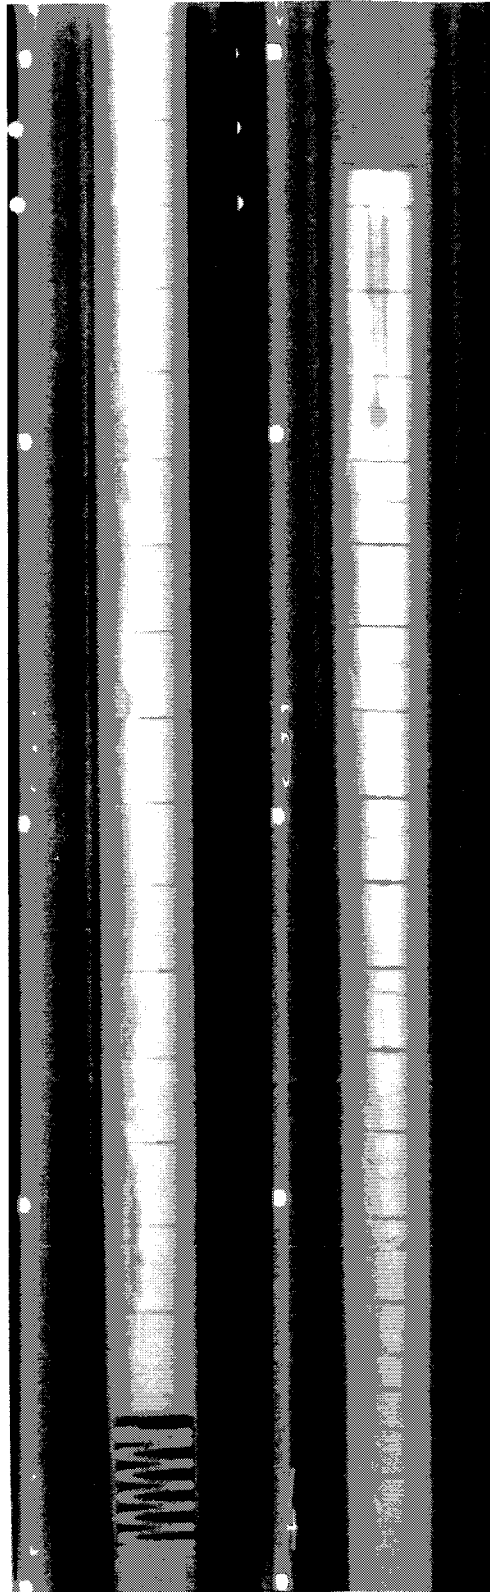
Appendix A1

There are some regions along the crack in the cladding with increased attenuation of the thermal neutrons (less blackening of the radiographic film). This phenomenon is interpreted as the presence of a reaction product between the UO_2 fuel and water on the surface of the exposed fuel. The reaction product, schoepite contains hydrogen and gives a large contrast in neutron radiography.

The rod has an axial crack along the main part of the cladding. The axial extent of the crack is 377 mm, which can be compared with the length of the fuel column, 361 mm according to the neutron radiography. The neutron radiography also showed that the rod has a 19 mm long plenum at the lower end of the rod and that there is an about 1 mm large gap between the upper end of the fuel column and the upper end plug.

Neutron radiography of rod 5 in test IFA-597.2.
The magnification is about 1,01x. Distance between
markings is 50 mm.

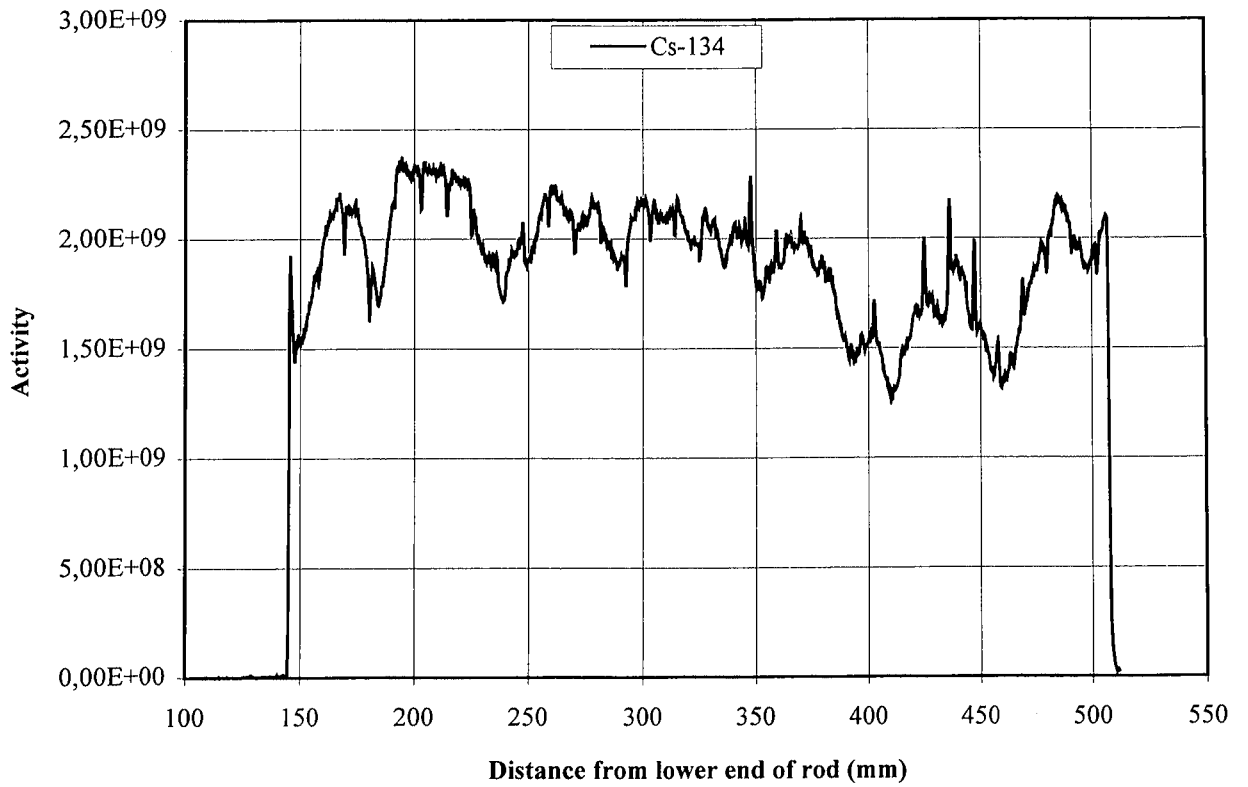
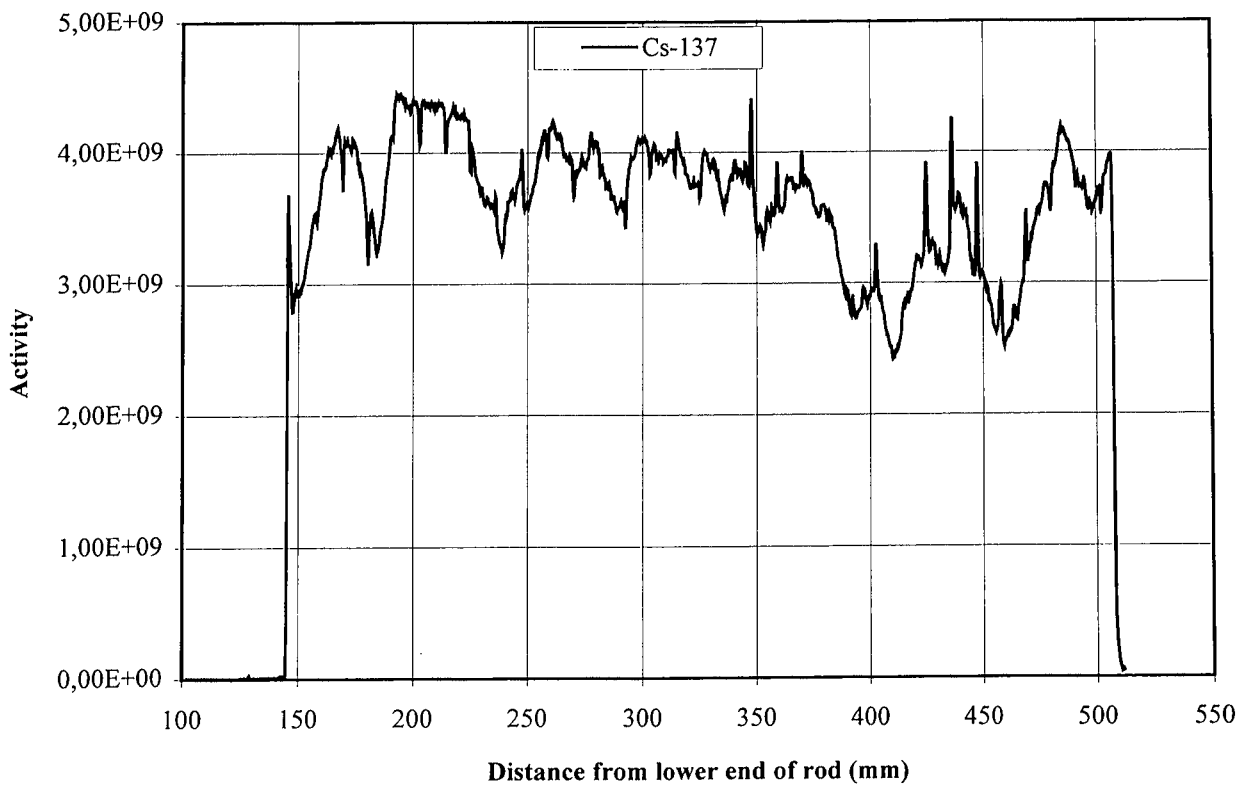
Appendix B1

The axial distributions of Cs-134 and Cs-137 are very irregular due to loss of Cs during the irradiation with a long crack in the cladding (Appendix B1).

Axial gamma scanning of rod 5 in test IFA-597.2.

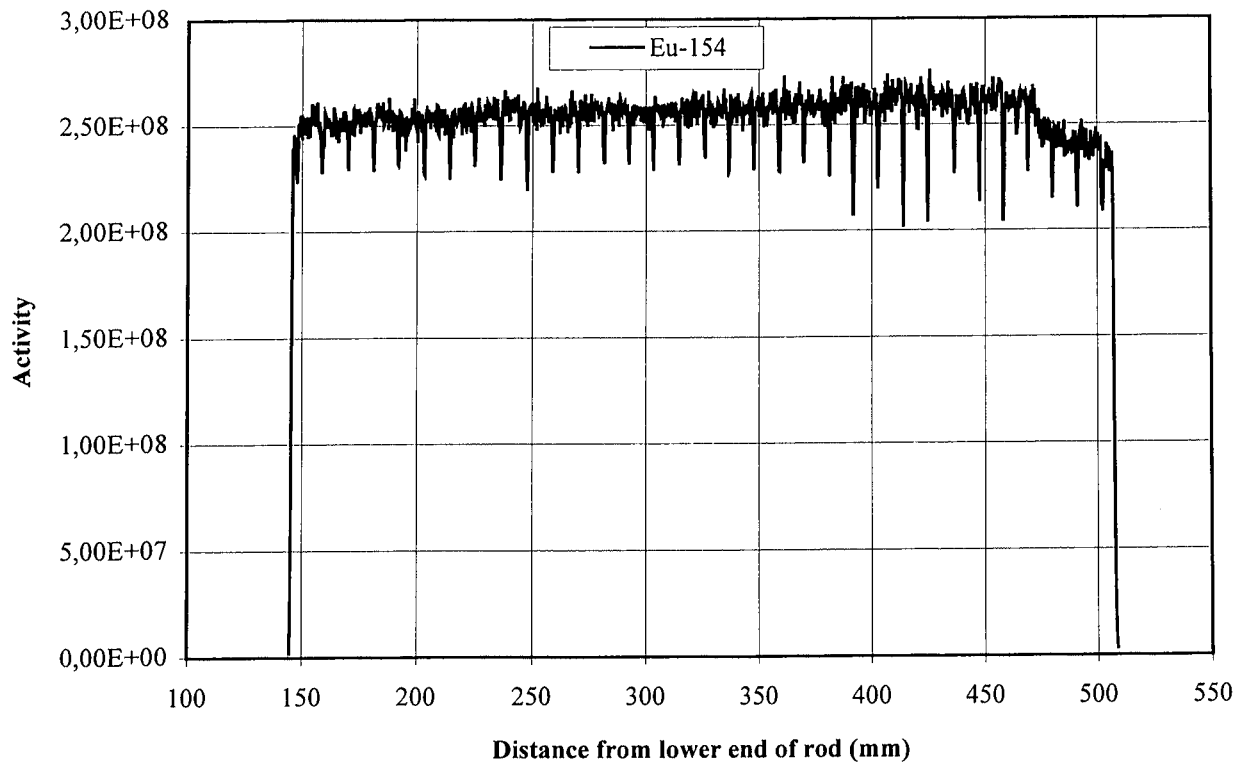
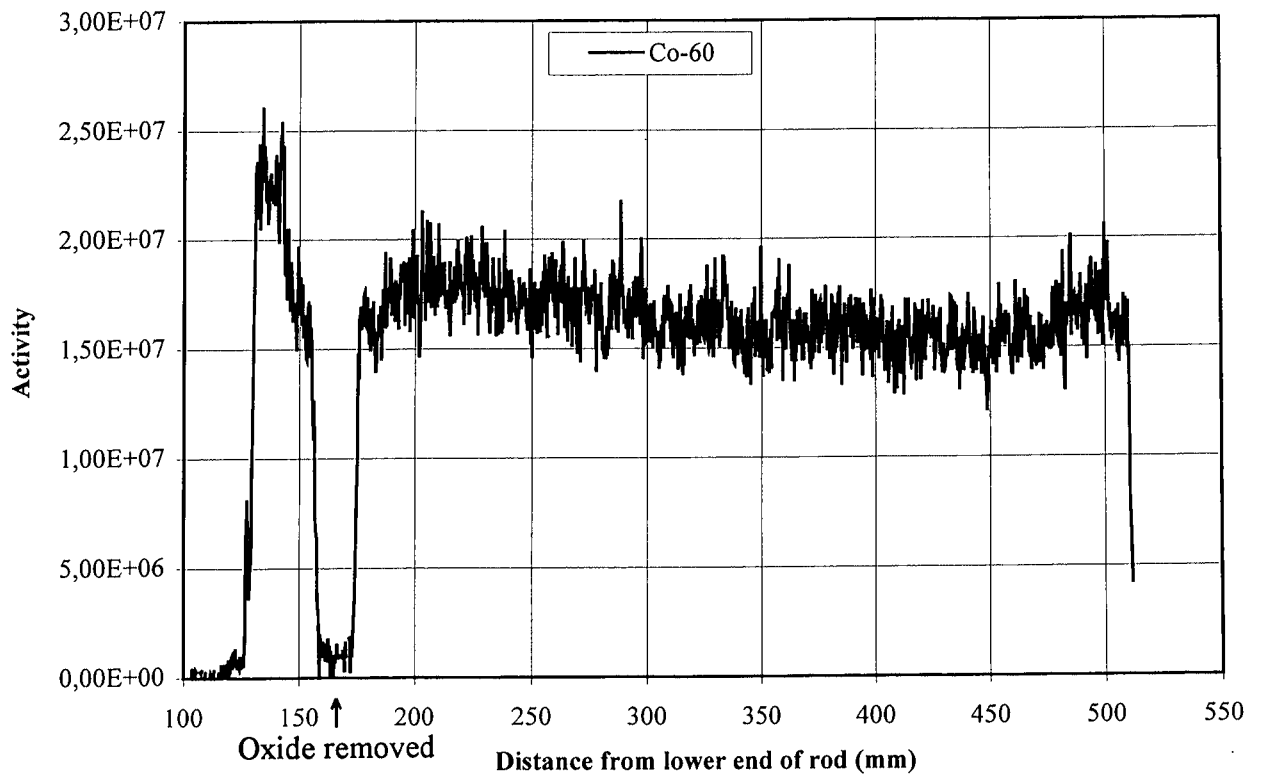
Appendix B2

The Co-60 activity originates mainly from crud deposited on the cladding during the irradiation in Ringhals 1. A region in the lower part, where the crud and oxide layer was removed in connection with refabrication is very conspicuous by the lack of Co-60 (Appendix B2). The highest Co-60 activity occurs in the lower part of the rod immediately below the UO_2 fuel and is caused by a spring in the gas plenum.

Axial gamma scanning of rod 5 in test IFA-597.2.

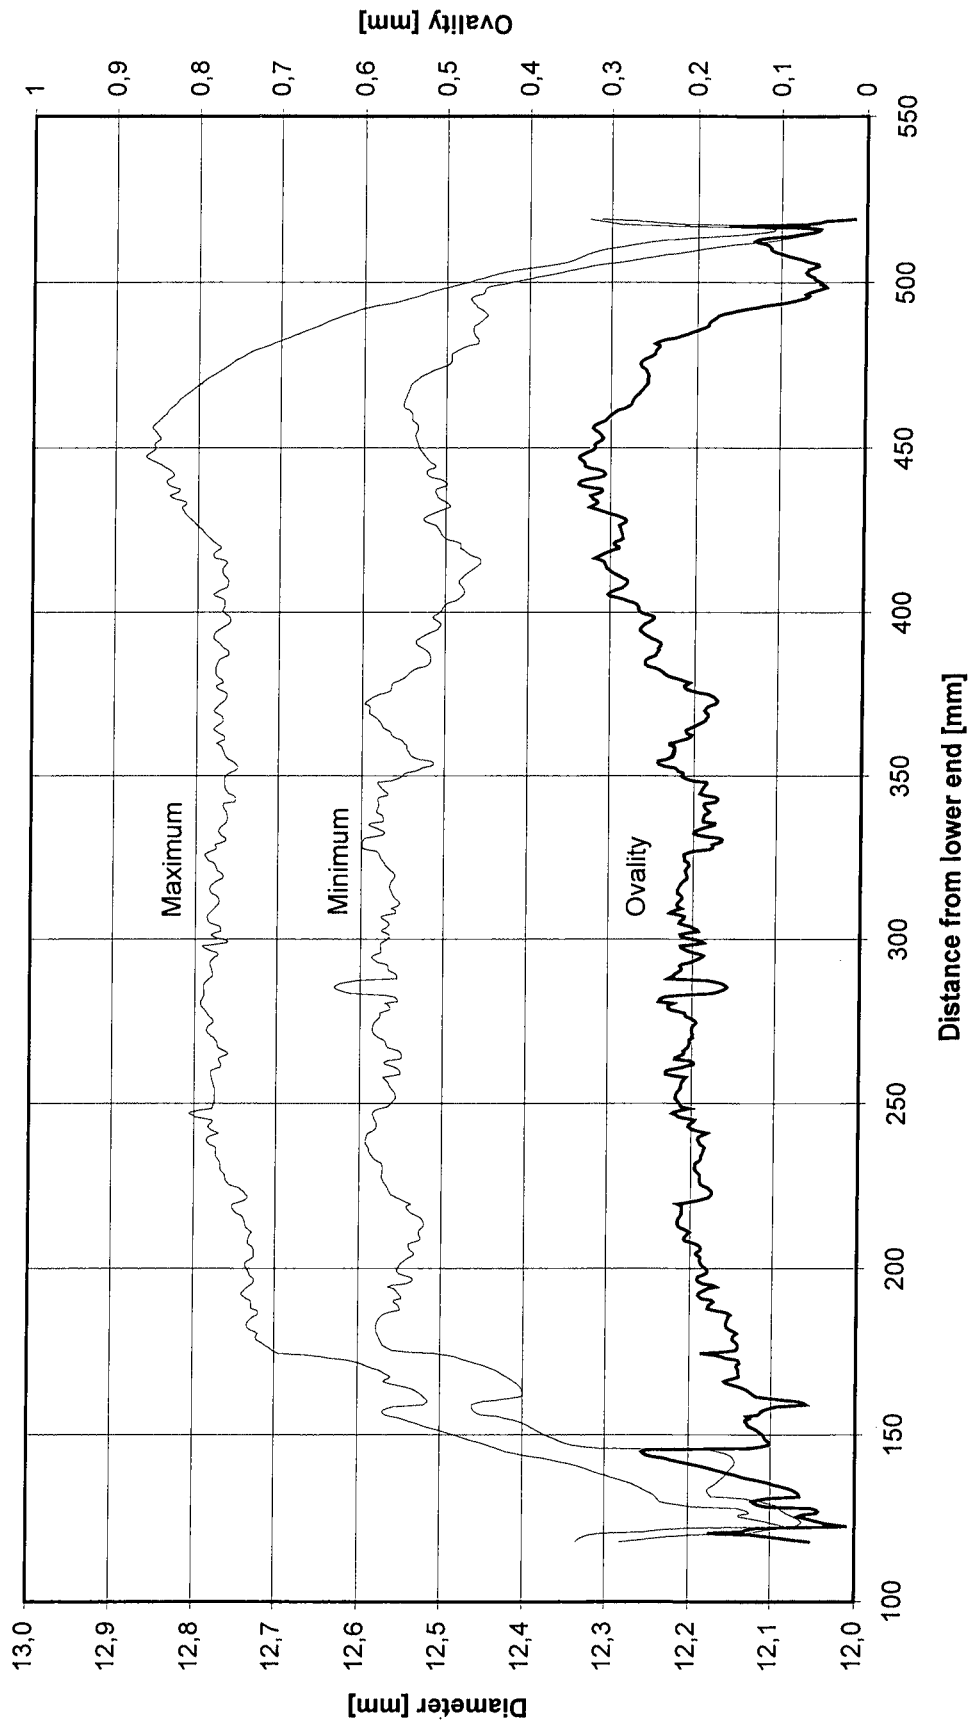
Appendix C2

A local minimum in the lower part of the rod (about 159-175 mm from the lower end of the rod in Appendix C2) is evidently caused by the removal of crud and outer oxide layer in this area in connection with the refabrication of the rodlet.

Profilometry of rod 5 in test IFA-597.2.
Diameter increase (min and max) and ovality.

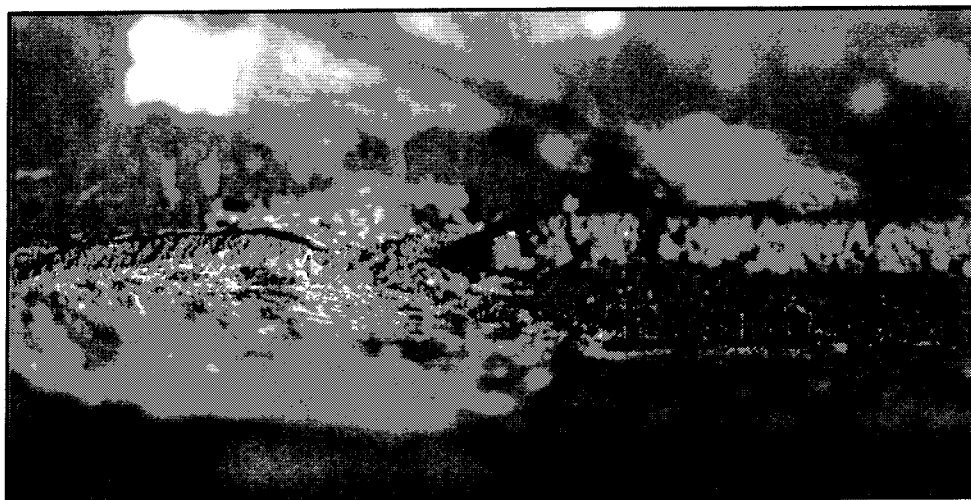
- near the upper end of the axial crack (Appendix D4, photo 3) and
- in a branch at the large step in the middle of the rod (Appendix D6, photo 1)
- at both sides of the branching at the lower end of the axial crack (one of these positions is shown in Appendix D5, photo 1)

D5.1 Detail of fracture surface with striations at the position where the crack is branched. 146 mm from rod bottom. Magnification 20x.

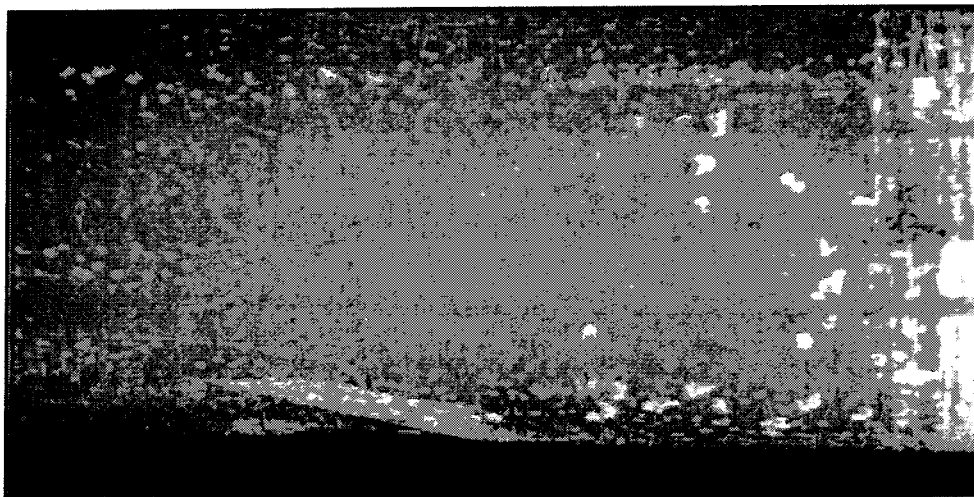
D5.2 Position where the crack is branched. Relative displacement between the sides of the crack indicates some shear component in the cracking mechanism. 146 mm from rod bottom. Magnification 5x.

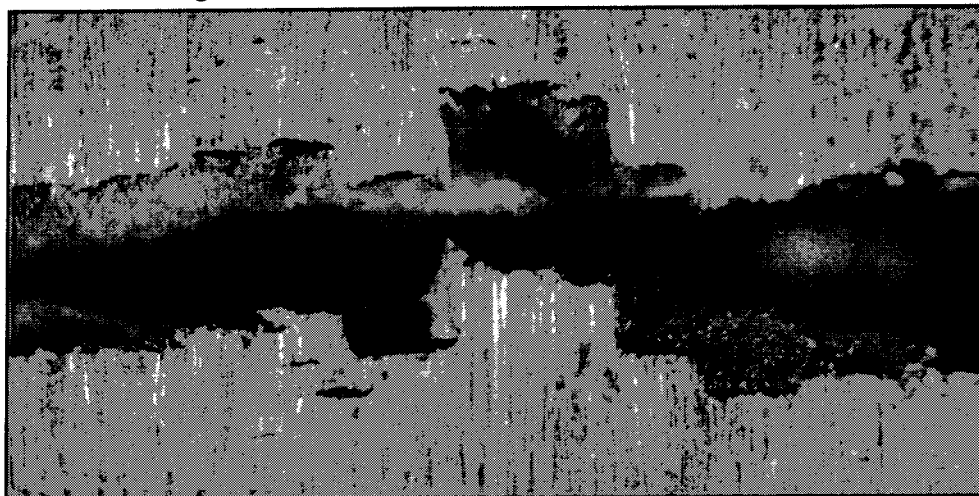
Minor cracks beside the main crack were observed about 166 mm (Appendix D5, photo 3) and 417 mm from the lower end (Appendix D3, photo 3). It was suspected early during the examination that the axial cracks had started at these observed locations with minor cracks beside the main crack, which could explain two axial cracks meeting each other about 286 mm from the lower end of the rod.

outer oxide layer was removed in connection with the refabrication at Kjeller (Appendix D1). The difference is however only partial. Steps occur also at other axial positions but are less conspicuous in regions with thick outer oxide. The minor cracks beside the main crack shown in Appendix D5, photo 3 are located at positions of oxide nodules in the outer oxide layer.

D5.3 Detail at position in the lower part of the rod where the outer oxide layer was removed in connection with refabrication. Observe minor cracks in oxide nodules beside main crack. 166 mm from rod bottom. Magnification 20x.

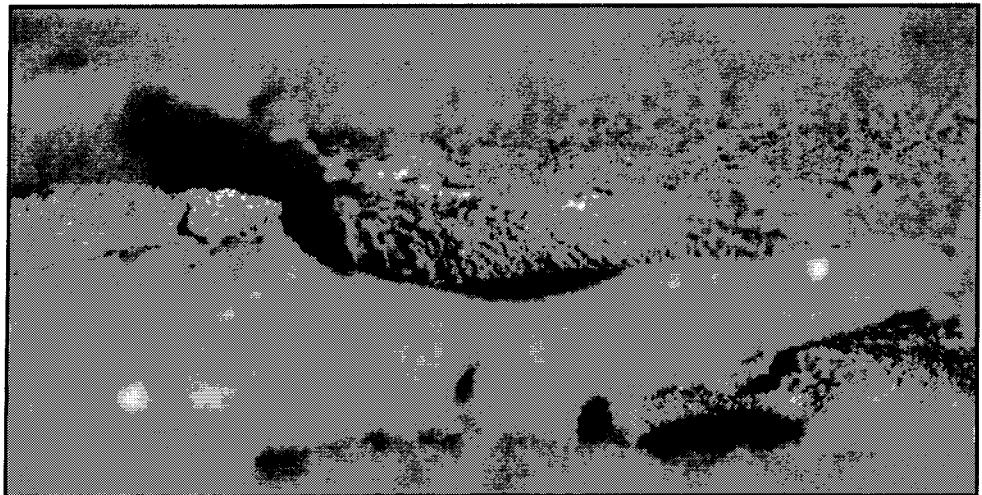
D6.1 Detail of fracture surface with striations. 286 mm from rod bottom. Magnification 20x.

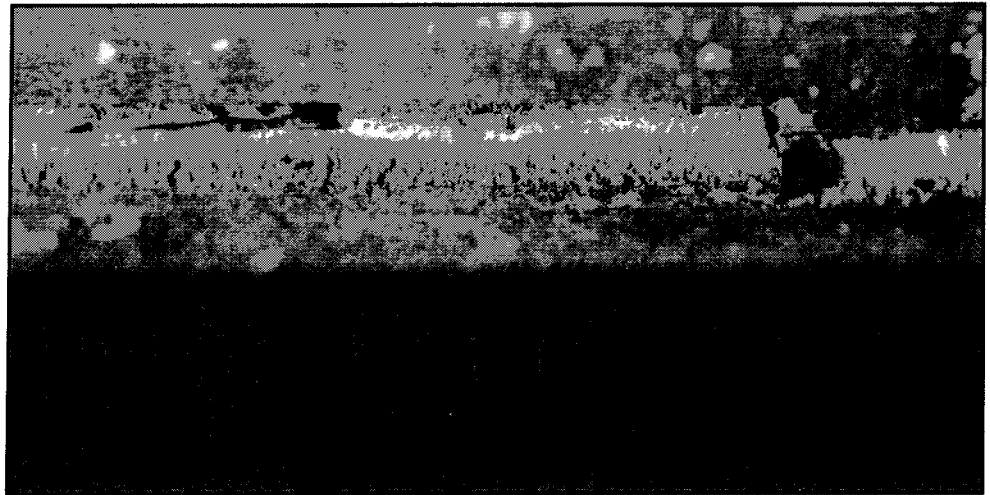
D6.2 Detail of fracture surface. Varying depth of part of fracture surface perpendicular to outer surface of the cladding. 373 mm from rod bottom. Magnification 10x.

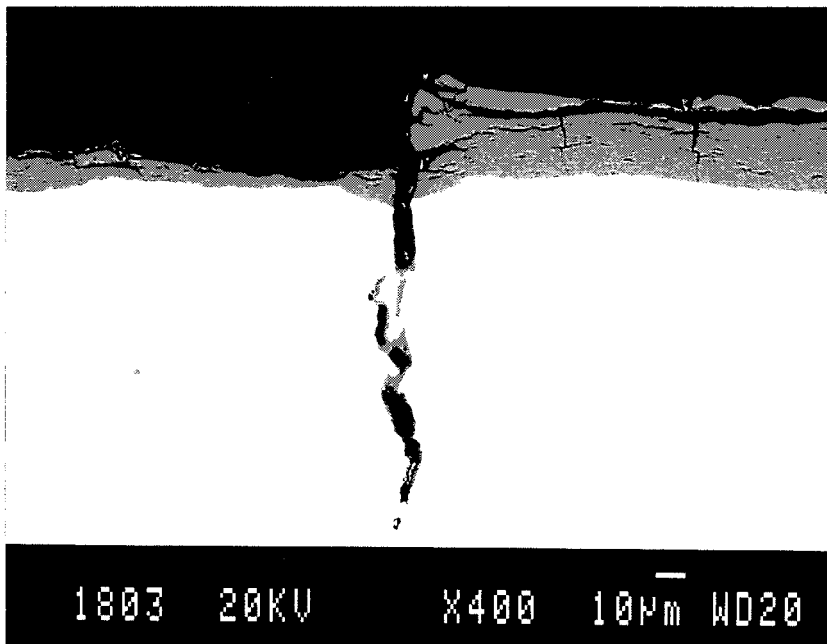
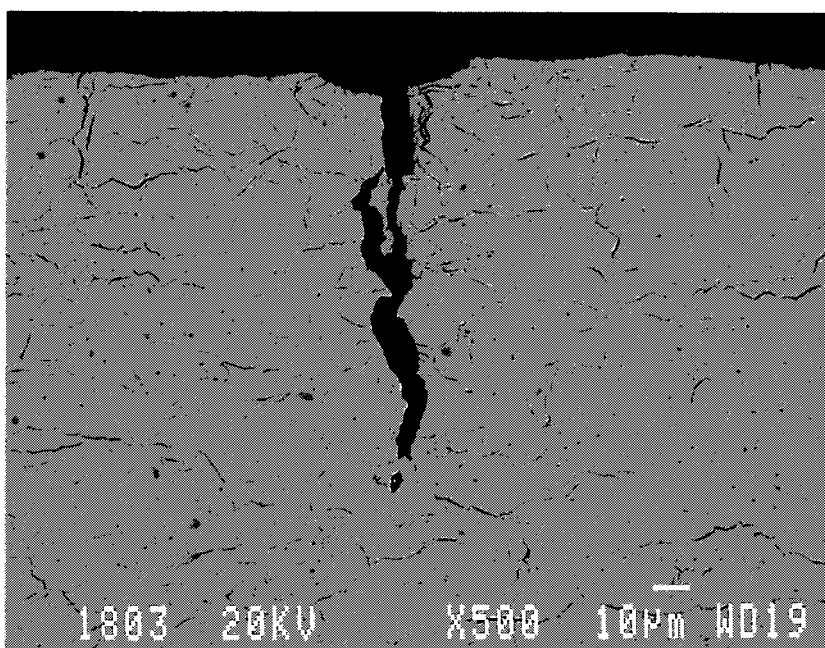
Appendix F5

Oxide contrast image. Magnification 400x.

Hydride contrast image. Magnification 500x.

Scanning electron microscopy of polished cladding surface.
Rod 5 in test IFA-597.2. Specimen 1803, 383 mm from rod bottom.

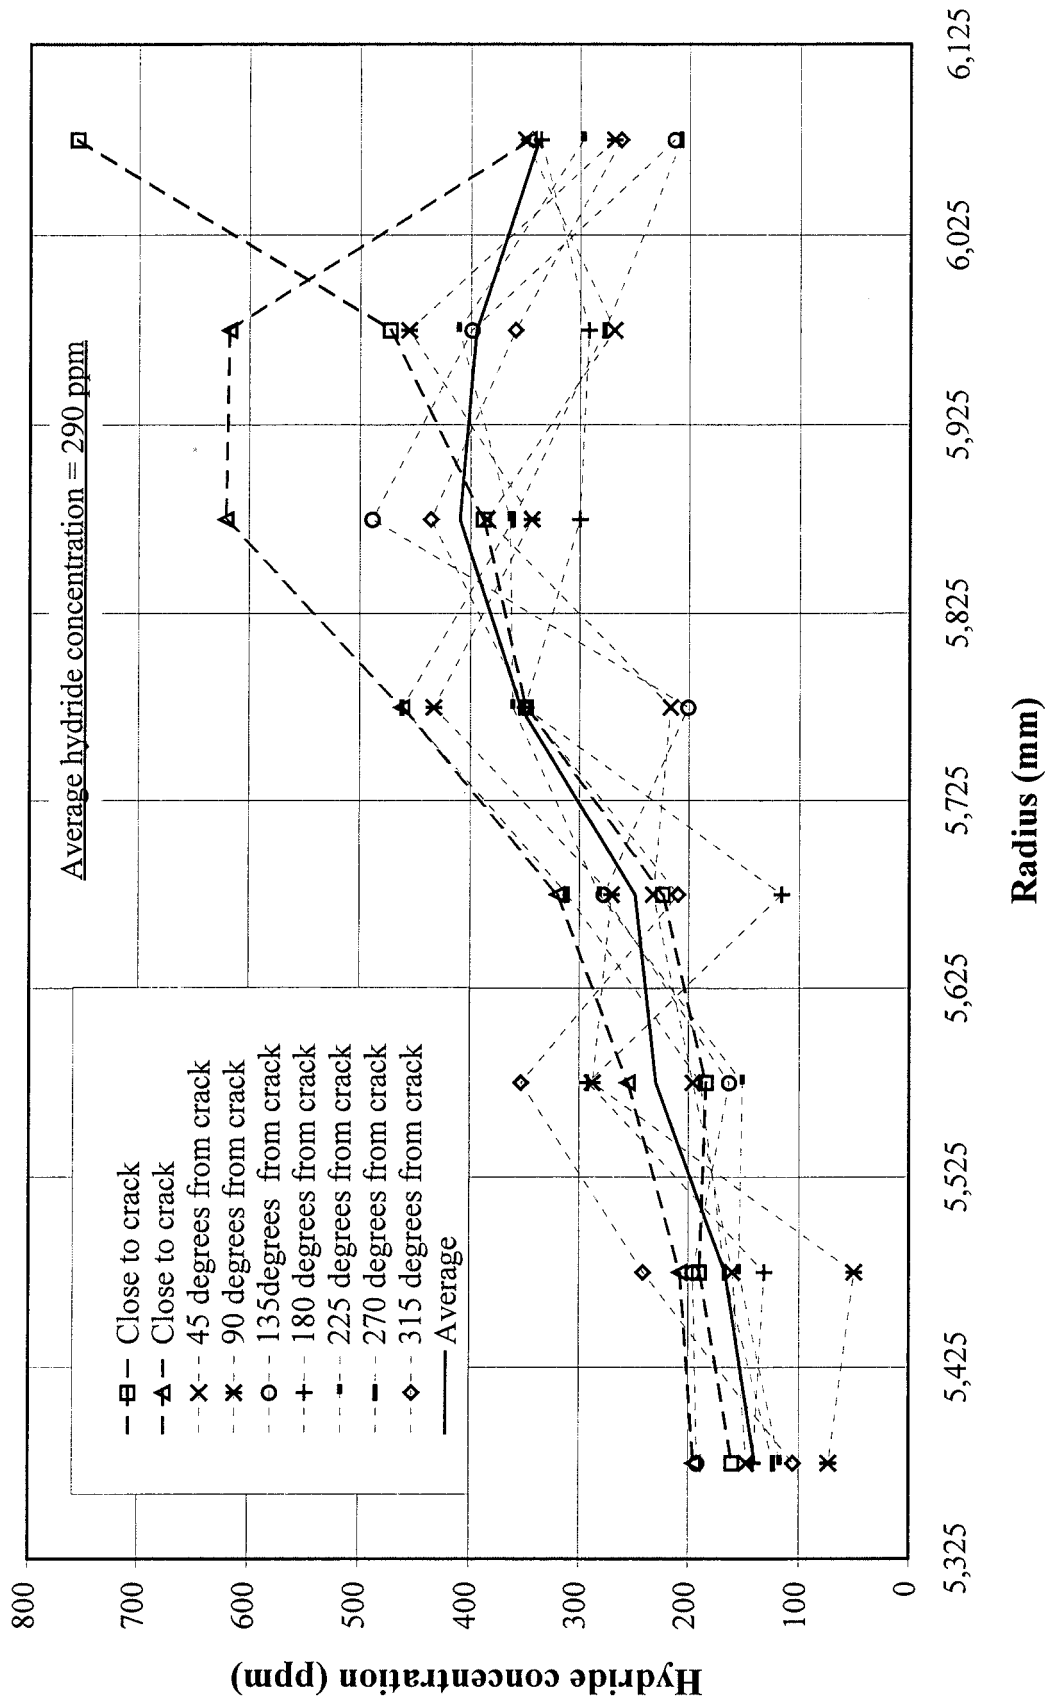
Appendix F8

The measured hydrogen contents are shown in Appendix F8. The curves refer to different angular positions with the crack at 0°. Two of the curves refer to measurements close to the crack, one measurement on each side.

The average measured hydrogen content amounts to 290 ppm H equivalents. The measurements show somewhat higher hydrogen content in the vicinity of the crack. The angular variation in hydride concentration may be insignificant or caused by the temperature gradients after the formation of the crack and not necessarily an explanation for the localisation of the crack.

Scanning electron microscopy of polished cladding surfaces. Rod 5 in test IFA-597.2. Specimen 1803, 383 mm from rod bottom. Measurements of hydride content at 8 different angular orientations.

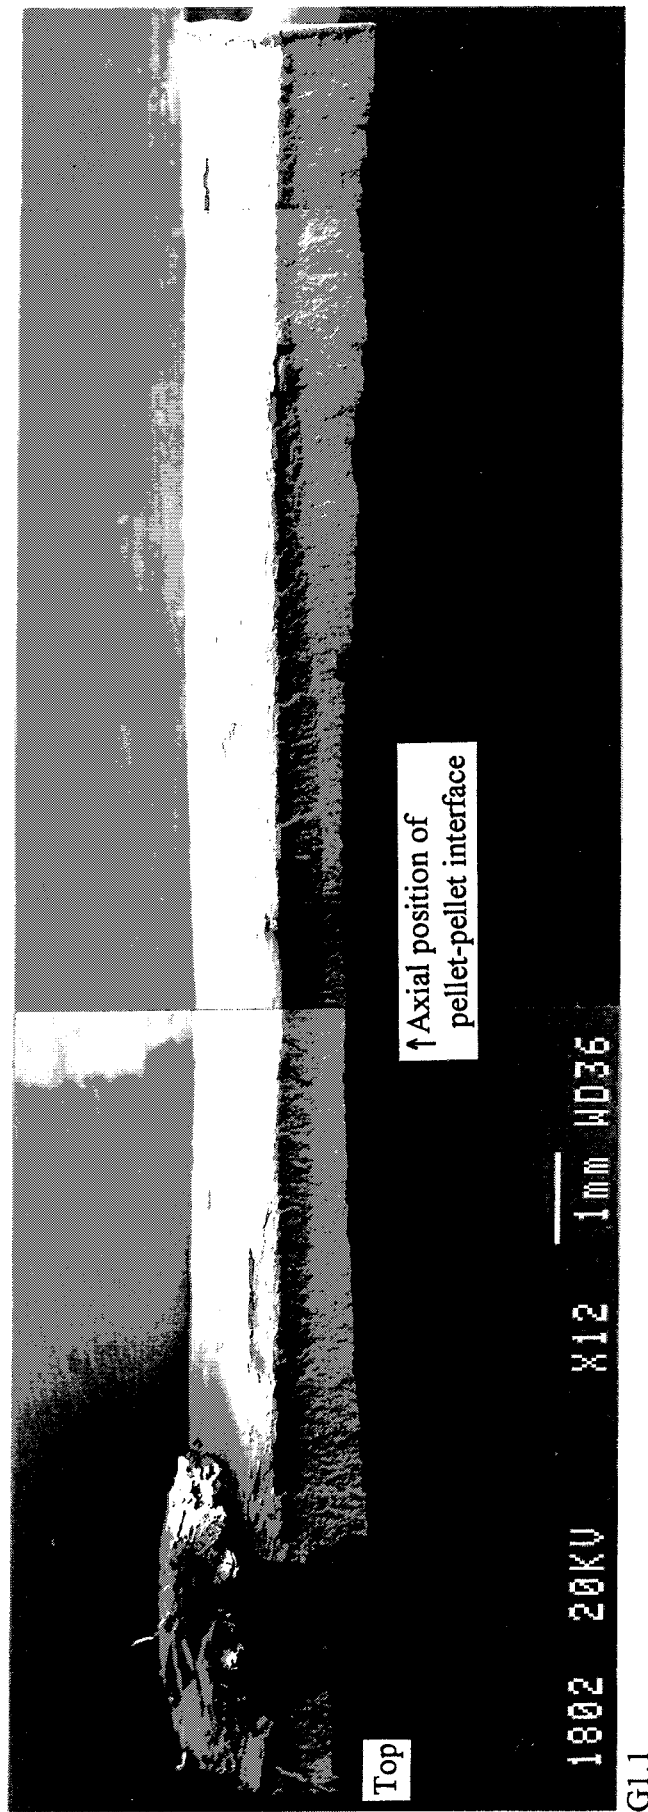
Appendix G1

The final shear crack is a small part of the crack surface in specimen 1802 (Appendix G1) and a large fraction of the crack surface in specimen 1801 (Appendix G7).

Scanning electron microscopy of cladding fracture surfaces.
Rod 5 in test IFA-597.2. Specimen 1802, 360-380 mm from rod bottom. Overview of specimen.
Magnification 12x.

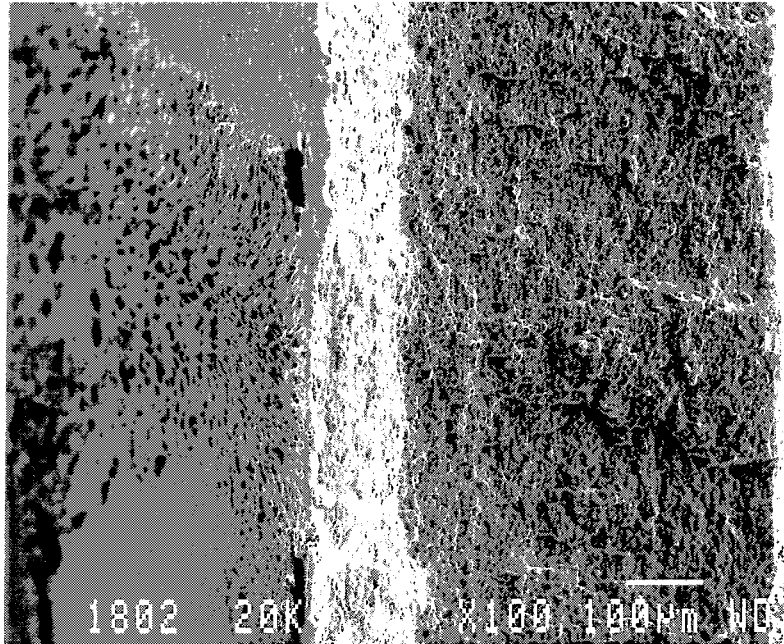
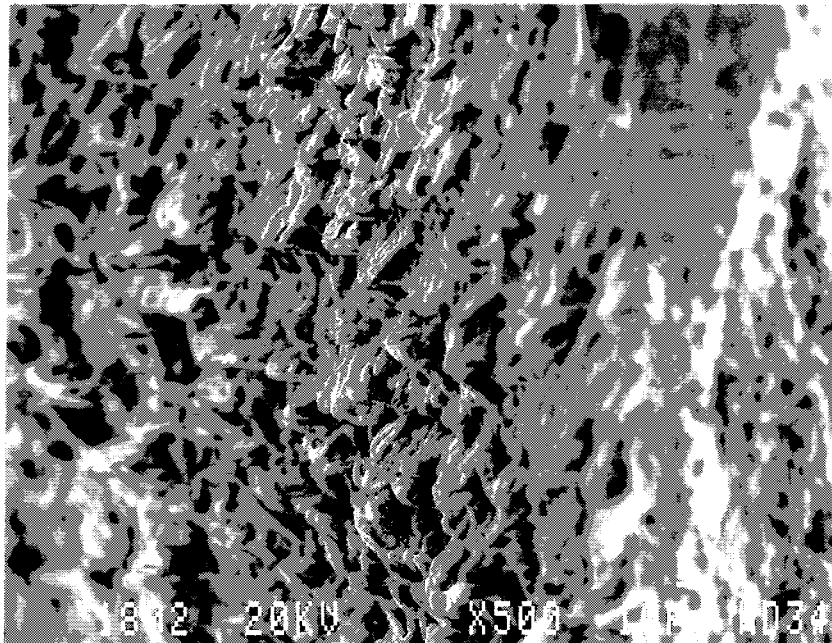
Appendix G6

G6.1 Overview of pellet-pellet interface. Magnification 100x.

G6.2 Detail of photo G6.1. Magnification 500x.

Scanning electron microscopy of cladding fracture surfaces. Rod 5 in test IFA-597.2. Specimen 1802. Clad inside oxide at position for pellet-pellet interface. Position see photo G3.1 in Appendix G3.

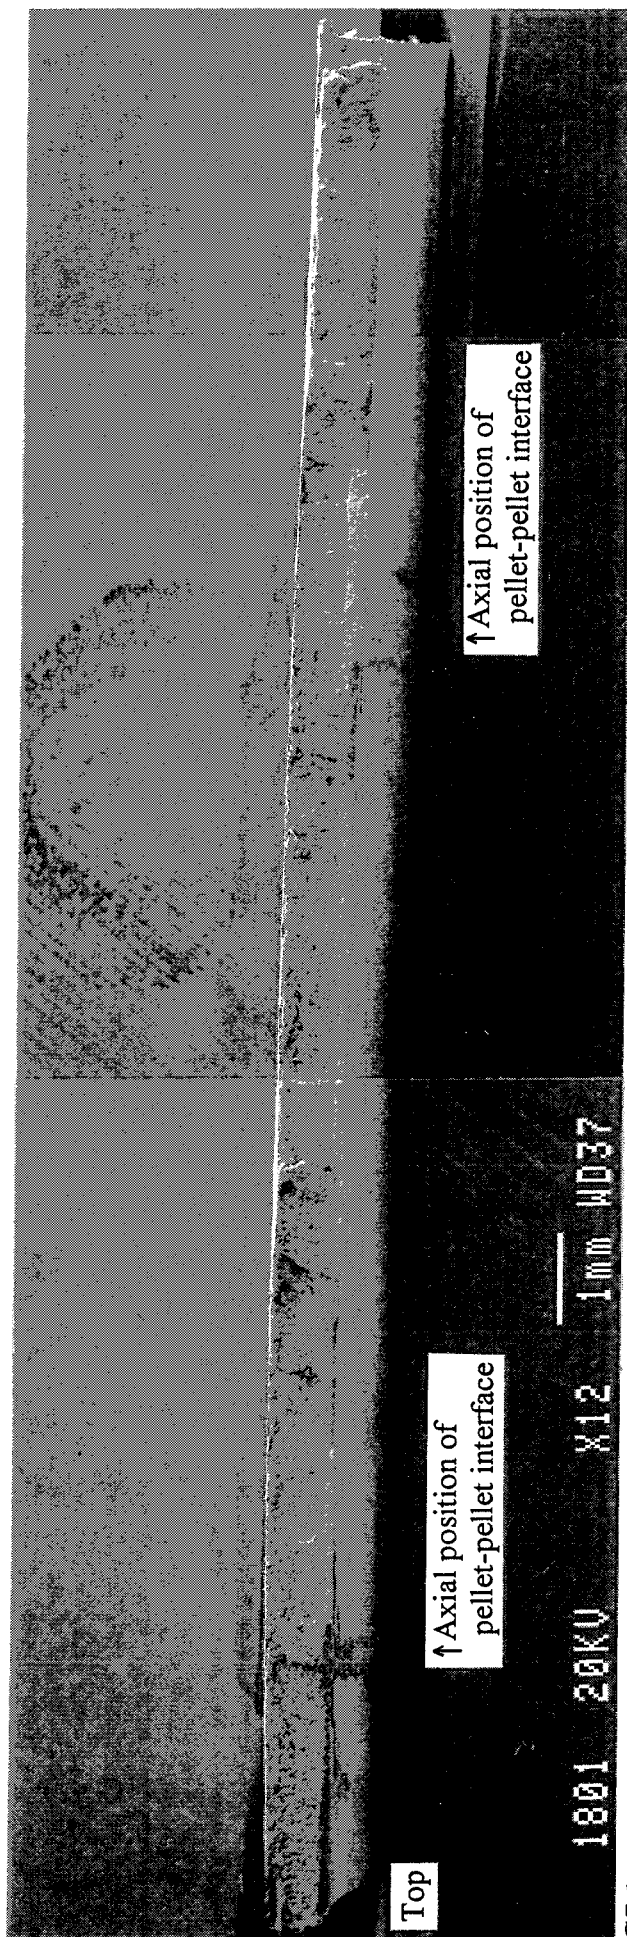
G7.1

Appendix G7 Scanning electron microscopy of cladding fracture surfaces.
Rod 5 in test IFA-597.2. Specimen 1801, 487-507 mm from rod bottom. Overview of specimen.
Magnification 12x.
