SKI Perspective

SUMMARY

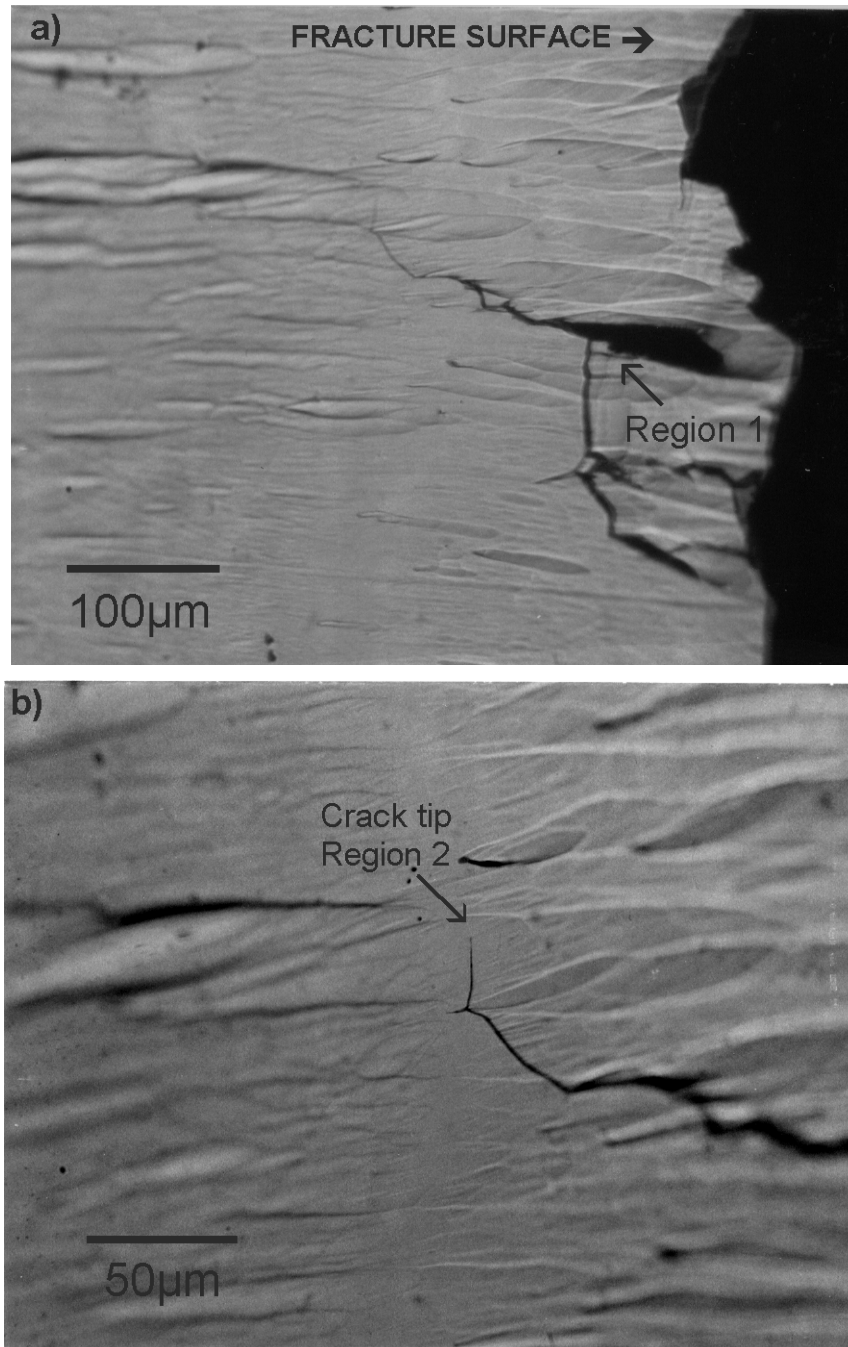
Figure 2 shows optical micrographs of the section of material selected for study. The extensive secondary cracking extends several grains away from the original crack plane.

Figure 2: Optical micrographs of prepared electron microscopy sample showing regions selected for analysis. a) Tertiary crack ~300µm from primary crack b) Crack tip.

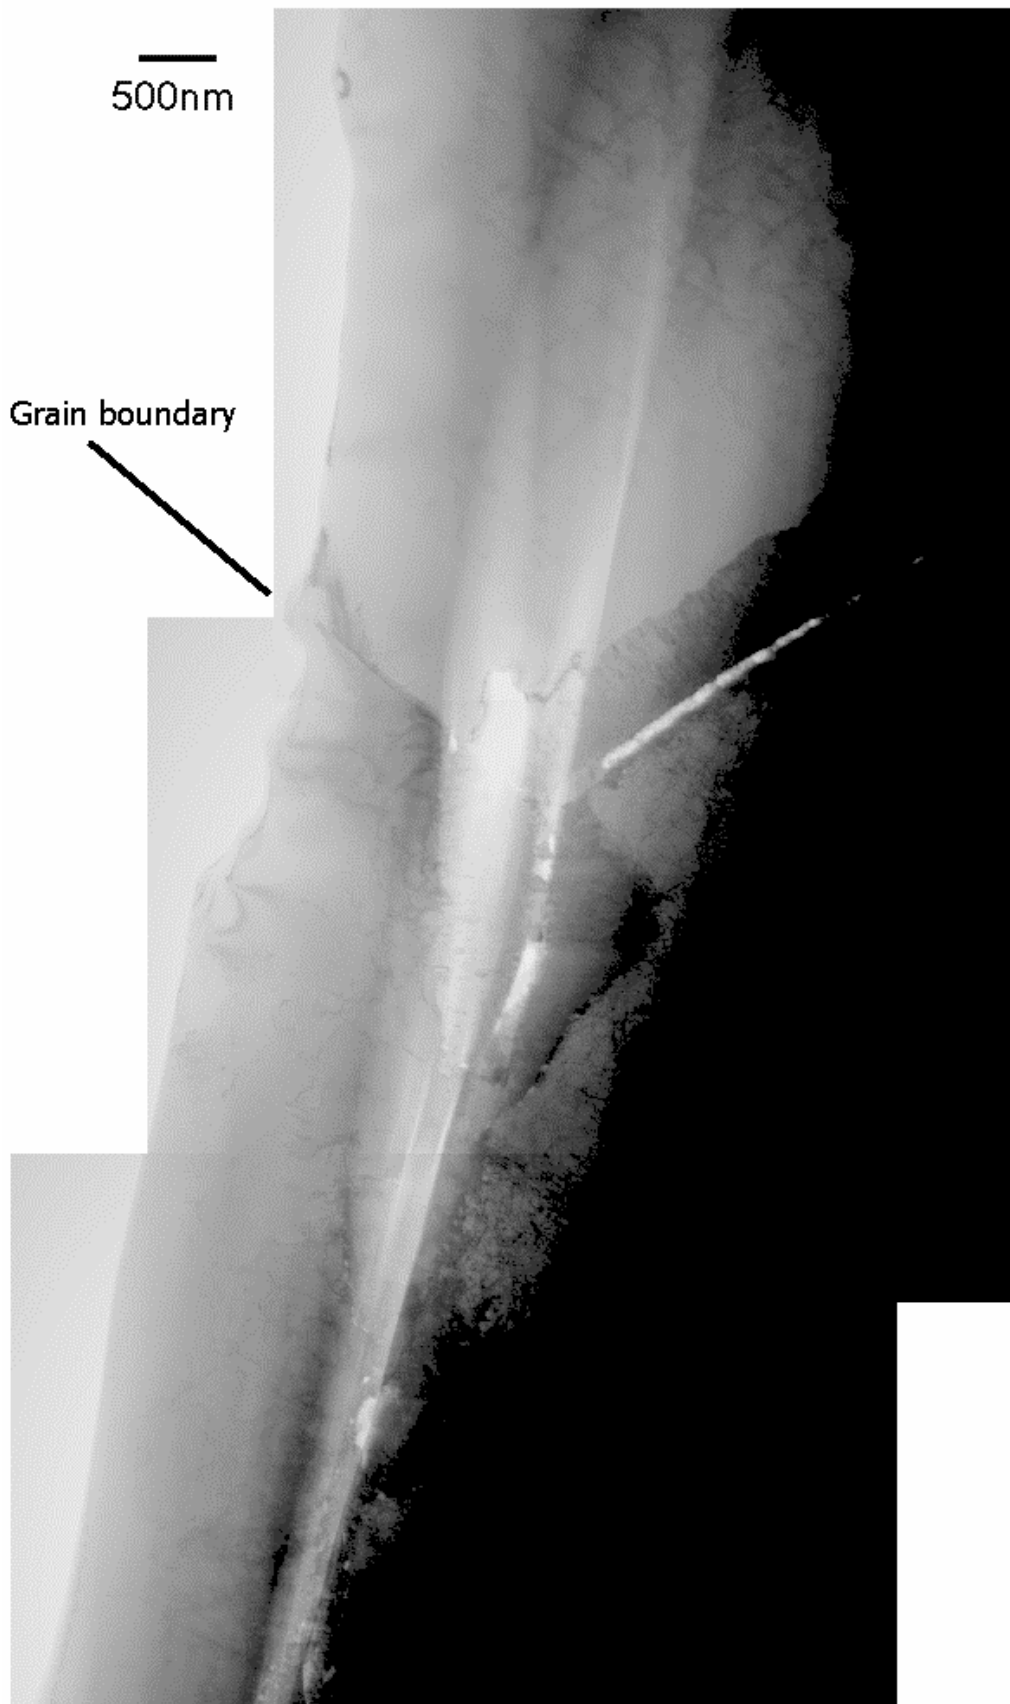
The first region studied (indicated in Figure 2a) was a branch off the main secondary crack and must have grown parallel to the stress axis within the CT sample. An electron micrograph of part of this crack is shown in Figure 3. The crack appears to have propagated along a grain boundary and changed direction at a triple point. The crack-walls are heavily oxidised and Figure 4a shows the open crack and the oxidised crack-wall near the triple point. At this point the oxide is ~500nm thick and is duplex in structure with the oxide near the metal showing a columnar grain structure whereas the grain structure of the layer adjacent to the crack is equiaxed. The oxide here is rich in chromium and iron and compositionally is more like an iron-substituted chromium oxide, $(\text{Fe,Cr})_2\text{O}_3$, than an iron chromite FeCr_2O_4 phase. Also shown in Figure 4b is a semi-quantitative compositional linescan across the oxide. The linescan starts in the steel before moving into the columnar-grained oxide. The point where the columnar structure ends and the equiaxed structure begins is also the point where the sulphur and nickel content of the oxide begins to increase. The results of quantitative analyses near the crack face are shown in Figure 5. The sulphur content of the oxide increases by a factor of ~2 in the 250nm from the centre of the oxide to the crack face. This image shows the crack is largely open but does contain some deposits. This crack-fill consisted of three components: (i) Fe,Cr-rich oxide (ii) an iron oxide [A] and (iii) a nickel sulphide [B]. X-ray spectra from these three components are shown in Figure 6. Most notable of these is the nickel sulphide, though the composition ($\sim\text{Ni}_2\text{S}$) suggests that this is not the Ni_2S_3 phase suggested by Hermansson. Though this spectrum shows a small oxygen peak, this is probably associated with traces of the oxide rather than belonging to the sulphide. Other spectra from this phase consistently show no oxygen content and also a constant composition.

Figure 3: Montage of electron micrographs showing analysis region 1. Crack walls are heavily oxidised and crack still is quite open.

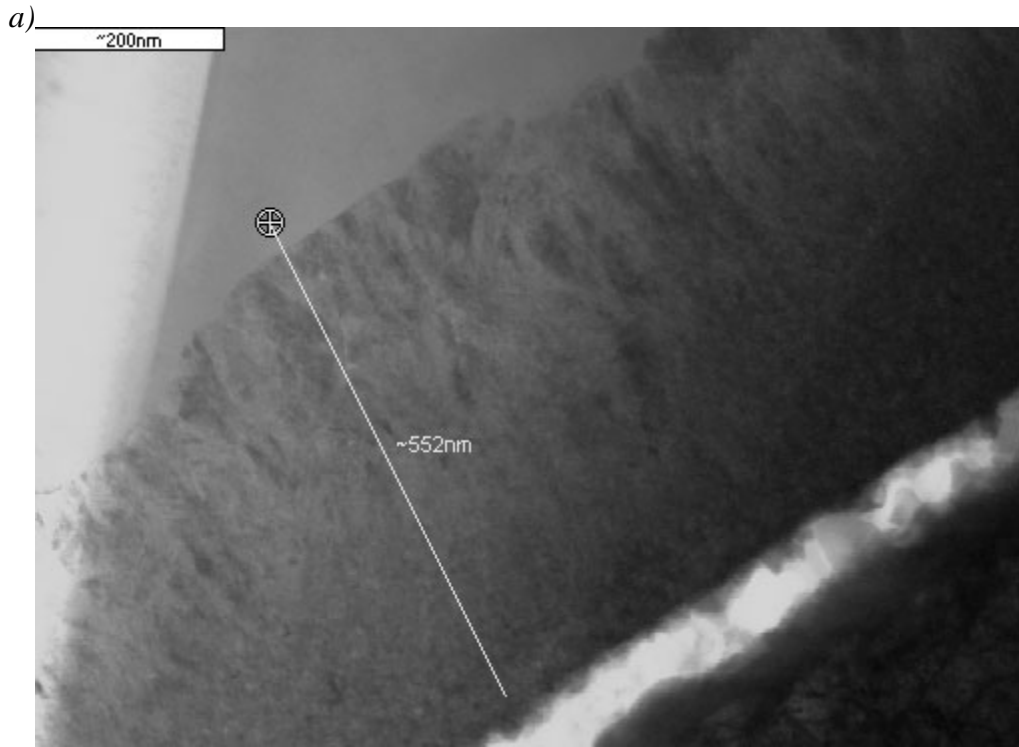
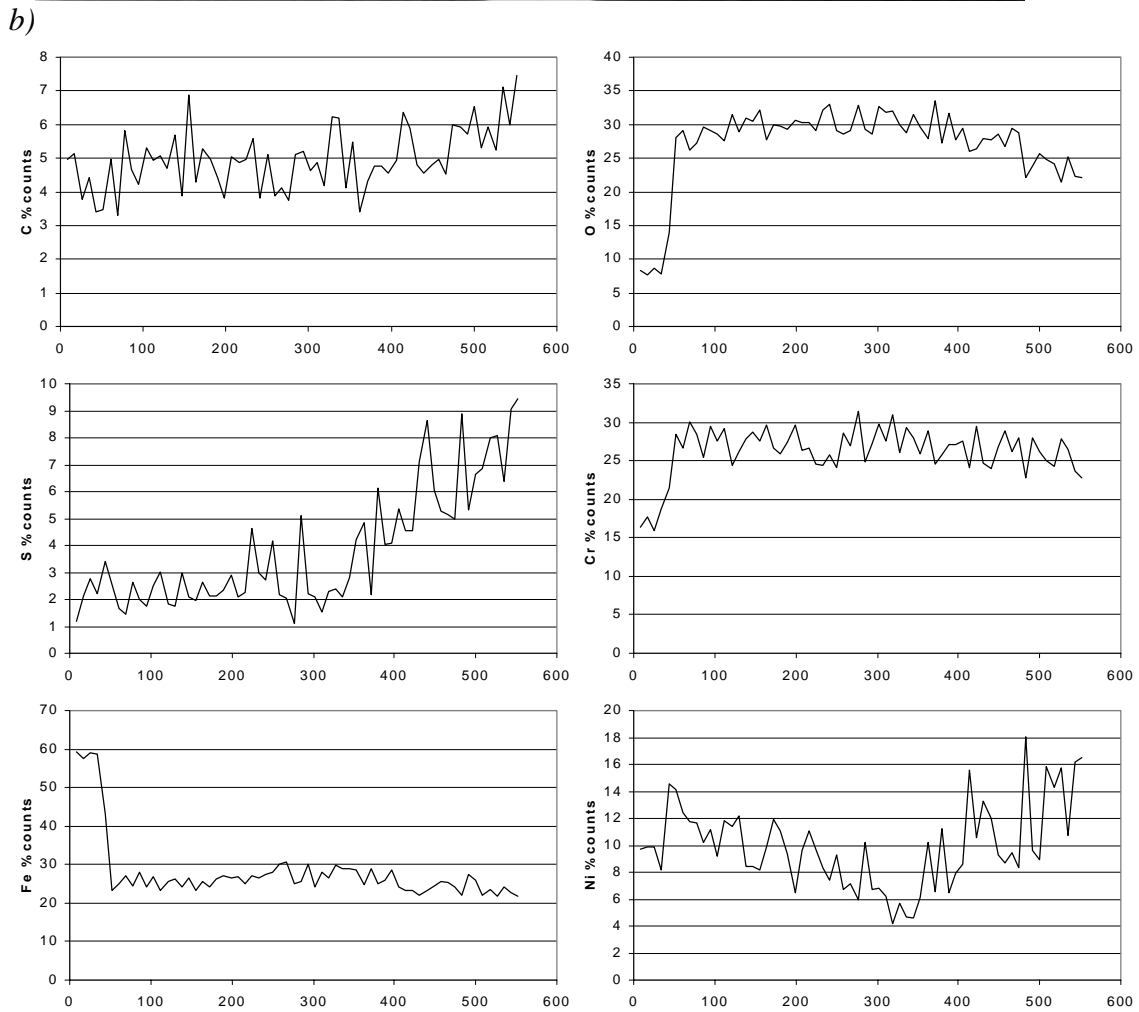
Figure 4: a) Crack wall oxide showing columnar and equiaxed layers b) semi-quantitative compositional profile along indicated line (distances in nanometres).

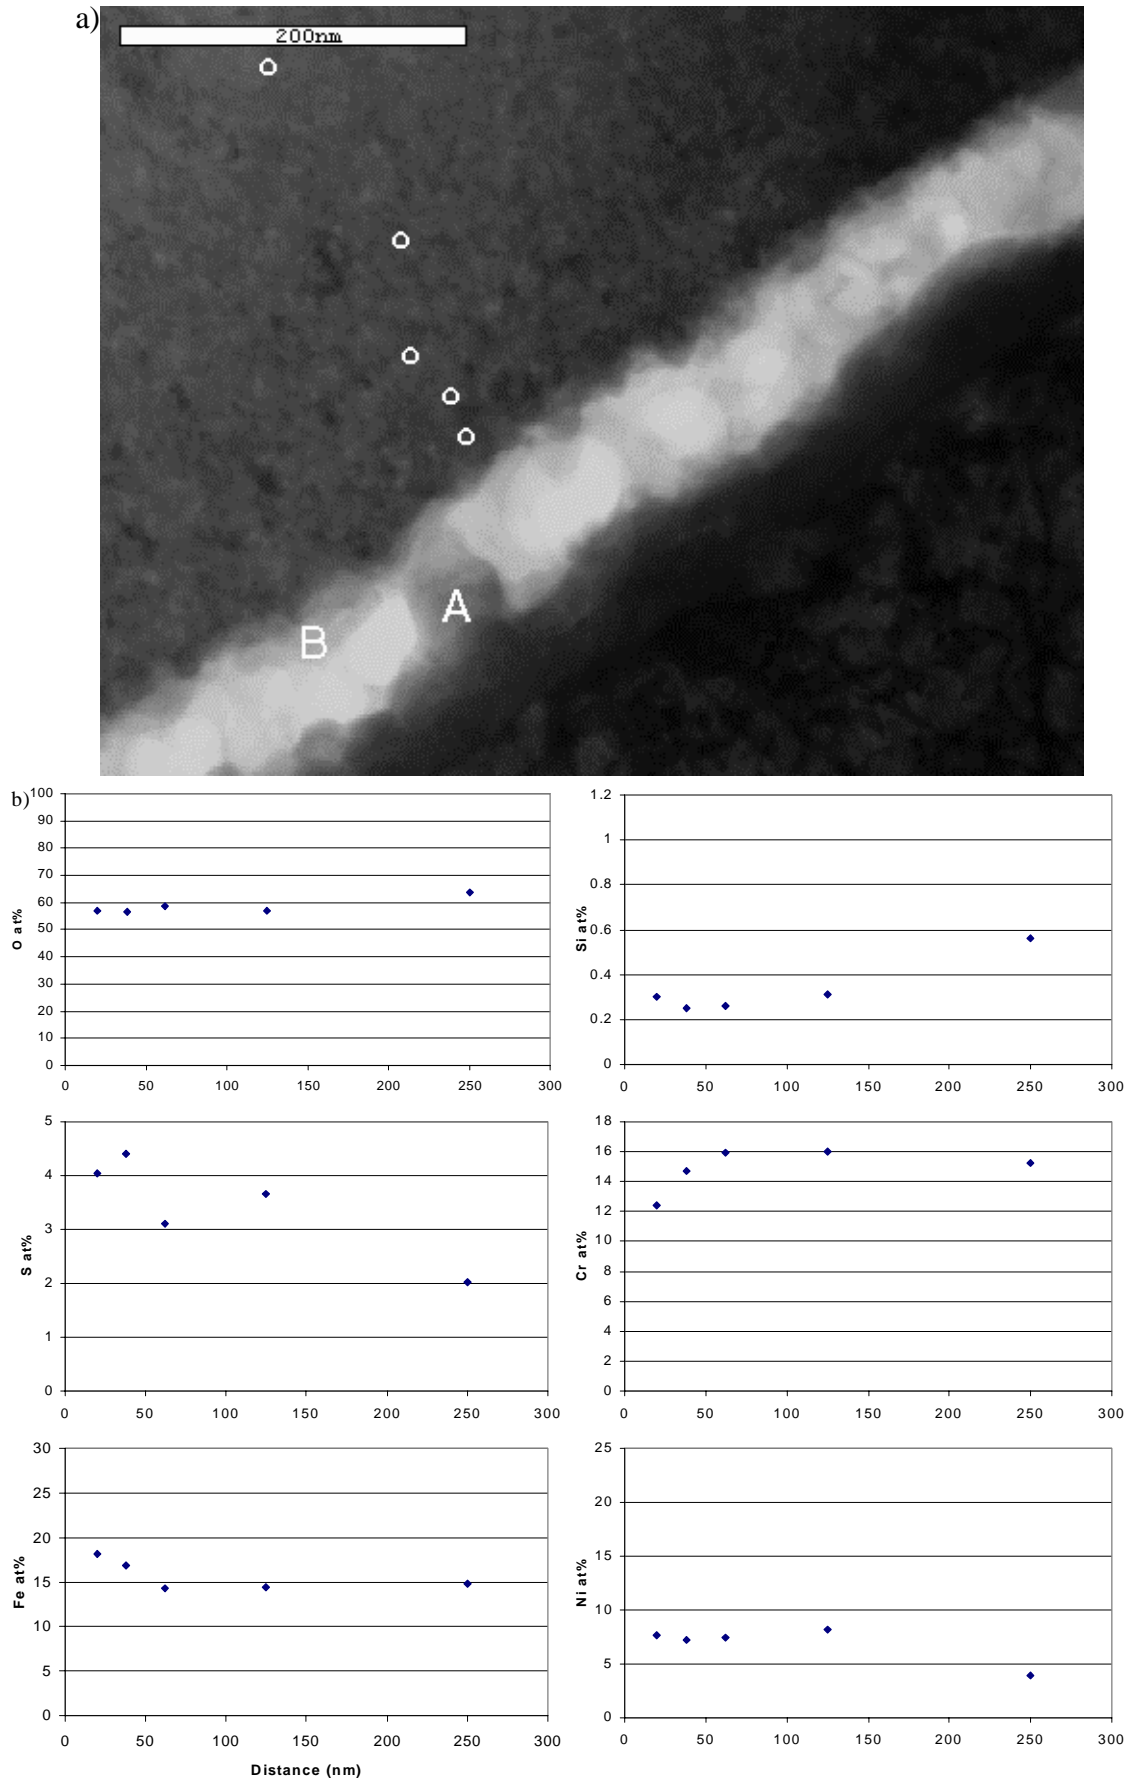
Figure 5: a) Crack in oxide showing analysis positions in crack-fill and crack-wall b) Analysis of crack-wall oxide as a function of distance from crack face

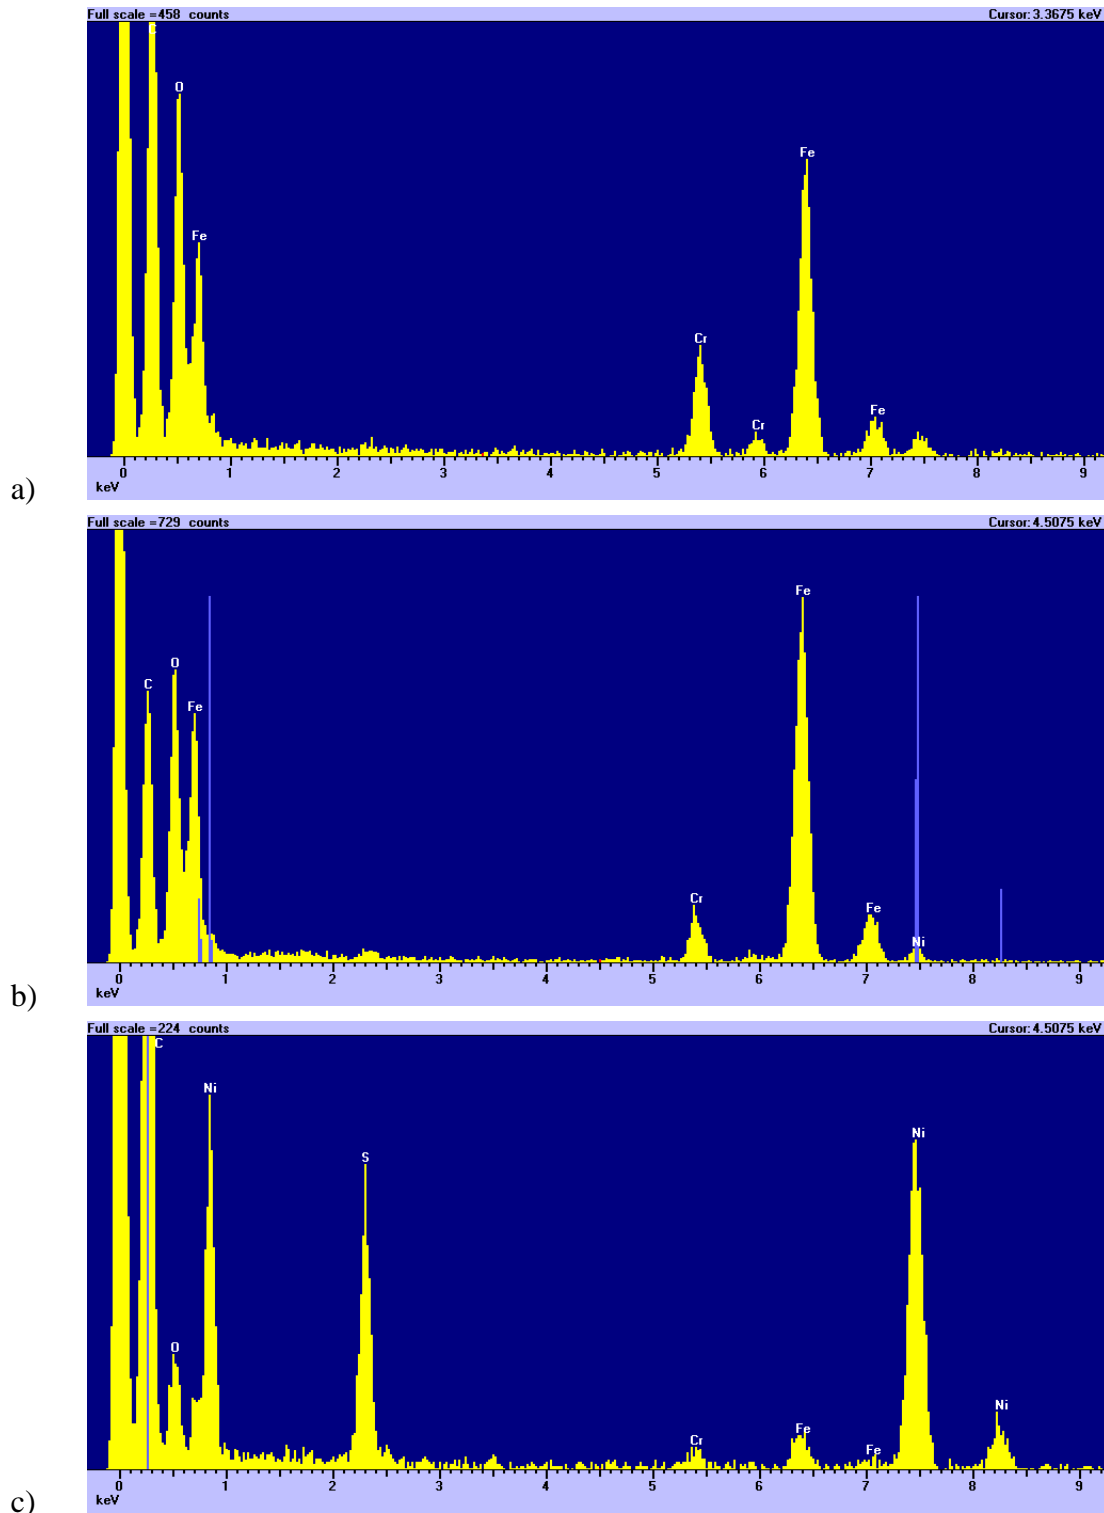
Figure 6: X-ray spectra from crack-fill constituents
a) Fe,Cr-rich oxide
b) Iron oxide (A in Figure 5)
c) Nickel sulphide (B in Figure 5)

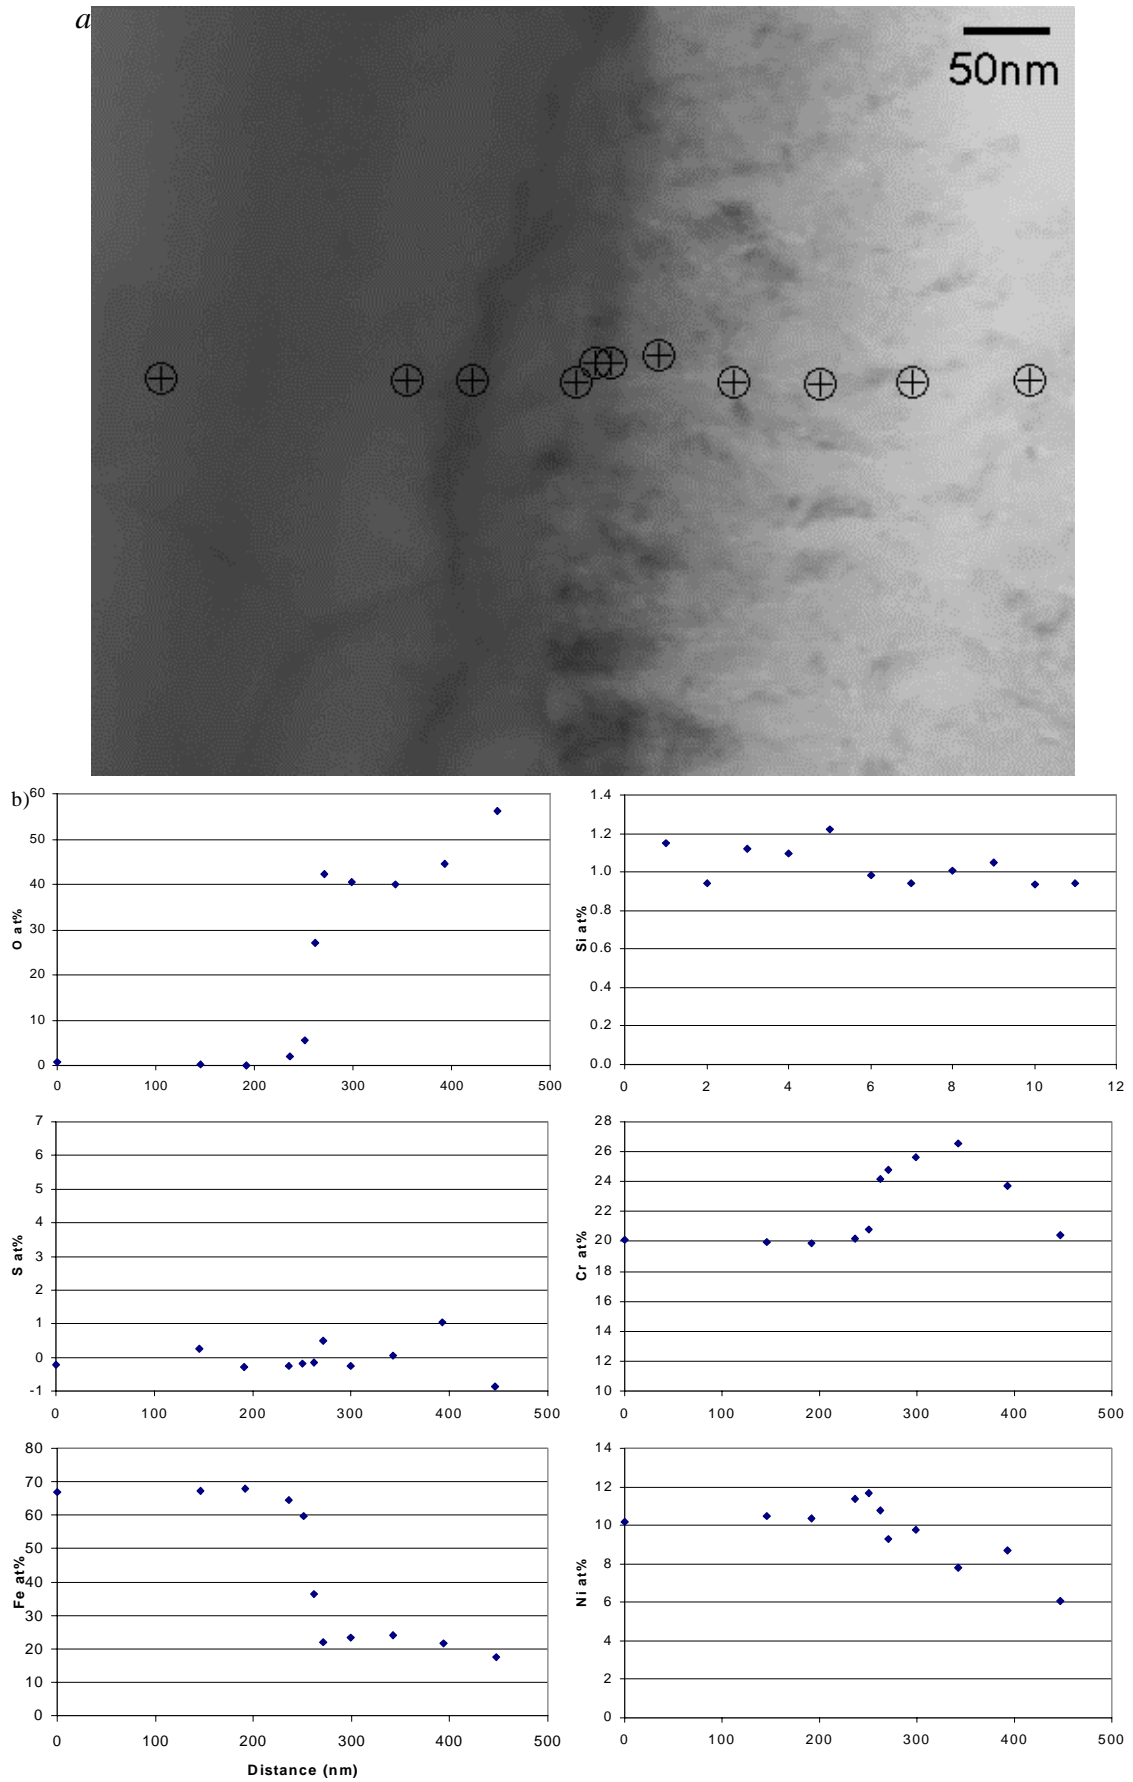
Figure 7 shows an image of the boundary between the 304 steel and the crack-wall oxide together with the analysis locations. The compositional profile generated from this data is given in Figure 7b. The oxide in this location is of the columnar-grained type and has a very low sulphur content. An interesting observation is that nickel appears to be slightly enriched at the boundary between the metal and the oxide. This result is

Figure 7: a) Image of metal-oxide boundary b) Compositional analysis across the interface

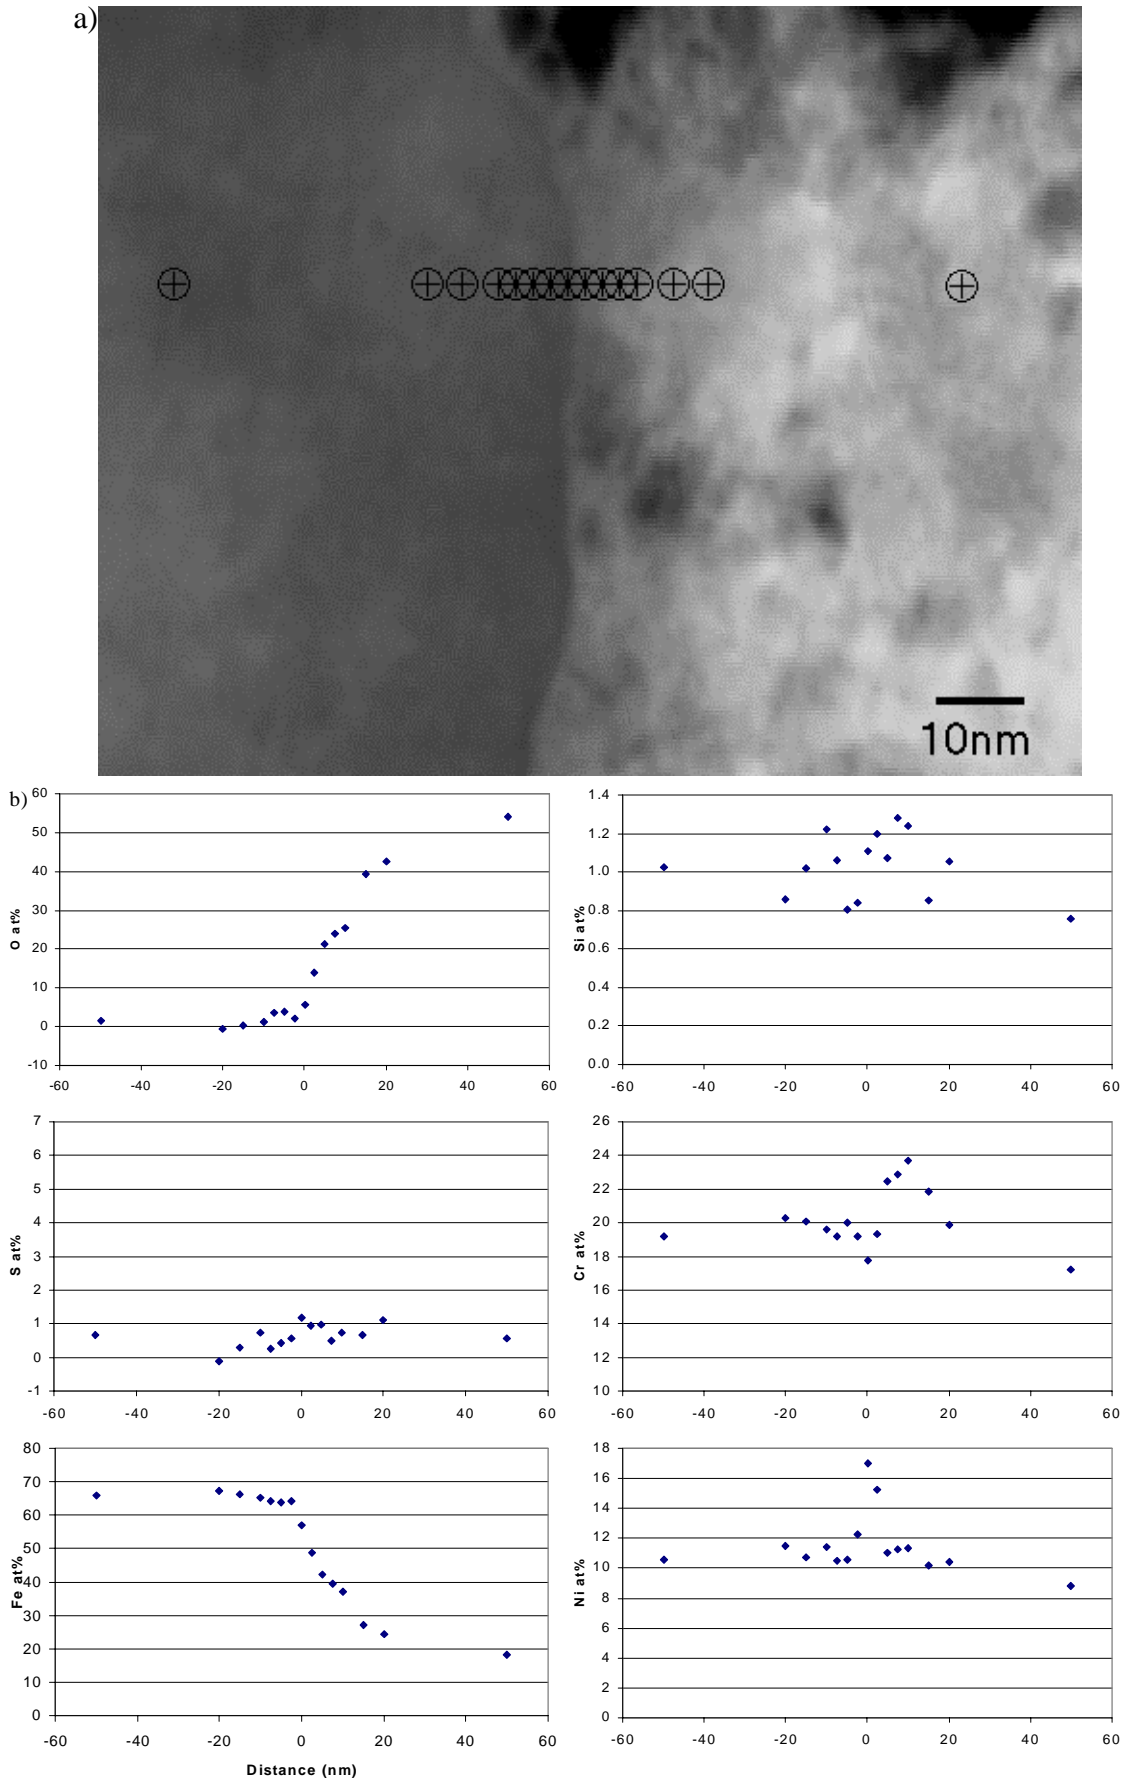
repeated in Figure 8 where a more detailed examination of an interface region was made. In this case, the boundary between the metal and the oxide was accurately aligned parallel to the electron beam. At this boundary, nickel was found to be sharply segregated. The profiles for iron and oxygen, however, exhibit a transition zone about 20nm wide in which the concentration gradually changes. The chromium concentration profile also exhibits a boundary region, though in this case, the concentration is raised compared to both the metal and the oxide.

Figure 8: a) High magnification image of metal/oxide boundary b) Compositional analyses across the interface

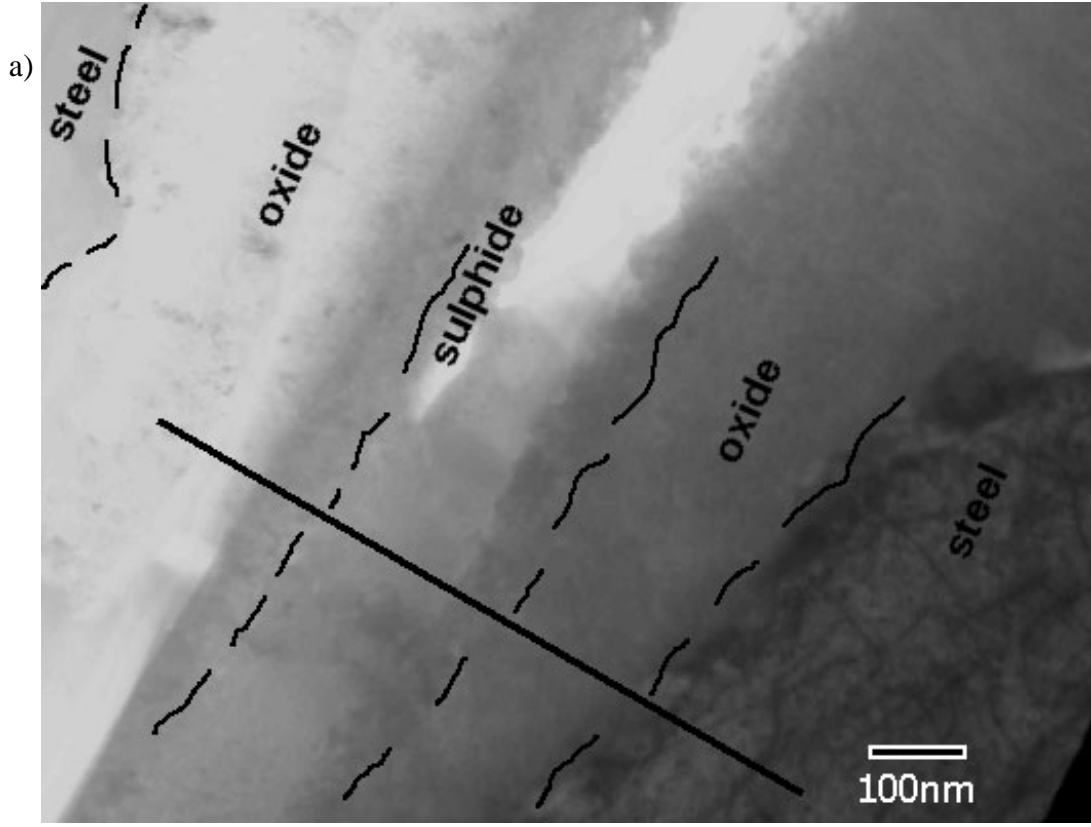
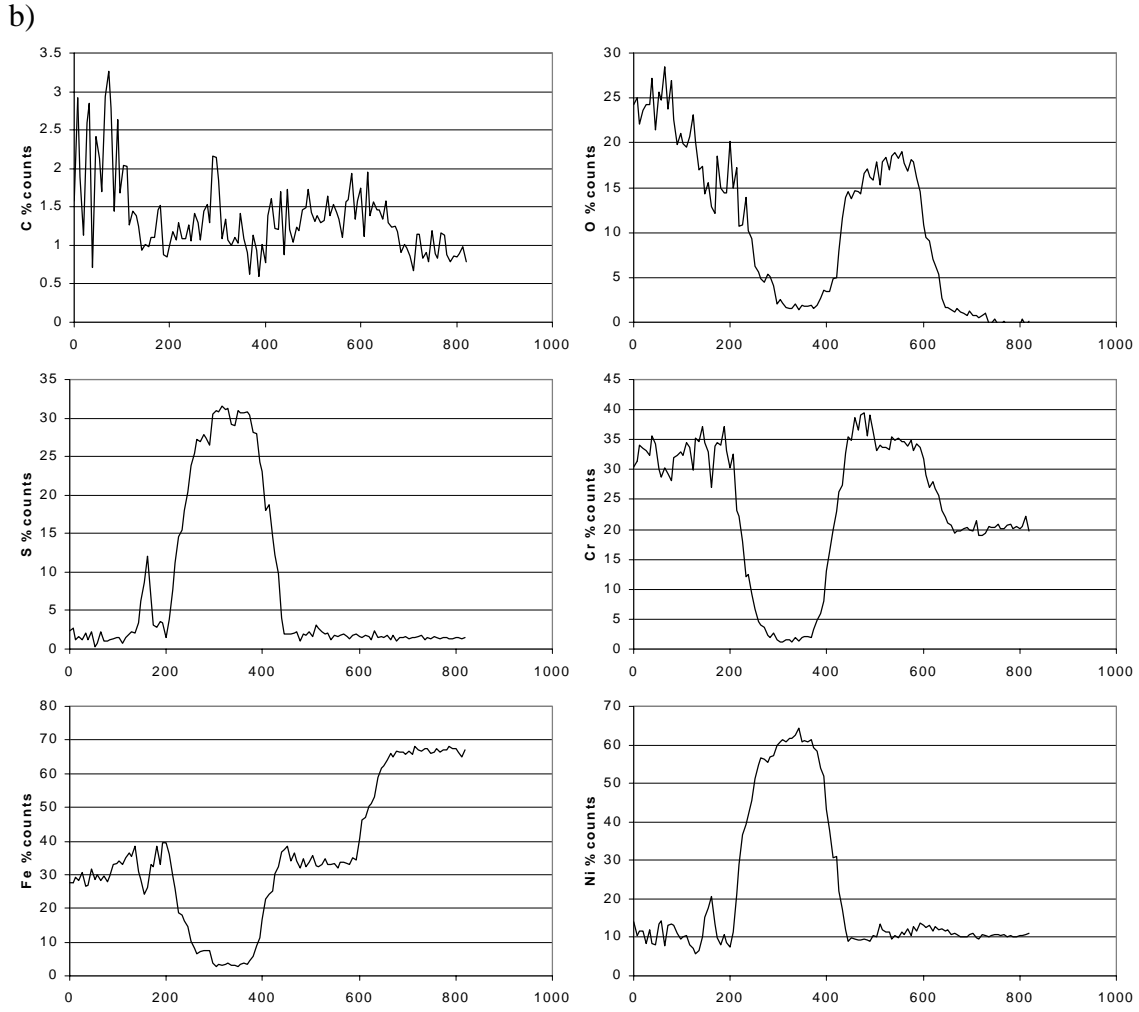
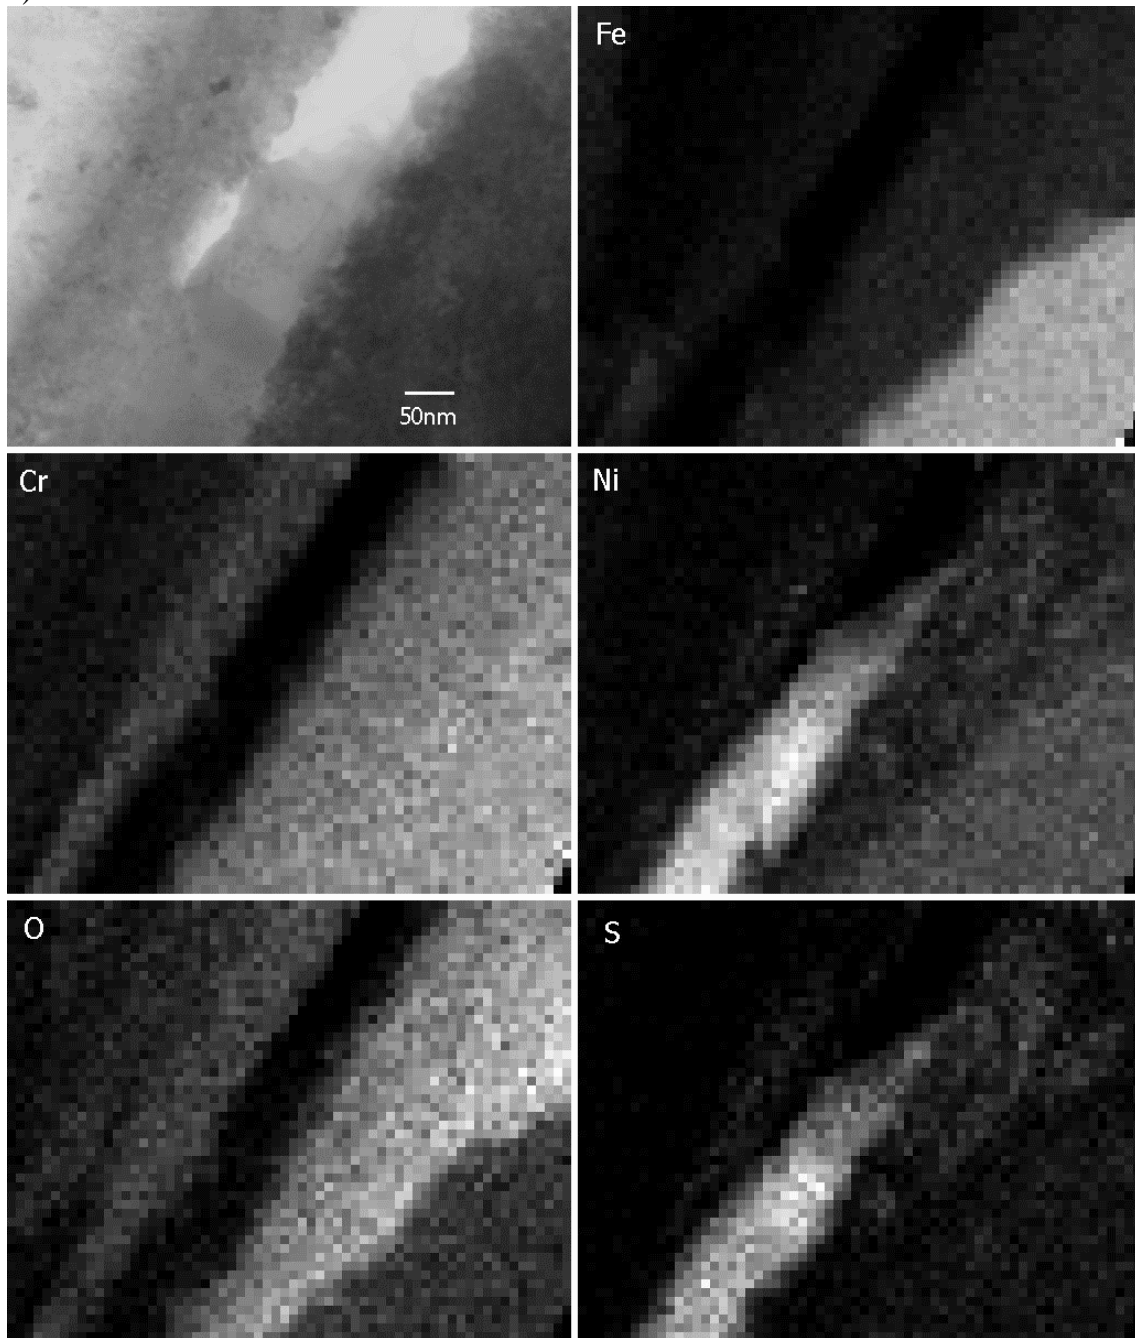
An image covering the whole width of the crack is shown in Figure 9a with the metal at the top left and bottom right-hand corners of the image. The linescan shown in Figure 9b begins in the oxide on the left-hand side of the crack, crosses a central region which contains precipitated nickel sulphide and corrosion debris, then crosses oxide on the right-hand side of the crack before passing in to the metal. The carbon profile shows that the crack is tightly filled with corrosion product at this location (compared to the top of the image where the crack is quite open). The oxygen profile shows that there is little or no oxygen associated with the central region of the crack, or in the metal as expected. Sulphur is found only in the central part of the crack and its distribution is closely mirrored by that of nickel. Chromium is enriched in the crack-wall oxide by almost a factor of two compared to the metal and the reverse is true for iron. X-ray maps from this region are shown in Figure 9c and clearly show the nickel sulphide precipitation within the crack.

Figure 9: a) Image of crack showing oxidised walls and central crack with deposits b) compositional linescan along indicated line c) X-ray maps illustrating the distribution of elements in this area.

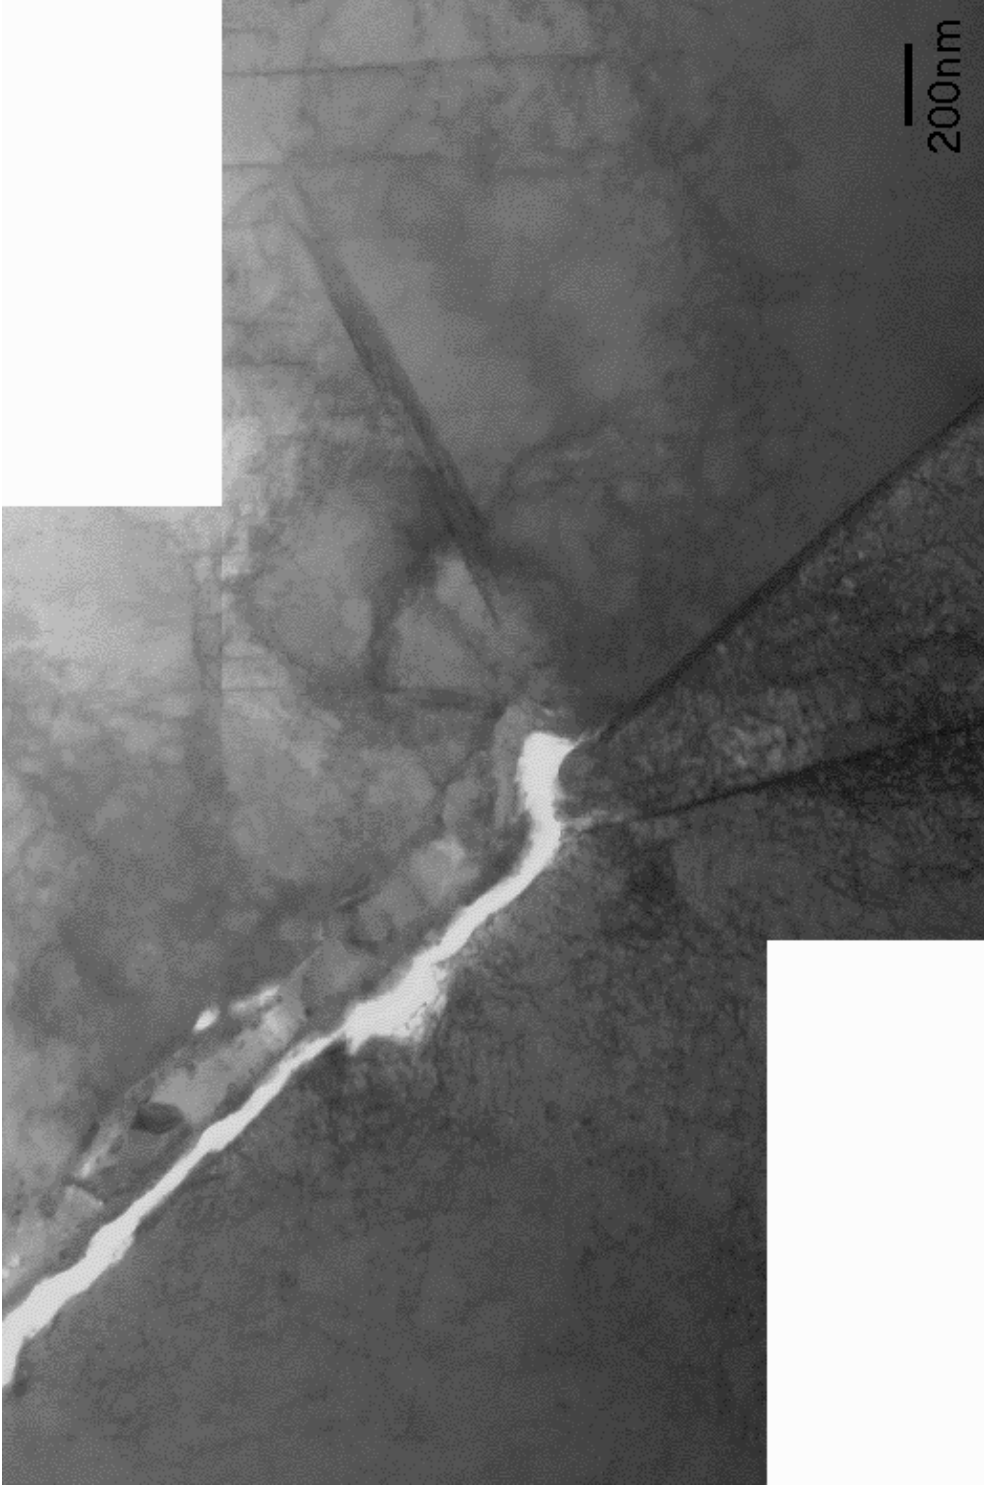
Further thinning revealed the crack-tip indicated earlier in Figure 2. The crack-tip is shown in Figure 10 and is clearly propagating along a grain boundary. The crack walls are heavily oxidised to a thickness of around 200nm and it appears that the crack is quite open right to the tip of the crack (though it must be recognised that this crack opening could have resulted from mechanical damage to the sample during preparation and handling). Interestingly, no chromium carbides or any other type of precipitation was found on this grain boundary (the visible part of this boundary extended $\sim 5\mu\text{m}$ ahead of the crack tip). X-ray maps illustrating the distribution of elements are shown in Figure 11 and are very helpful in interpreting the microstructure of this crack tip. The open crack is lined with a layer of $(\text{Fe,Cr})_2\text{O}_3$ on top of Fe_2O_3 . These oxides contain particles of nickel ranging in size from 10nm to 100nm. This is represented schematically in Figure 12. Occasionally, sulphur is associated with the nickel, even to the very end of the crack.

The cracking studied in this work was far removed from the main propagating crack in the original CT testpiece and, judging from the width of the corroded region shown in Figure 10, may not have been actively propagating. However, several interesting findings can be identified. First, as already mentioned, the oxide present on the crack walls was found to contain sulphur. There was also a considerable quantity of sulphur deposited in the crack as a form of nickel sulphide, though probably not the Ni₂S₃ phase. It is likely that this storage of sulphur in the crack-fill oxides accounts for the long duration of the periods of accelerated crack growth after a sulphate transient during the SCC testing. Secondly, evidence that implicates sulphur in the SCC process was found at the crack-tip where sulphur was detected within a few nanometres of the tip and in the precipitate ahead of the visible crack-tip shown in Figure 13. This is similar to the findings reported by Scott (1999) of perhaps the only published analyses of stress-corrosion microstructures in stainless steel which noted, as in the present case, that solution impurities penetrated practically to the crack-tip.

Figure 10: Montage of electron micrographs showing crack tip propagating along grain boundary

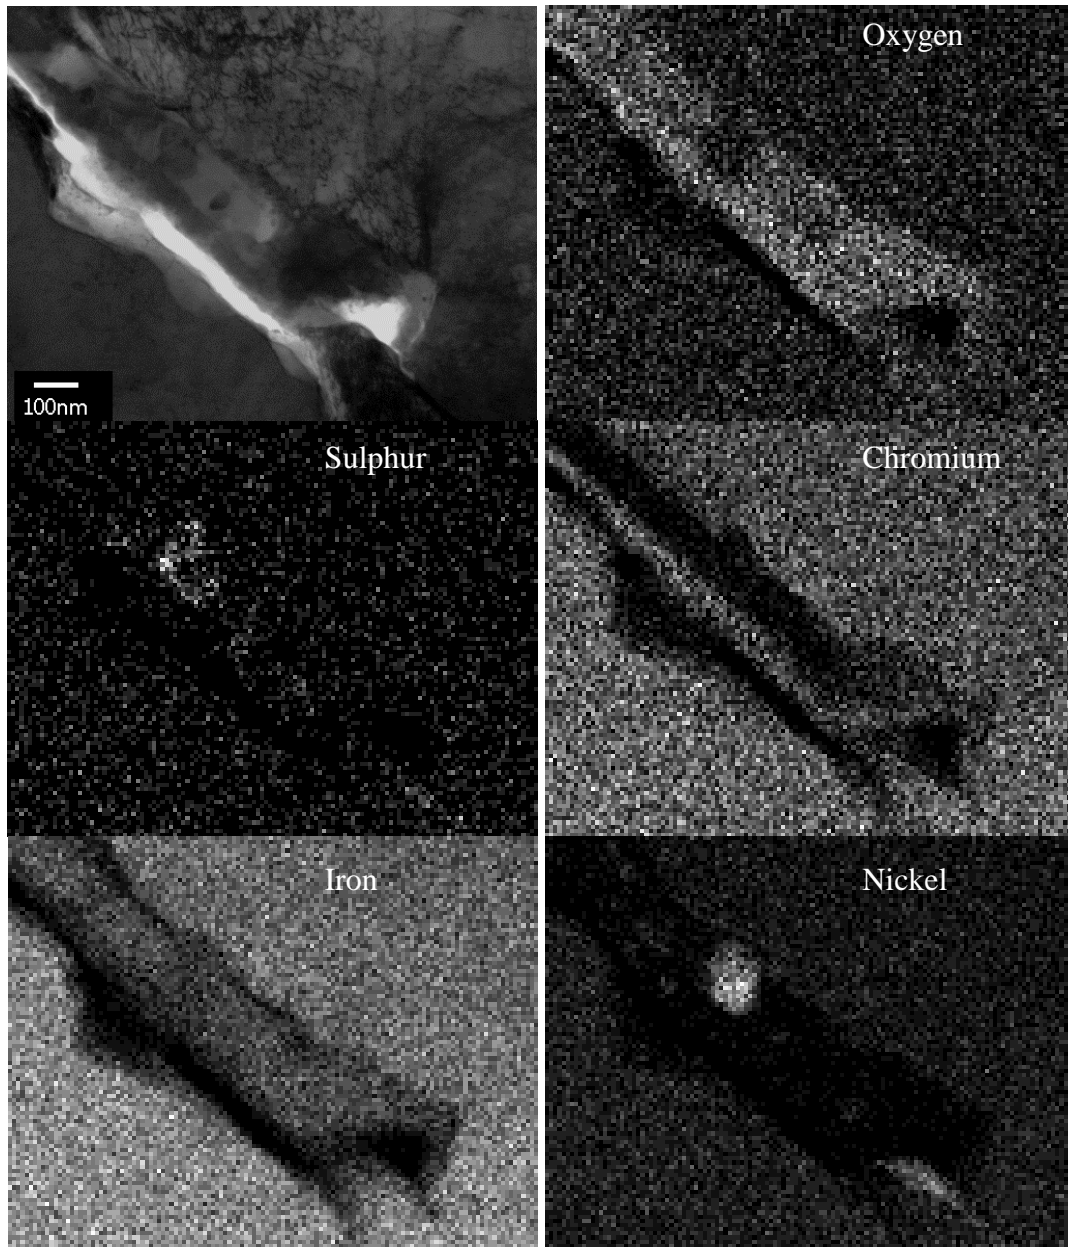
The separation of nickel from the other corrosion products is further illustrated in Figure 11 where nickel metal islands and more areas rich in nickel and sulphur are seen. The presence of nickel metal particles parallels the findings of Thomas (Thomas and Bruemmer 2000) in the study of Alloy 600. In that work the presence of Cr₂O₃ in the main crack was also highlighted and distinct from the presence of both NiO and Cr₂O₃ in the 'degraded' grain boundaries which intersected the main crack. Of course, there is a great difference in the nickel concentration in Alloy 600 compared to 304, which makes the presence of nickel metal in the present case all the more remarkable.

Figure 11: X-ray maps showing distribution of elements near crack tip

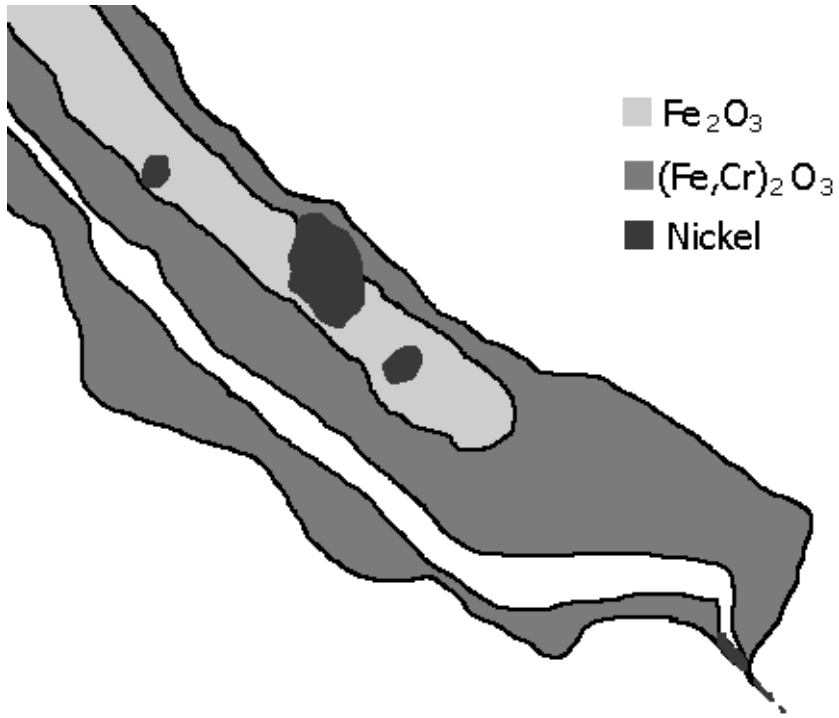
Figure 12: Schematic illustration of distribution of phases near crack tip
