SKI Perspective

SUMMARY

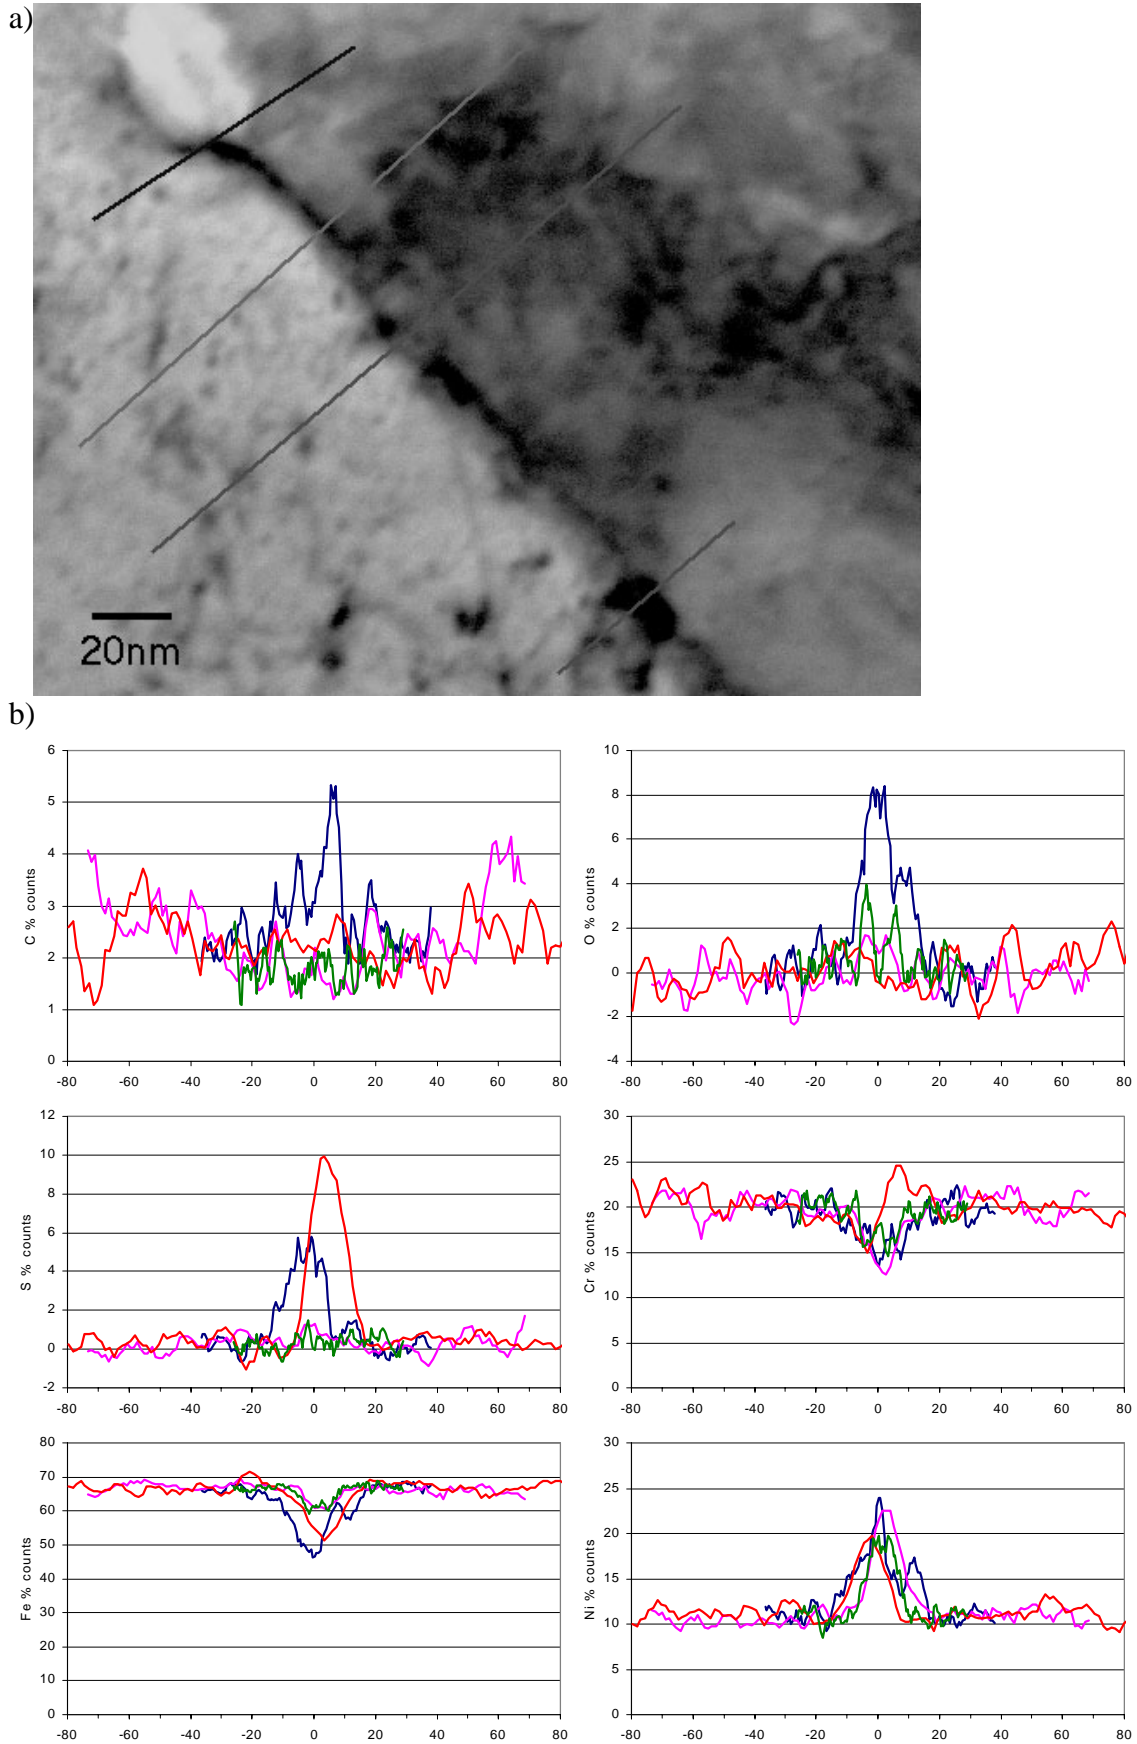
The tip of the intergranular crack is shown at high magnification in Figure 13a. This image shows that the crack tip is quite blunt, though at only $\sim 20\text{nm}$ wide it is only a tenth of the crack width shown in Figure 11. This crack tip can be seen in Figure 11 and may represent a re-initiation of crack growth. The EDX compositional profiles shown in Figure 13b start with a profile just 5nm behind the crack tip which shows a small carbon peak near the centreline (probably an artefact due to the resin used in the sample preparation); oxygen and sulphur are enriched and must be related to the corrosion process at the crack tip; chromium is depressed and nickel enriched at the grain boundary which is typical for a grain boundary in sensitised stainless steel. Further back from the crack tip, the oxides that are present are rich in chromium and poor in nickel compared to the steel matrix, so it appears that this profile shows that the oxidation of the steel proceeds initially via an ingress of oxygen rather than by outward diffusion of the metal ions. It is also very interesting that sulphur is identified within 5nm of the crack front.

The second profile is from 30nm ahead of the crack tip. The distribution of elements at this location is perfectly normal for a grain boundary in sensitised stainless steel and quantitative analysis showed the grain boundary composition to be Fe-11.4Cr-25.2Ni (wt%) compared to matrix levels of Fe-18.8Cr-11.6Ni at a distance of 45nm from the grain boundary.

The third profile crosses a 30nm precipitate on the grain boundary 60nm ahead of the crack tip. The precipitate is rich in sulphur and possibly chromium. The presence of sulphur in the precipitate is intriguing since sulphides are rare in stainless steels and, though the nearby crack tip is a possible source, the precipitate was not obviously connected by porosity to the crack tip.

The final profile was acquired from a location ~150nm from the crack tip and shows chromium depletion and nickel enrichment similar to the second profile.

Figure 13: a) Crack tip and location of linescans b) semi-quantitative linescan analyses across crack tip and material ahead of crack.
