Research

Crack Characterisation for In-service Inspection Planning – An Update

Jan Wåle

May 2006

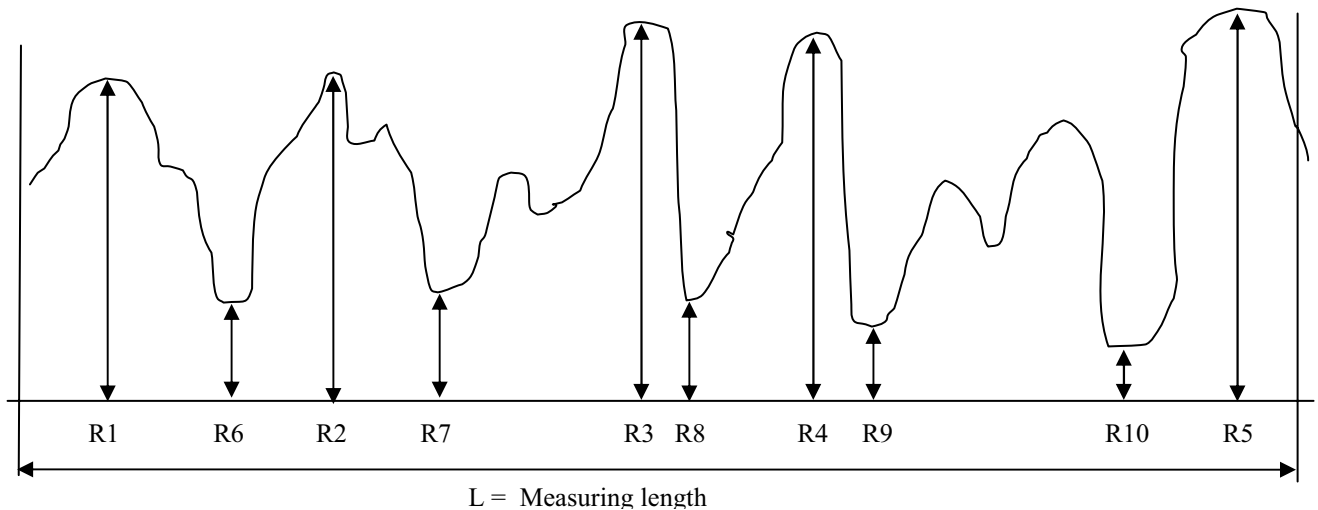
The crack surface roughness that is of interest is the one on a macro scale and not smaller than the grain size level. Therefore, a measurement length, L , in a range of 1-2 mm and micro-graphs at magnifications between 20 and 100 times, were used when ever possible.

$$R_z = \{ (R_1 + R_2 + R_3 + R_4 + R_5) - (R_6 + R_7 + R_8 + R_9 + R_{10}) \} / 5$$

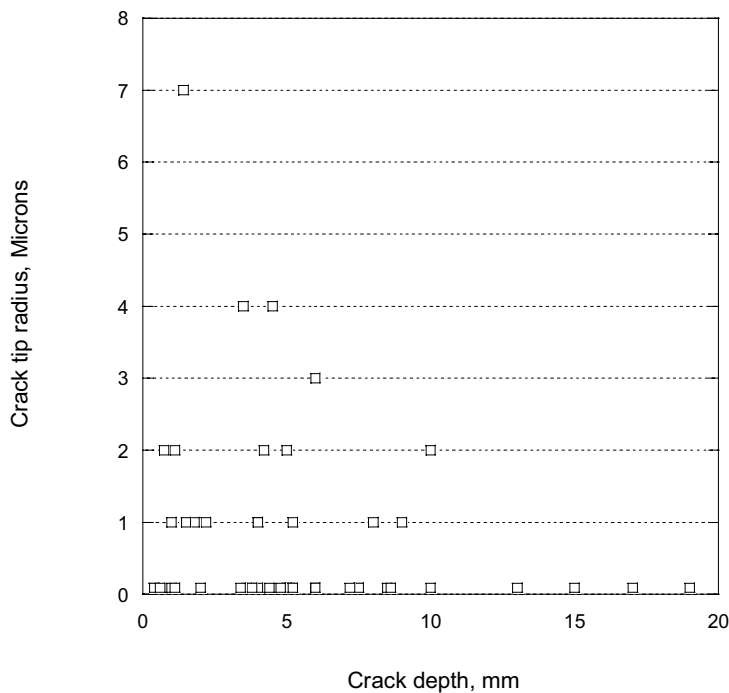
Figure 6-12 Crack tip radius versus crack depth of IGSCC in austenitic stainless steels

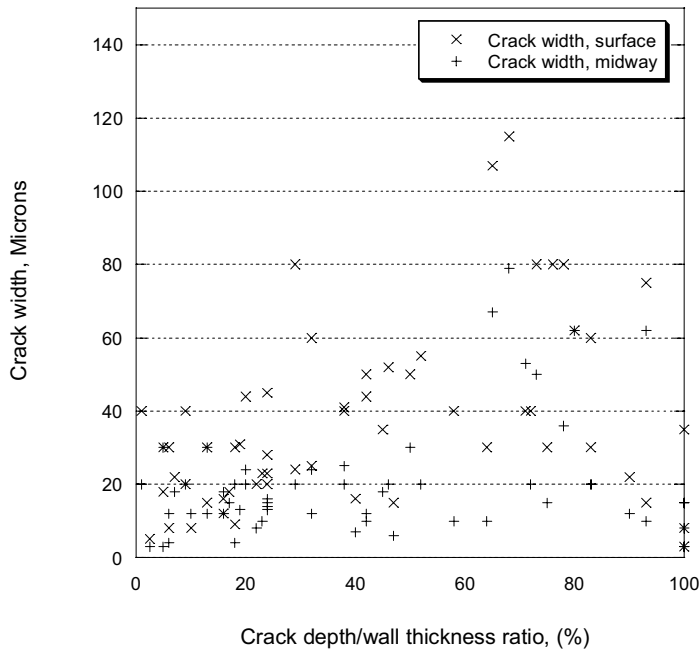
Figure 6-16 Crack width at surface and midway versus crack dept/wall thickness ratio of IGSCC in austenitic stainless steels

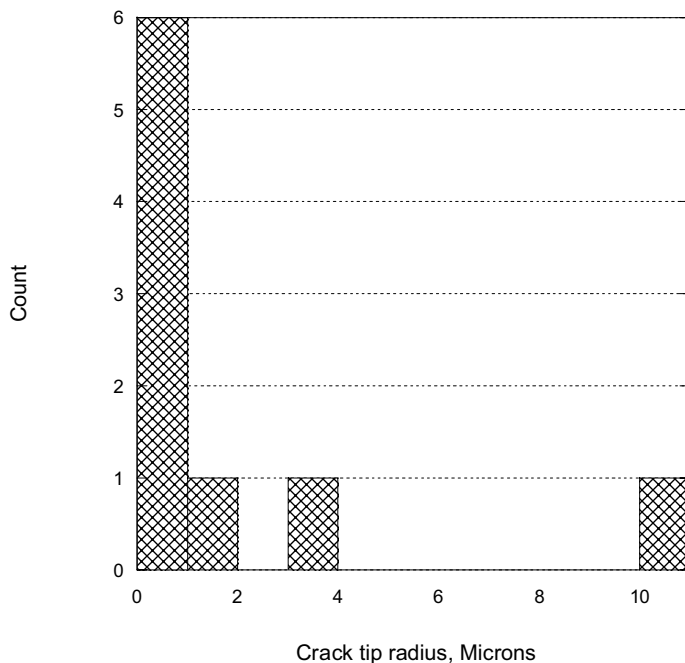
The crack tip radius was evaluated for 9 cases. Values close to zero is dominating but a few extreme values were measured, probably due to secondary corrosion. The distribution is shown by Figure 7-3.

Figure 7-3 Distribution of crack tip radius for 9 cases of IGSCC in nickel base alloys.

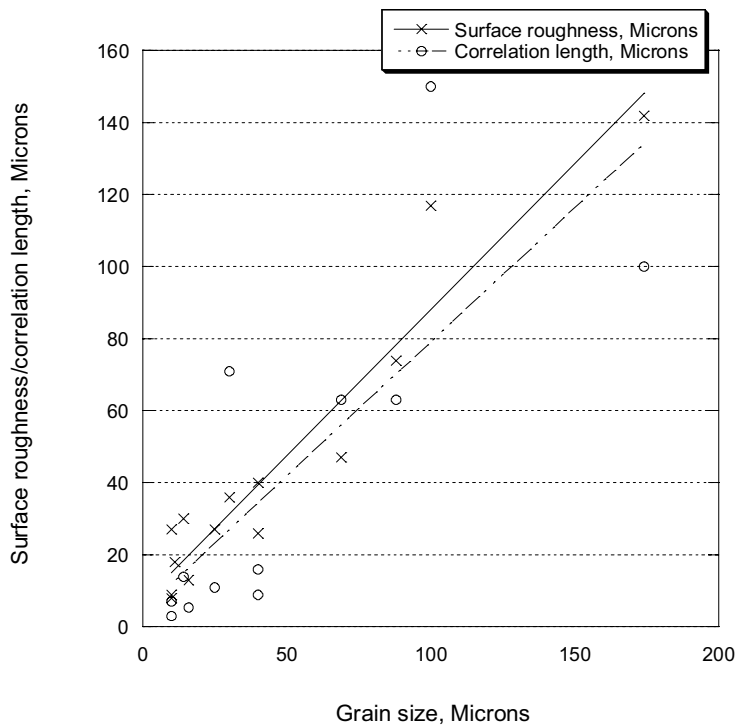
Figure 7-4 Surface roughness/correlation length versus average grain size of IGSCC in nickel base alloys.

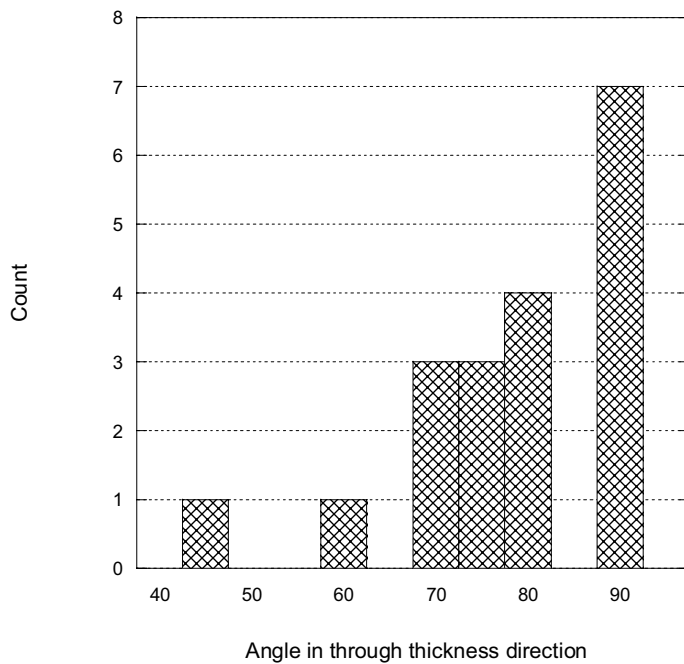
Figure 8-2 Distribution of orientation in through thickness direction of IDSCC in Nickel base alloy weld metal

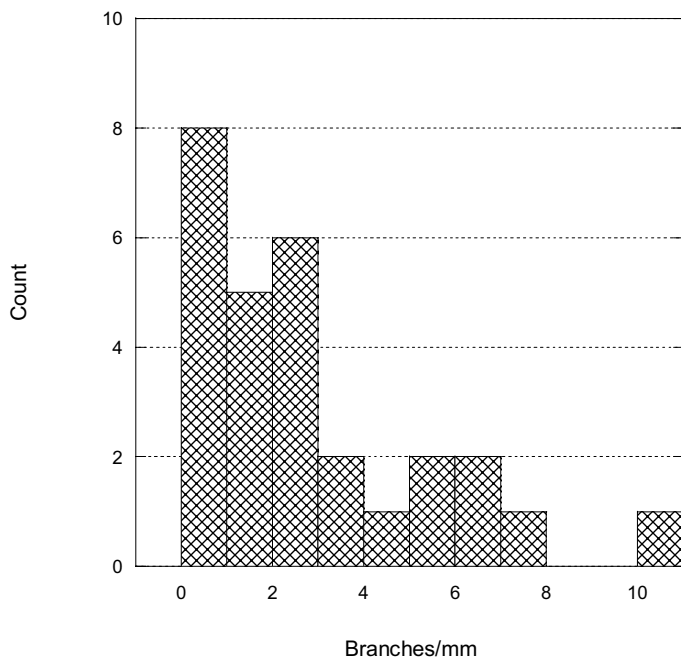
Figure 9-3 Branching in through thickness direction of TGSCC in austenitic stainless steels
