An Applied Study on the Decontamination and Decommissioning of the Map Tube Facility 317 Area Argonne National Laboratory, Chicago

Geoff Varley
Chris Rusch

January 2005

NAC International
32 Bell St
Henley on Thames
Henley-on-Thames RG9 2BH
Oxfordshire
UK

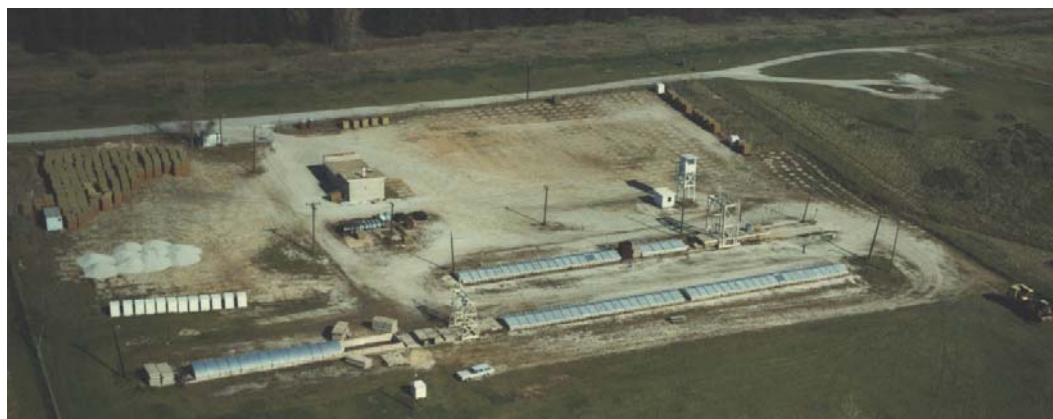
Figure 2-4 Overhead View of Area 317

ANL stored low and intermediate-level (transuranic) waste in four of the vaults, the three vaults in the lower row on Figure 2-4 and the left-hand facility in the upper row on Figure 2-4. The deep vault (right-hand facility on the upper row with overhead crane above the facility [Figure 2-4]) was used exclusively to store intermediate-level radioactive waste. Small containers of highly radioactive waste (HLW) were stored in the MTF, middle facility in the upper row on Figure 2-4.

The interim remedial action strategy uses available information including recent and historic aerial photographs (for MTF see Figure 2-4 and Figure 2-15), employee interviews, routine environmental monitoring information, compliance monitoring of surface and ground water, preliminary characterization radiological surveys, site closure sampling, and facility design information. The report “Design Memorandum for the Decontamination of the ANL 317 Area Map Tube Facility” (ANL-AT-0004) contains this information for the MTF.

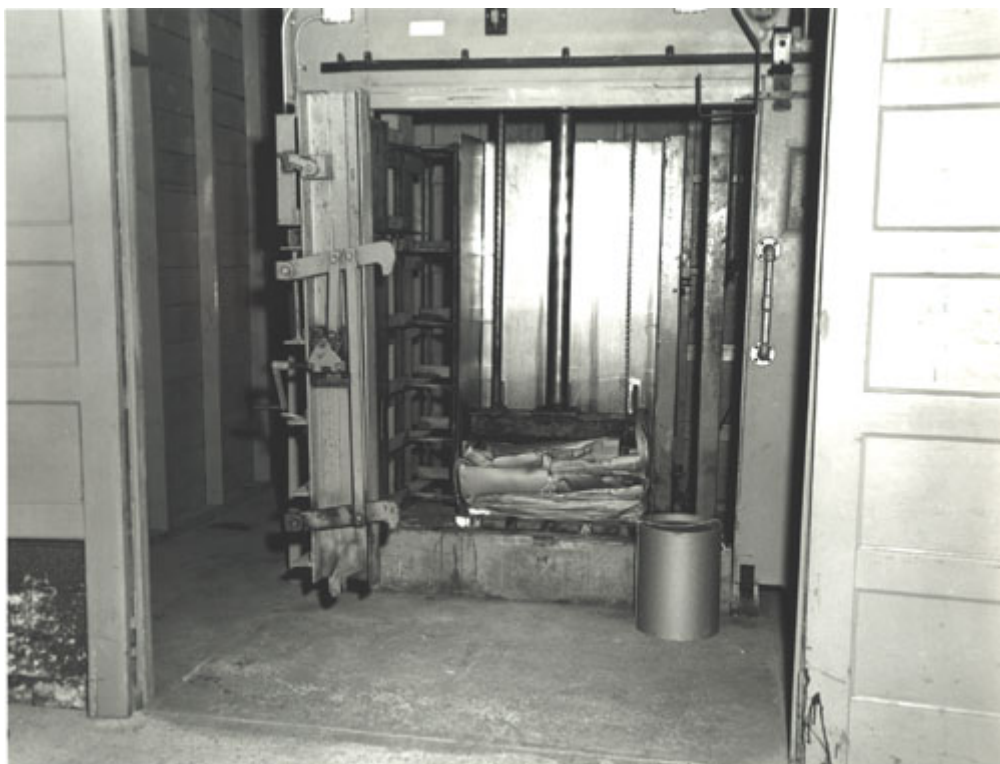
Figure 2-5 Waste Compacting Equipment

The Bailer Building was located in the 317 Area. Originally, the building was used to compact radioactive waste. This included waste compaction equipment (Figure 2-5) used in that era. Figure 2-6 shows compacted LLW being loaded into storage and transport bins. The tubes of the MTF were not designed to receive or store compacted waste.

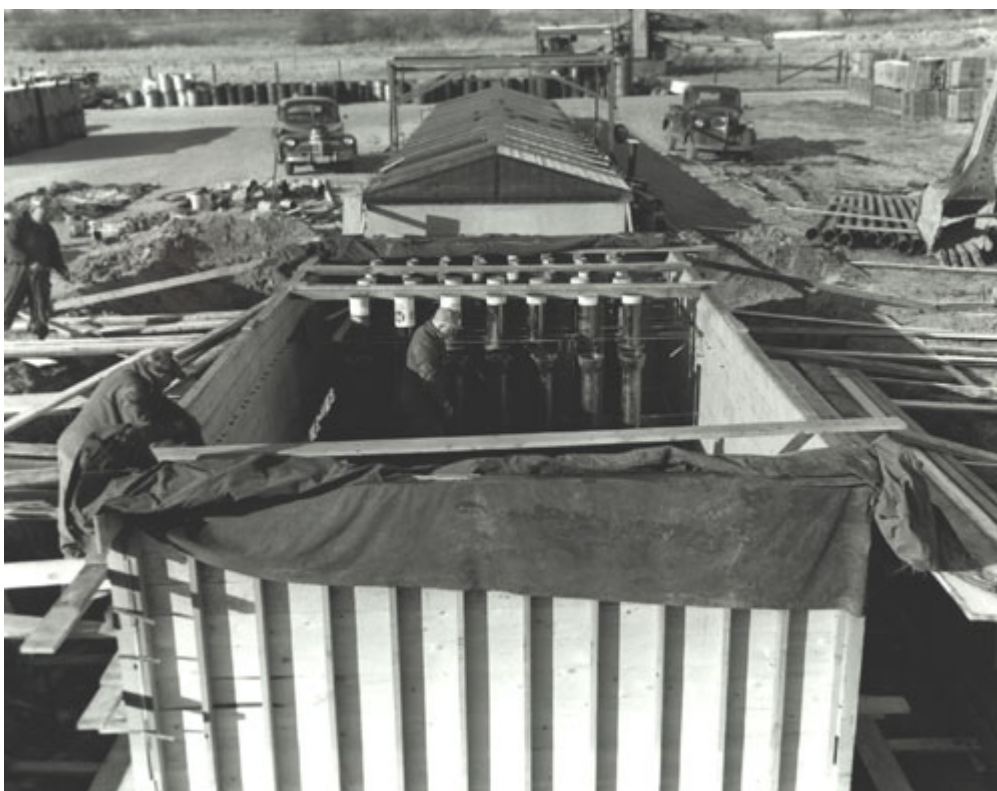
Figure 2-7 MTF During Construction

The MTF was a large concrete block structure (Figure 2-7) that was constructed in 1952 for the purpose of storing radioactive waste. The block is 4 meters wide, 8.5 meters long and 6.4 meters deep (5.8 meters of which is below grade level). The block contained 129 cast-iron, bell and spigot¹ sewer pipes that were positioned vertically in the block during construction, see Figure 2-7 and Figure 2-8. Five pipes (hereafter referred to as “tubes”) were 25.4 cm in diameter, 84 tubes were 15.2 cm in diameter and 40 tubes were 10.2 cm in diameter. All tubes were the same length, approximately 6.2 meters.

The tubes were essentially vertical when the MTF was constructed, see Figure 2-7. However, forces from concrete pouring, shifting and settling, etc caused the tubes to become off-vertical by as much as 10 cm. When drilling operations first began, there was some trial and error associated with compensating for the fact that the tubes were at a slight angle. It was very important to compensate for this situation because the drill could contact the cast-iron tube (see Figure 3-17, Figure 3-18 & Figure 3-19) and thereby release contaminated material.

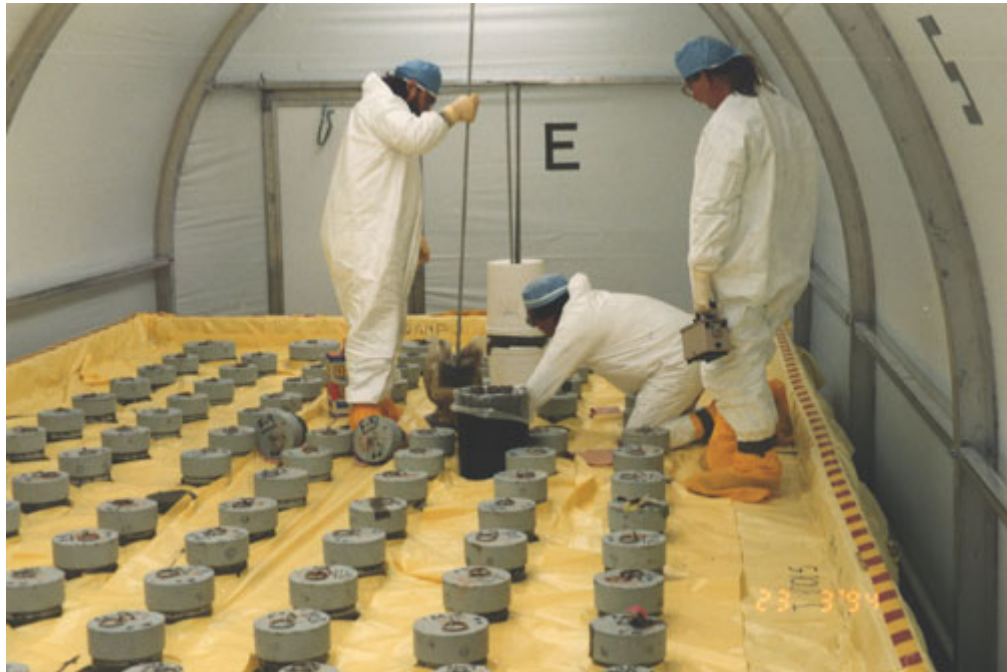
Figure 2-11 Tubes with Caps in Place

The mouth of each tube was covered with a loose-fitting lead cap approximately 15.2 cm thick. The caps are pictured in Figure 2-11. The cap weights are listed in Table 2-1.

Each tube that did not contain debris was rinsed with a high-pressure water jet, scrubbed with a stiff bristle wire brush (Figure 2-11) and rinsed again with the high-pressure water jet. The residual water and sediment was pumped into three, 208 liter galvanized steel drums (Figure 2-12). An approved absorbent material was added to the drums which were then moved to an on-site mixed waste facility.

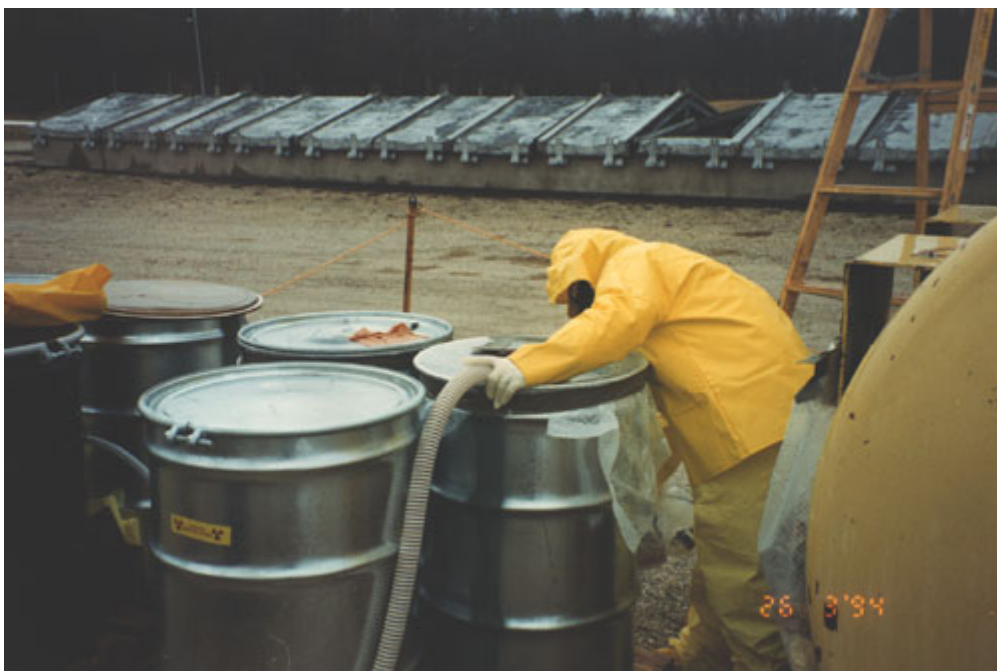
Figure 2-12 Vault Roof Deterioration

The removable MTF roof deteriorated in the late 1970s and was removed. Figure 2-12 provides a good representation of such roof deterioration over one of the LLW vaults pictured in the figure. This allowed the tubes to be exposed to the weather and became one of the principal paths for tube flooding.

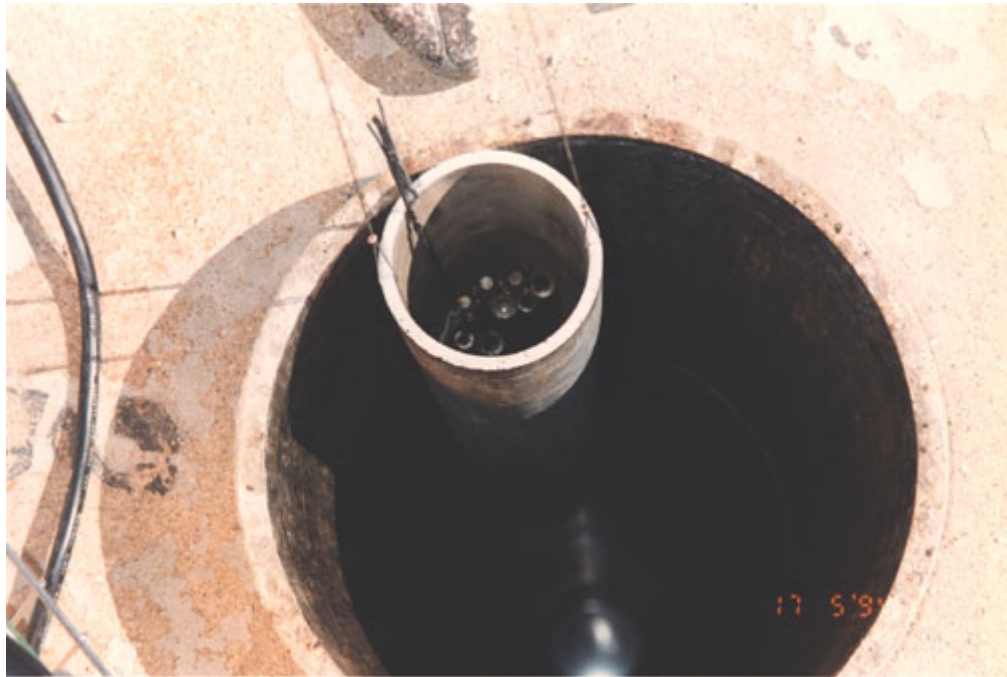
Figure 2-13 Tube Contents Located in Map Tube

Figure 2-13 provides an example of the contents of a tube. At least nine tubes contained debris which ranged in weight from the weight of a paperclip up to 23 kgs. Table 2-3 lists the contents and radiation level in the tubes that contained debris.

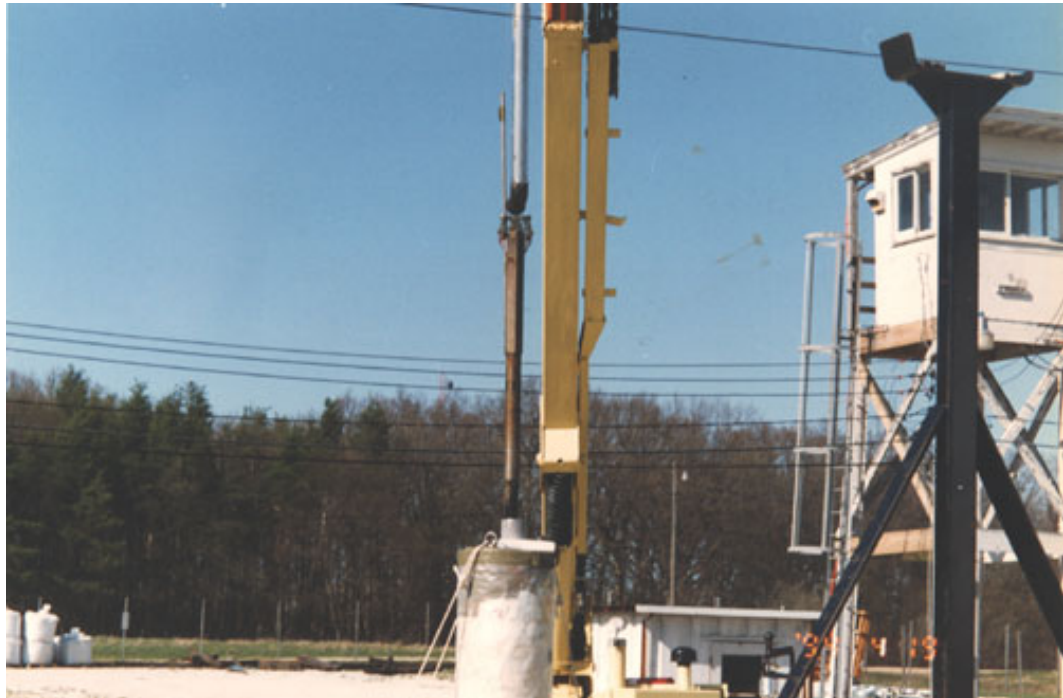
Figure 2-14 Container with Activated Steel

At the time of the characterization of the MTF in 1993, there was still some wire, bolts and an object that looked like an experimental breeder reactor (EBR) fuel assembly located in the tubes. The object (Figure 2-14) that looked like an EBR blanket assembly turned out to be a container with activated steel rods.

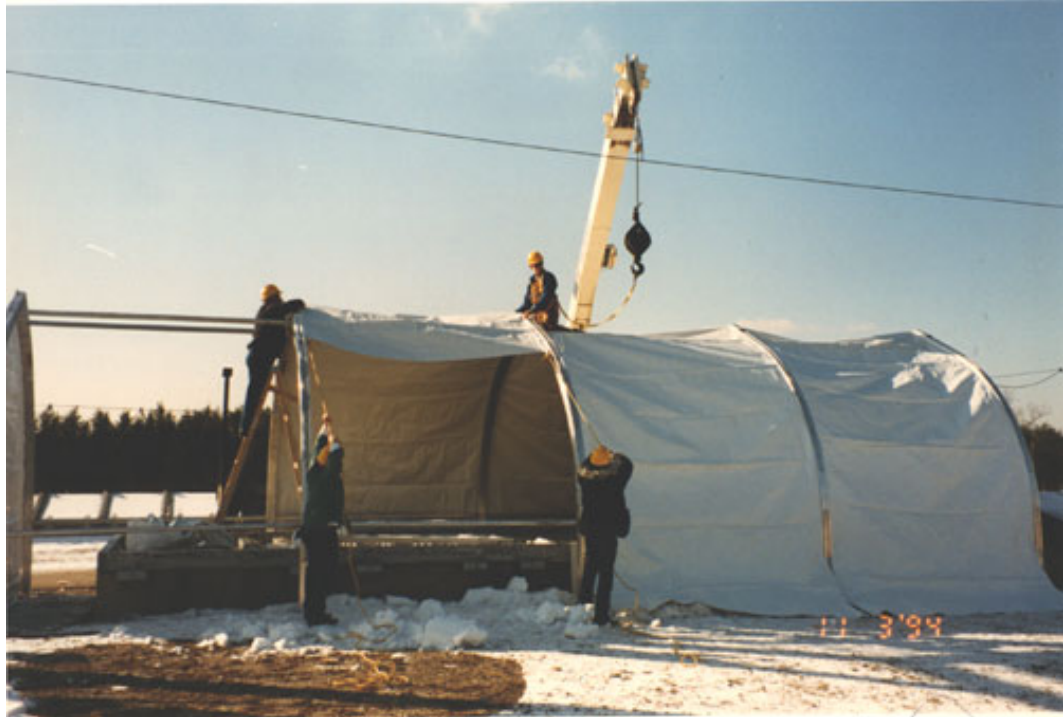
Figure 3-1 MTF Containment Equipment

During a six-week period from late 1993 to early 1994, the Energy Technology Engineering Center, Rocketdyne Division of Rockwell International¹ (ETEC) characterized the MTF. The first phase of the characterization was to assemble a temporary tent-type structure over the MTF, as shown in Figure 3-1. This provided two functions, airborne radiation containment and protection from the elements.

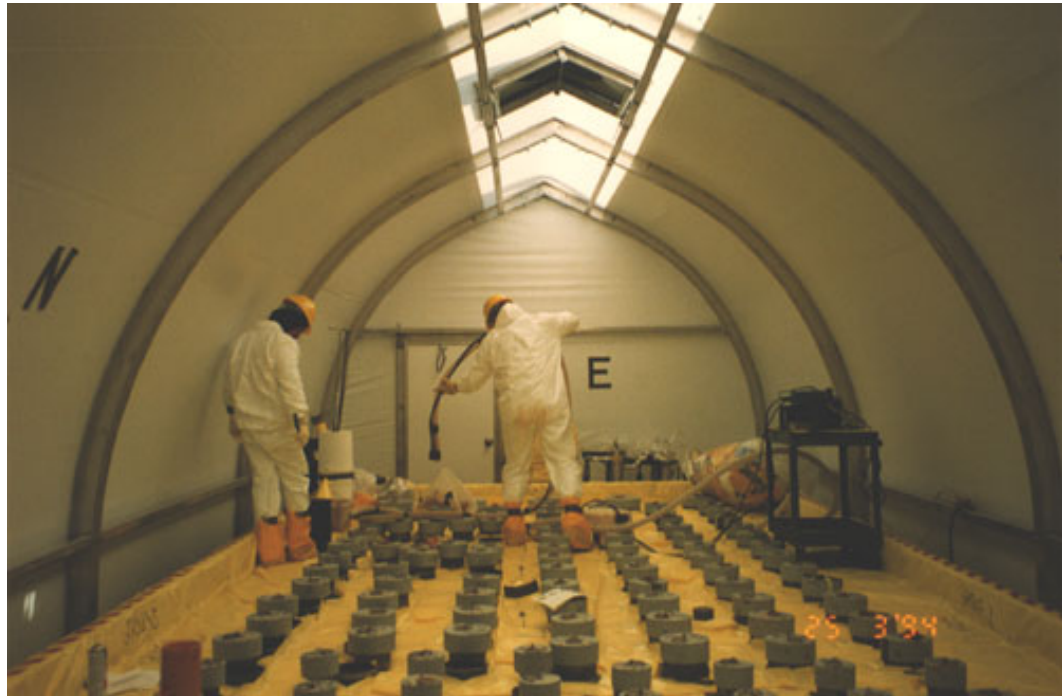
Figure 3-3 Pumping Equipment

ANL did not have a permit to treat mixed waste so a two-stage water removal process was performed. The water in each tube was pumped down to a depth of about 46 cm (Figure 3-3) into a 3,400-liter tank. The water in this tank was evaporated with on-site ANL liquid evaporation equipment.

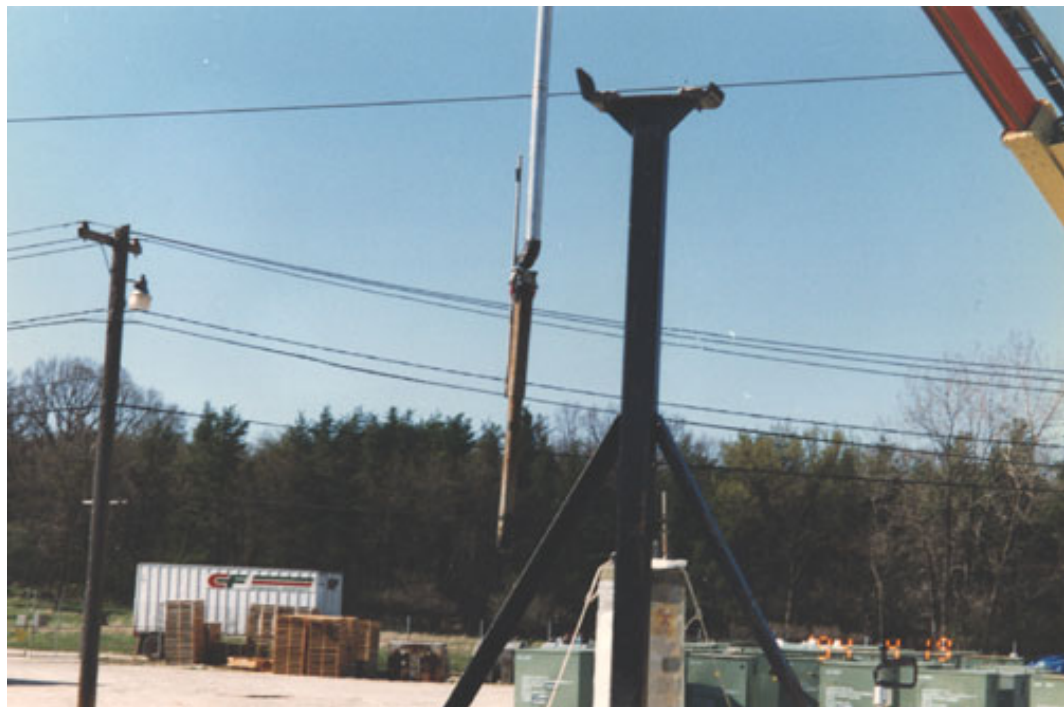
Figure 3-4 Grappling Equipment

The debris was handled with long-reach grappling tools (Figure 2-14, Figure 3-4 and Figure 3-5) that could grip, snare, or scoop a variety of objects. In order to minimize exposure, significant dry run and mock-up training was conducted. Three different handling procedures were defined for debris

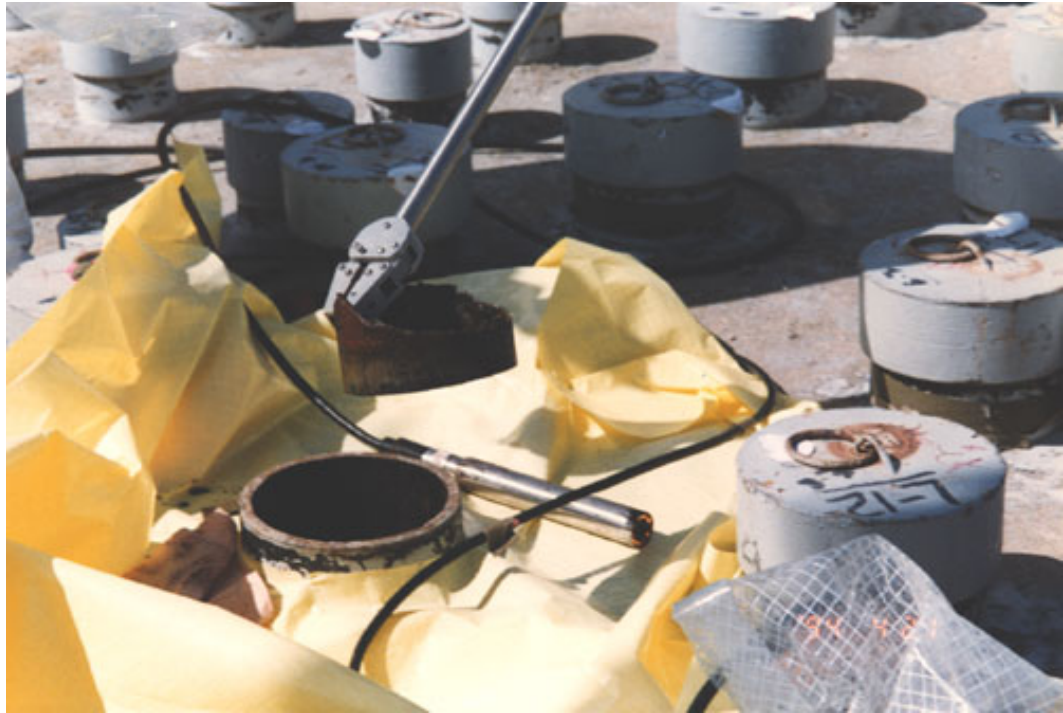
Figure 3-5 Grappling Equipment with Object from Tube

For category (1), the debris was removed from the tubes and handled by personnel on the ground using a 1.8-meter grapple (Figure 3-5) and inserted in a shielded transfer/storage canister (a typical canister is shown in Figure 3-6). For categories (2) and (3), the debris was withdrawn using long-reach grapple equipment that was handled by personnel from the top of a man-lift. The equipment and materials required for dewatering the tubes are listed in Appendix B.

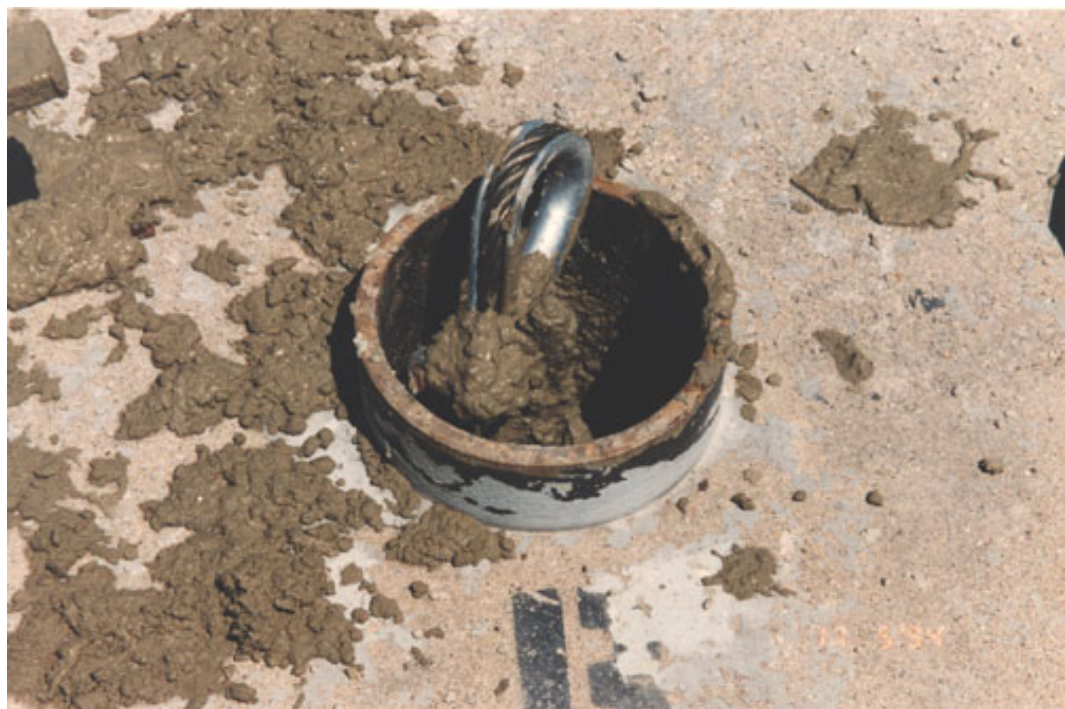
Figure 3-7 Lifting Eye Inserted in Tube

The lifting device consisted of a 6.1 meter long piece of #4 rebar with a 4.6 meter long 1.3 cm wire rope attached to the rebar. The wire rope had a lifting eye at one end. This assembly was inserted into each tube with the lifting eye positioned at the top of each tube (Figure 3-7) and sealed in place with concrete. This process

1. Provided a lifting mechanism for removing the concrete core,
2. Sealed the tube so that water could not enter or exit the tube
3. Added strength to the fragile cast-iron tube

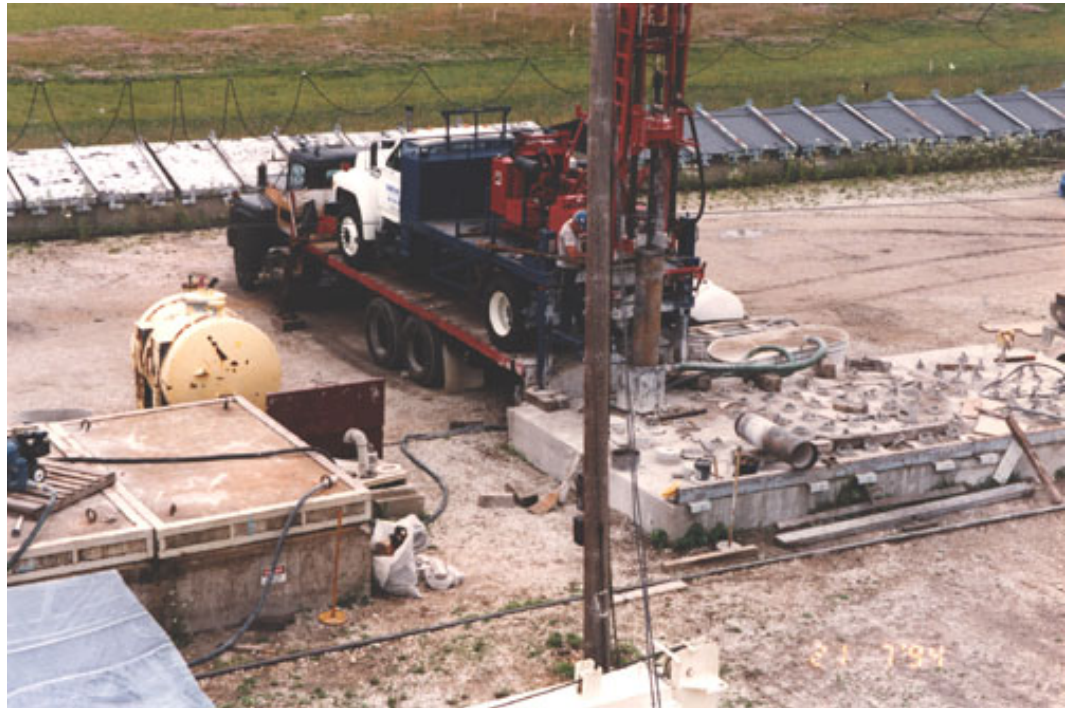
Figure 3-8 Core Drilling Rig on Flatbed Truck

The core-drilling rig was mounted on a flatbed truck (Figure 3-8) so that the equipment could be moved when access to the deep or north vaults was required. The flat bed truck dimensions from the end of the truck to the rear axle (Figure 3-8) were adequate to allow the drill rig to be positioned over every tube in the block.

Any of these three project constraints precluded the use of excavation and sectioning of the MTF block or demolition. By using a mobile drill rig mounted on a flatbed truck (Figure 3-8), the drilling operation could be interrupted with minimal impact on the MTF dismantlement.

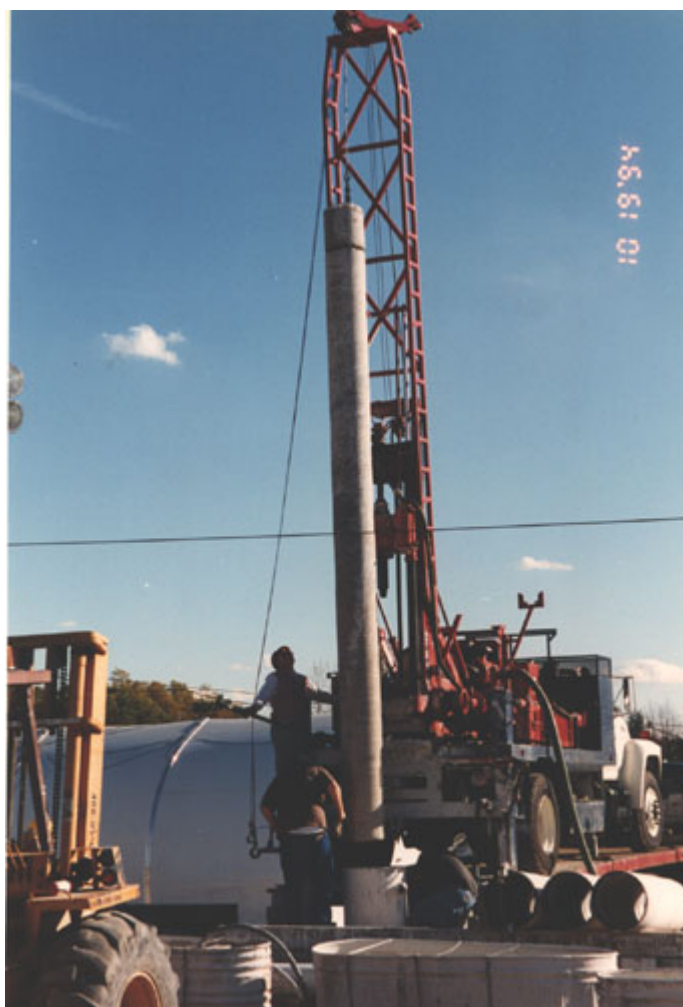
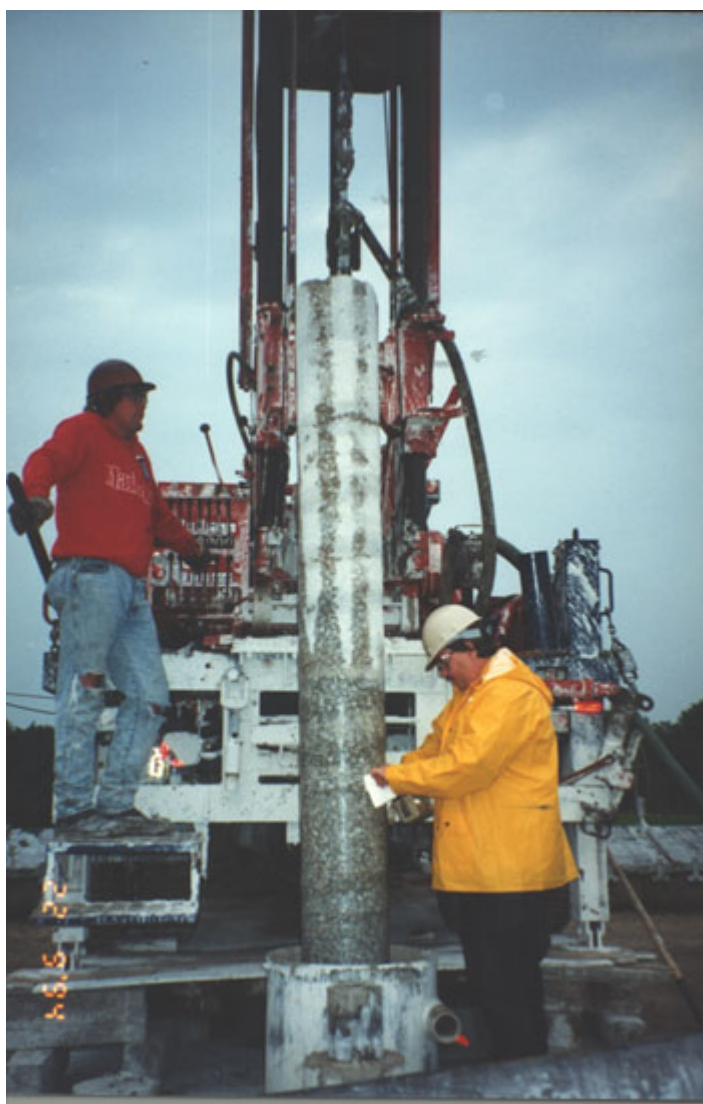
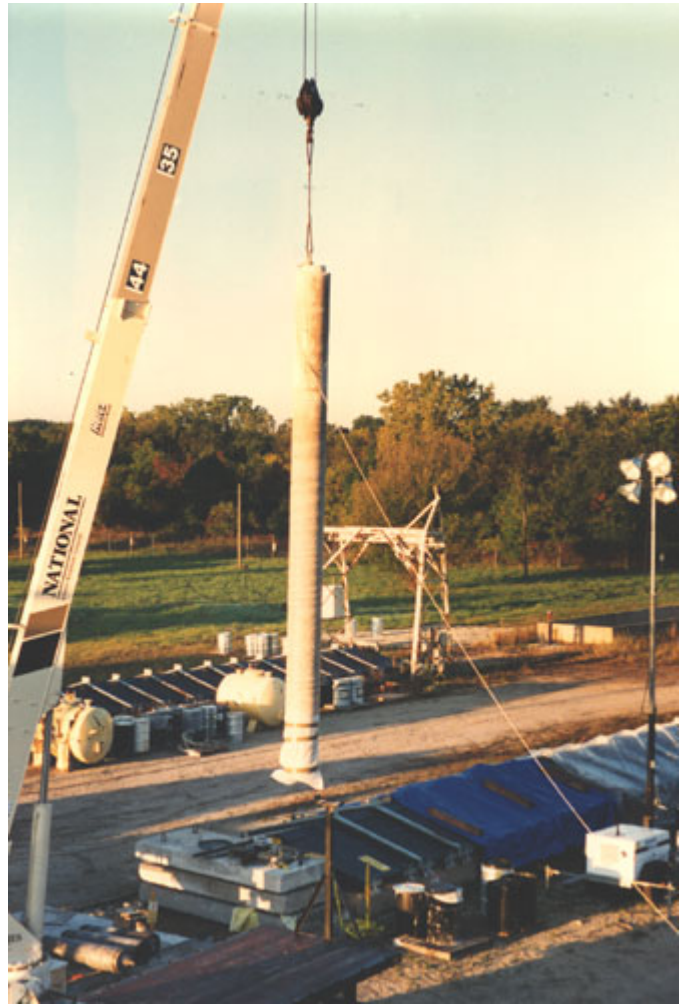
Upon completion of the coring operation, where possible the core was removed immediately (Figure 3-9, Figure 3-10 and Figure 3-11). In some instances, cores were left in place for a period subject to crane availability for removing the cores and the shipment schedule for transferring the cores to the Hanford LLW site.

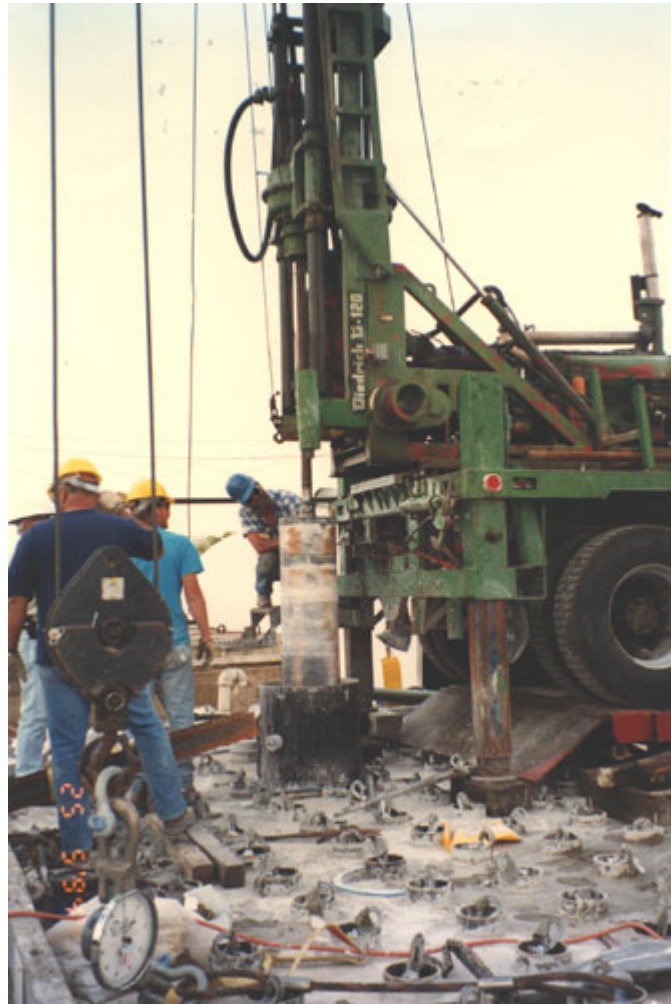
Figure 3-13 Core Drilling Cooling System

After the coring operation for a tube was complete, radiological analysis of the cooling water indicated if the tube had been breached during the drilling process. If the tube was not breached, the water would be pumped into a large storage container where the fines would settle and the water could then be recirculated. If a tube was breached, the water with fines was pumped into drums for disposal as contaminated LLW.

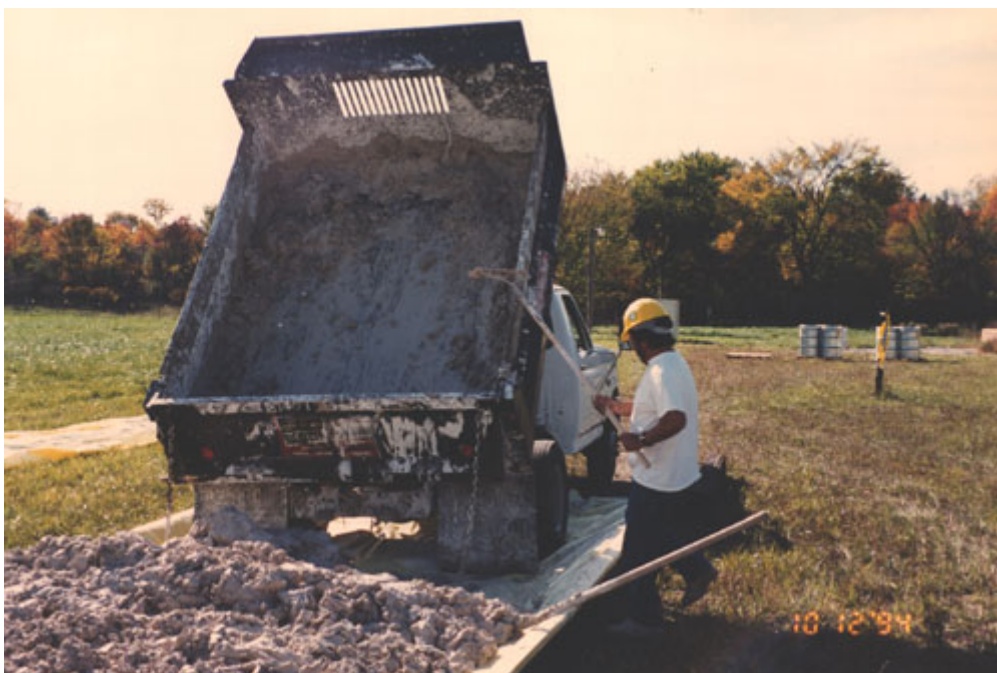
Figure 3-14 Dumping Concrete Fines

Originally, the plan was to use the non-contaminated fines to fill the voids in the block following removal of a tube. However, this was not possible because the fines formed a thick paste that could not be pumped.

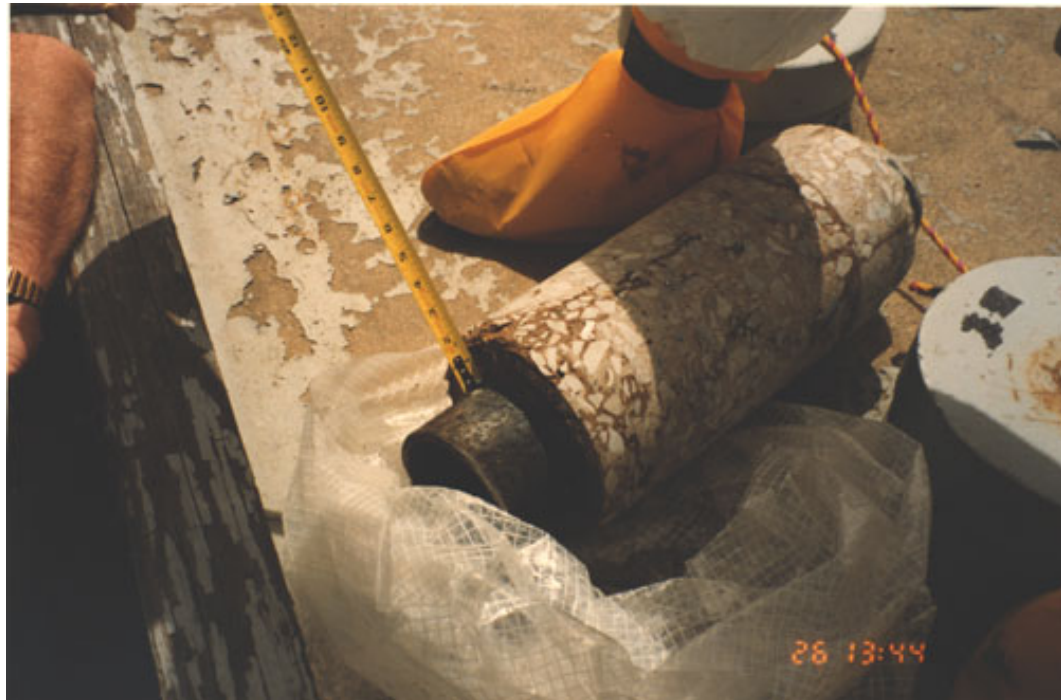
Figure 3-15 Separated Tube Section

After the end caps and top portion of the tubes were removed, the tubes were wrapped with three layers of 0.03 cm thick, nylon-reinforced plastic sheeting.

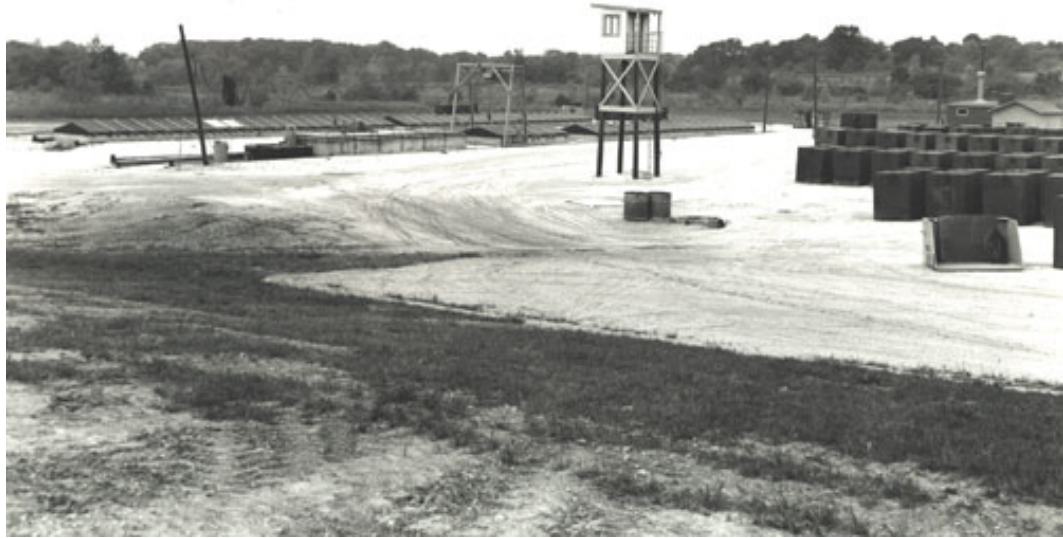
Figure 3-16 Overhead Crane Over MTF

First, at the time of the dismantlement of the MTF, there were radioactive waste storage facilities that were still operating in Area 317. Specifically, two of these facilities were the deep vault and the north vault, which were located in-line with the MTF (see Figure 2-2 and Figure 2-3 and Figure 3-16). Tracks that allowed access via an overhead crane ran along either side of these three facilities. The overhead crane in Figure 3-16 is positioned over the MTF. It was necessary for the overhead crane to have access to the vaults on either side of the MTF; therefore, the technology used to dismantle the MTF had to allow this operational flexibility.

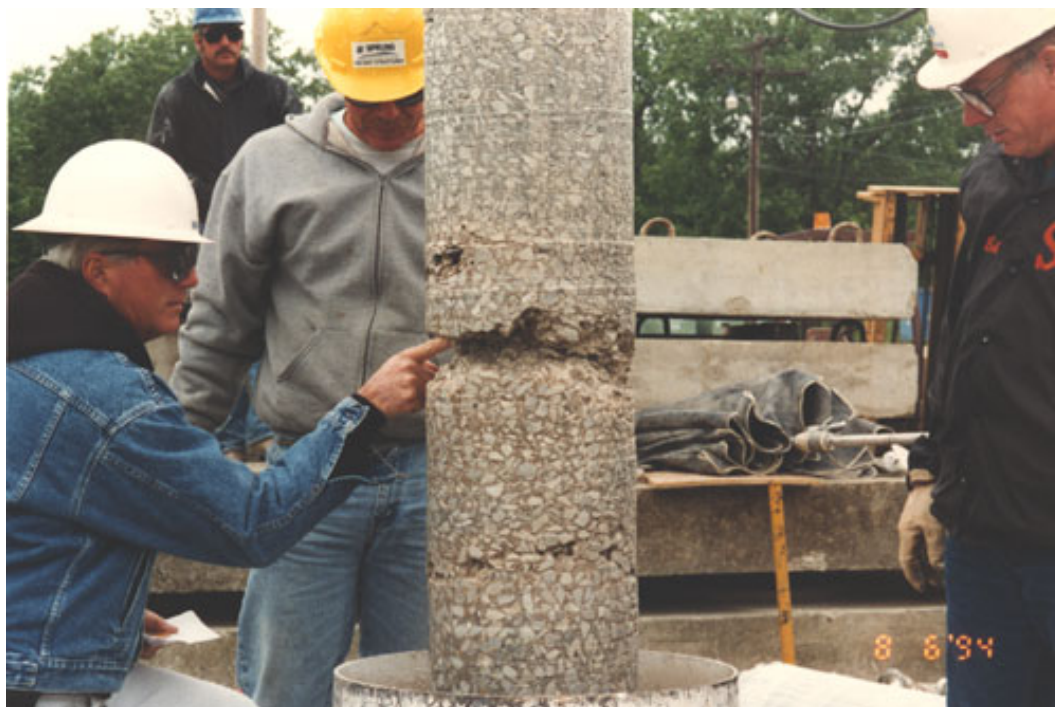
Figure 3-20 Voids in Concrete

Voids (Figure 3-20), cracks and other defects including objects (pipes, wood, cabs, etc) that were buried in the concrete caused a loss of cooling water. Again, concrete would be injected or poured into the offending location and allowed to solidify before coring could continue.
