Crack Characterisation for In-service Inspection Planning

SKI Report 95:70

Peter Ekström
ABB Atom AB, S-721 63 VÄSTERÅS

Jan Wåle
SAQ Inspection Ltd, Box 49306, S-100 29 STOCKHOLM

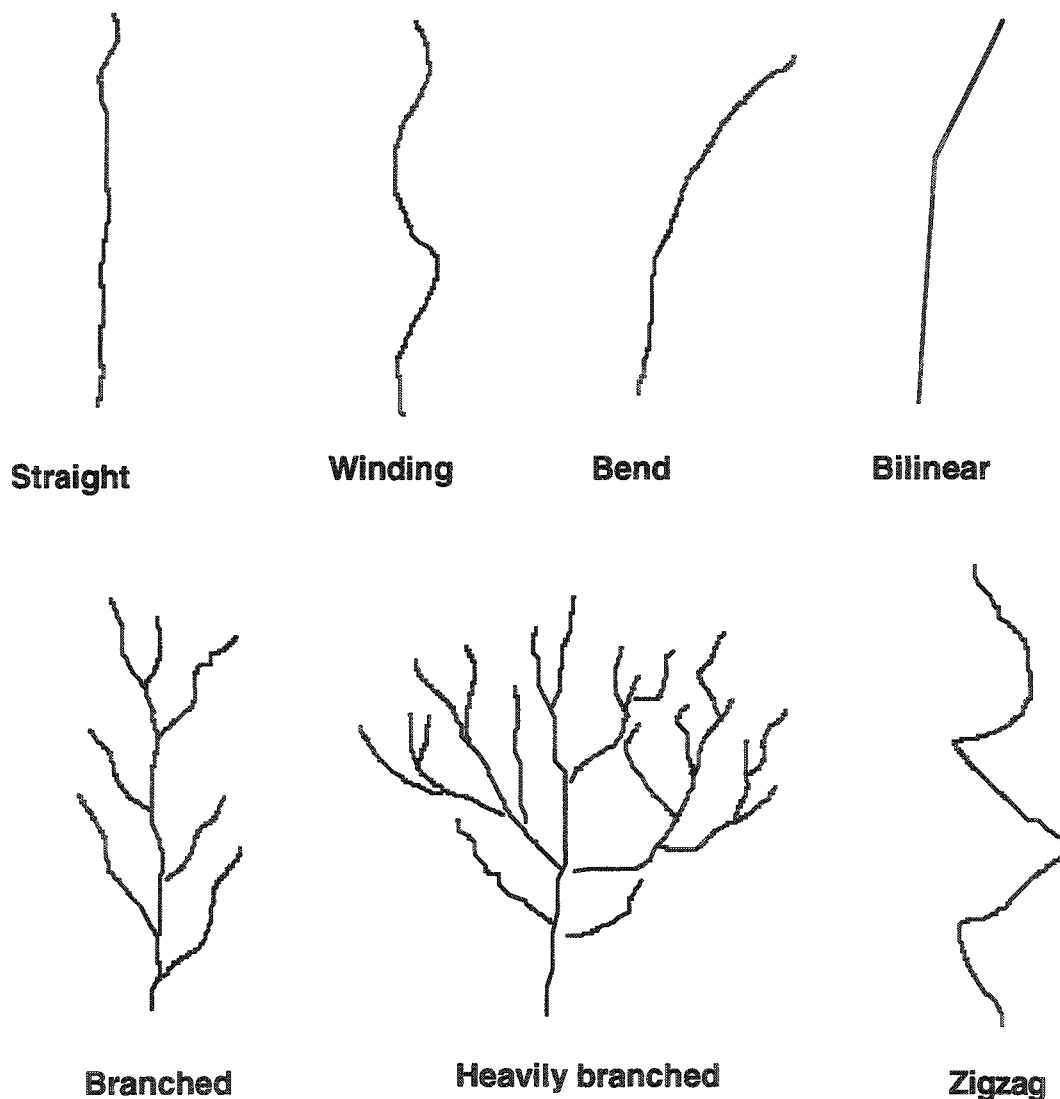
Fig. 2, Schematic illustration of different types of crack shapes.

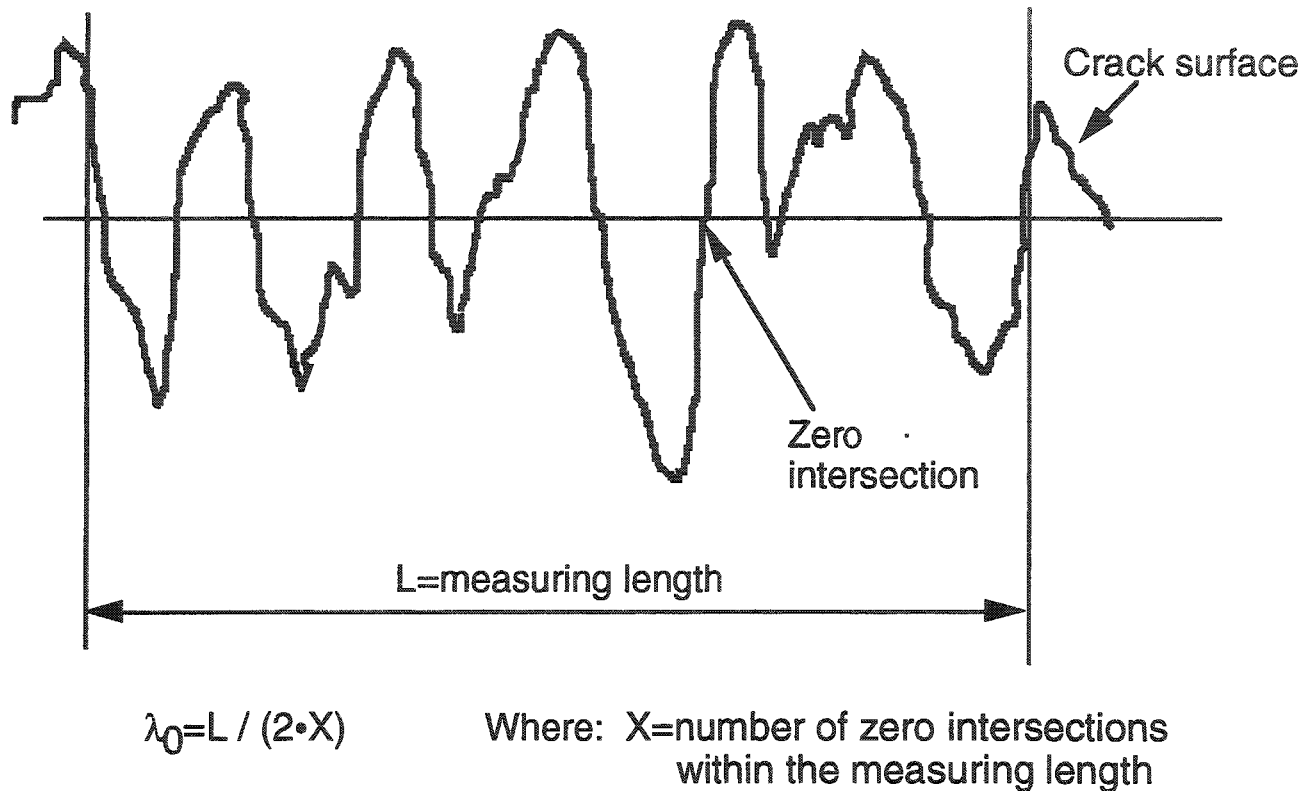
Fig. 4, Definition of correlation length, λ_0 .

Correlation length: The correlation length, λ_0 , controls the rate of change of surface height with distance along the surface. To calculate λ_0 from its theoretical definition is rather complicated and involves a large number of measurements. In this work an empirical formula for the correlation length has been used, see Fig. 4.

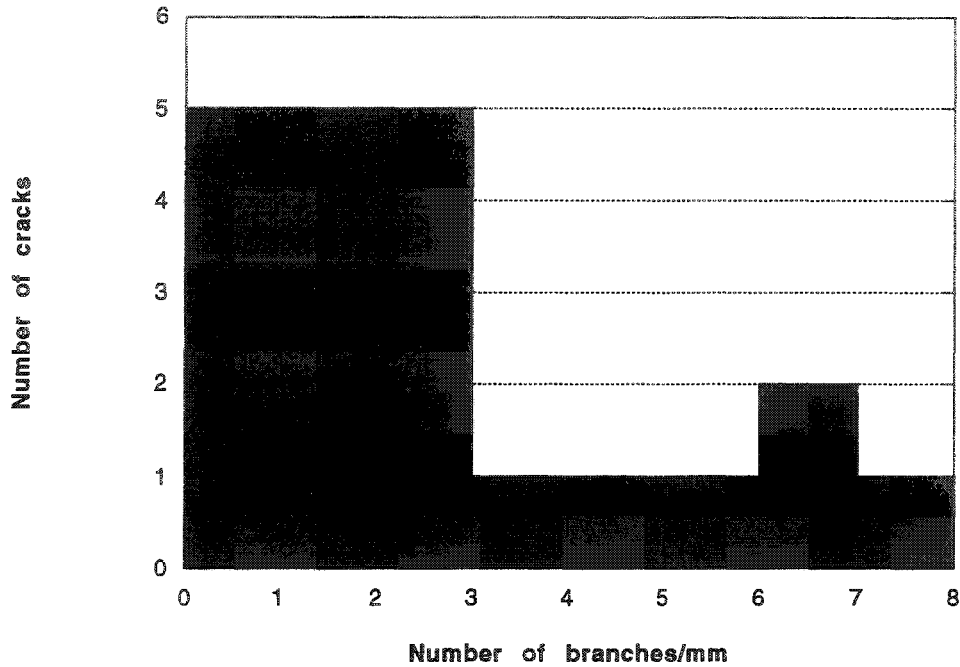
Fig. 5, Degree of branching for 21 TGSCC cracks in austenitic stainless steel.

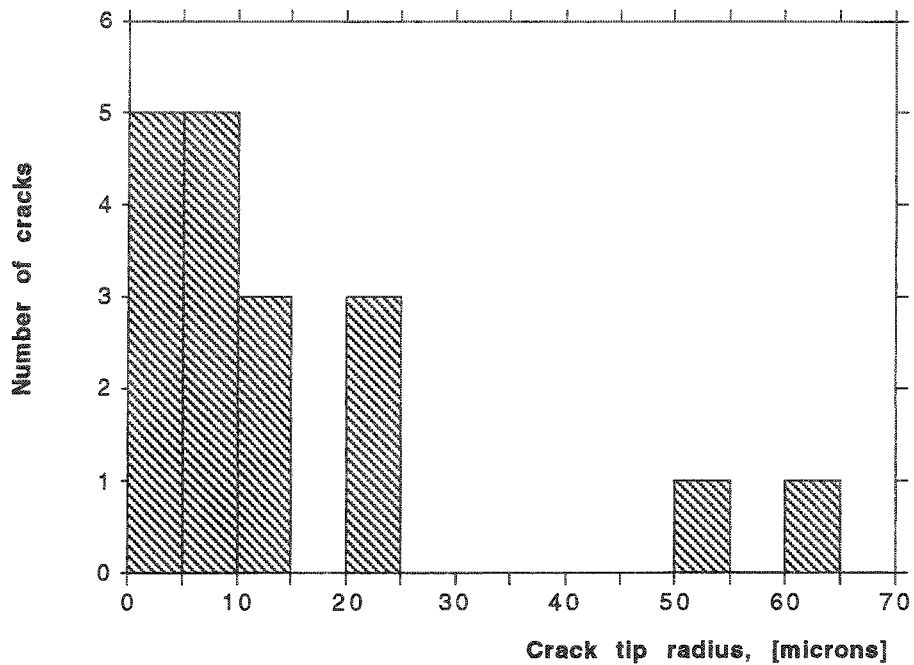
Fig. 6, Crack tip radius for 18 corrosion fatigue cracks in ferritic low alloy steel.

A crack tip radius $\geq 10 \mu\text{m}$ was measured for eight out of 18 evaluated cracks. The distribution of crack tip radii is shown in Fig. 6. The mean value is 13 μm .

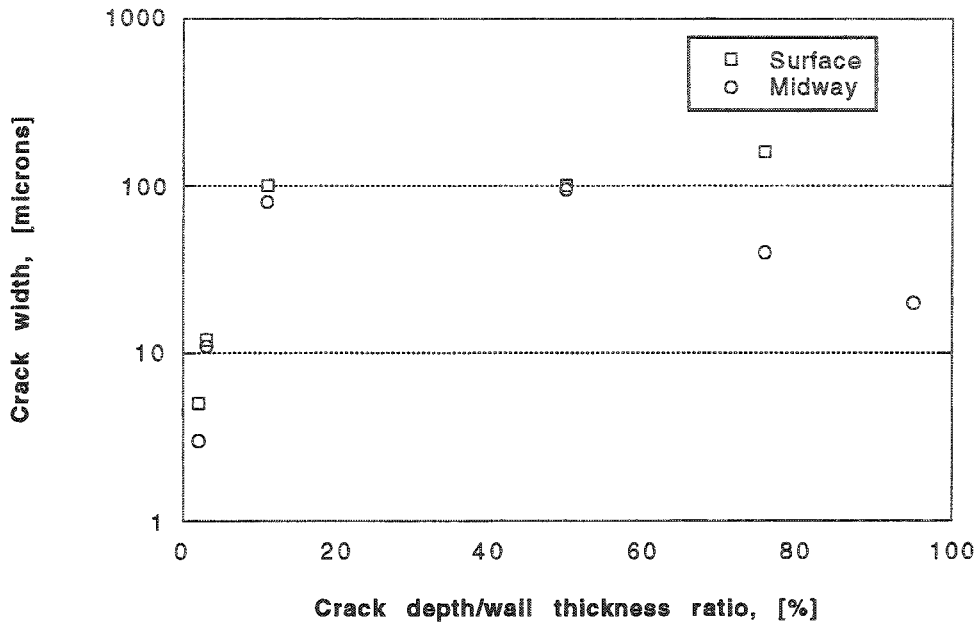
Fig. 8, Crack width at surface and midway for 6 mechanical fatigue cracks versus crack depth/wall thickness ratio.

Seven mechanical fatigue cracks in ferritic low alloy steel were evaluated. The range in crack depth, wall thickness and crack depth/wall thickness ratio is 0.5-15 mm, 5-140 mm and 2 - 100%, respectively. The crack width was measured at three points for each crack. The results are presented in Fig. 8 and 9, where the crack width at surface and midway are plotted versus crack depth/wall thickness ratio and the crack width at each measuring point is plotted versus distance from crack tip, respectively. An anticipated increased crack width with increasing crack depth and crack depth/wall thickness ratio could be observed.

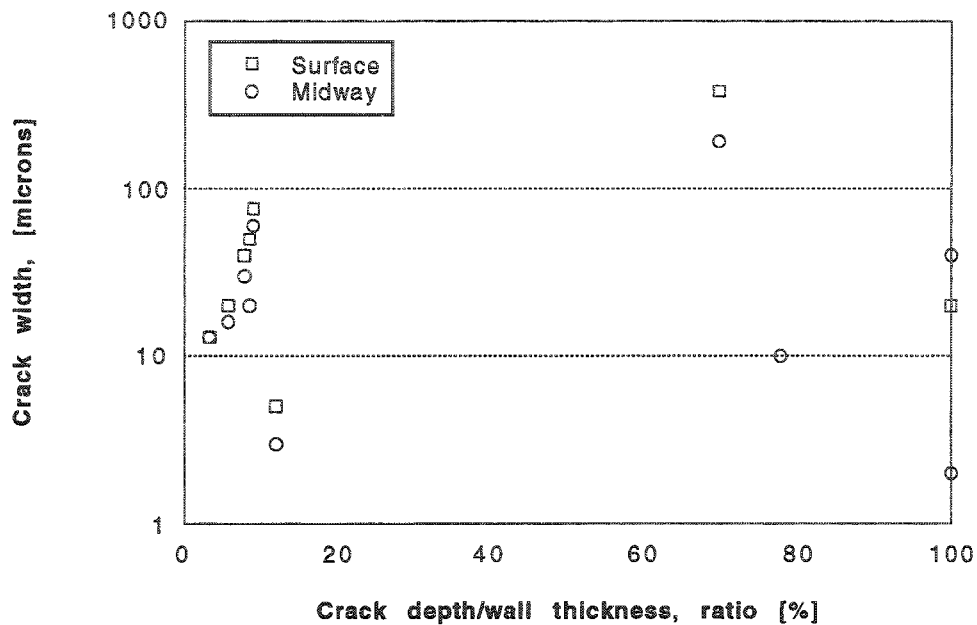
Fig. 15, Crack width at surface and midway for ten thermal fatigue cracks in austenitic stainless steel versus crack depth/wall thickness ratio.

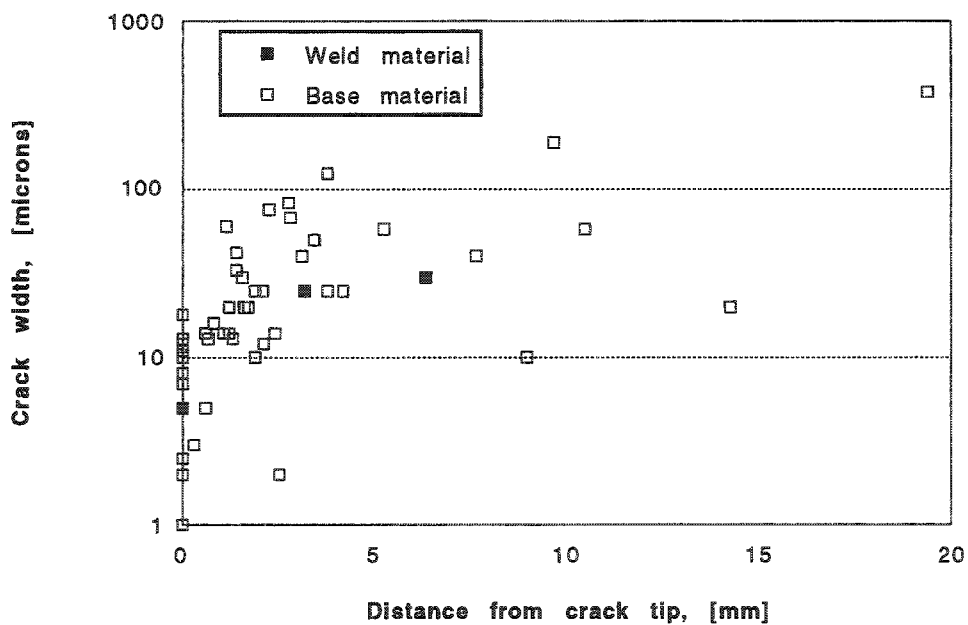
Fig. 16, Crack width at three locations for each crack versus distance from crack tip for 20 thermal fatigue cracks in austenitic stainless steel.

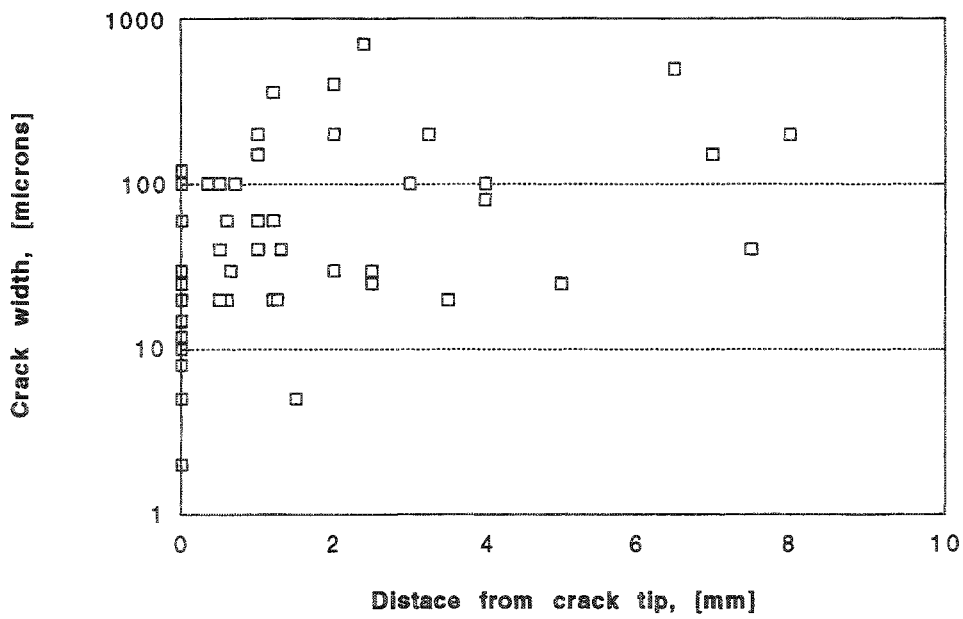
Fig. 19, Crack width at three locations for each crack versus distance from crack tip.

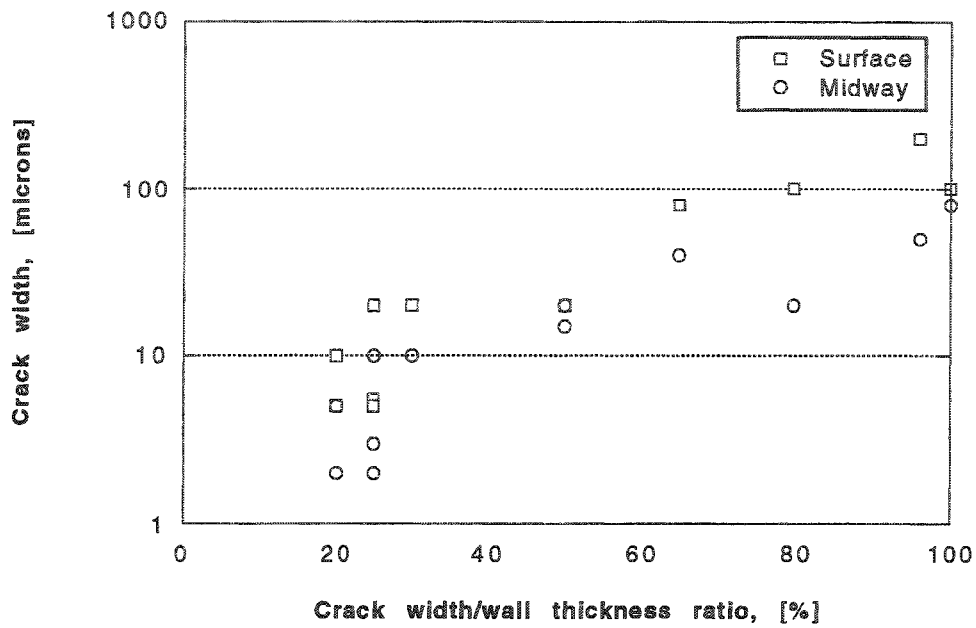
Fig. 21, Crack width at surface and midway for 13 IGSCC versus crack depth/wall thickness ratio.

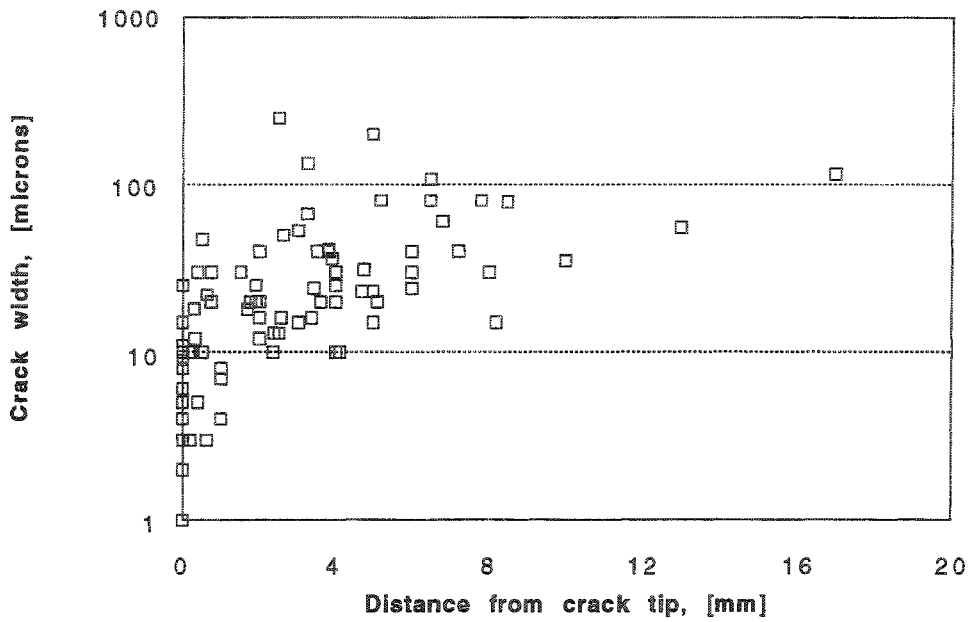
Fig. 26, Crack width at three locations for each crack versus distance from crack tip.

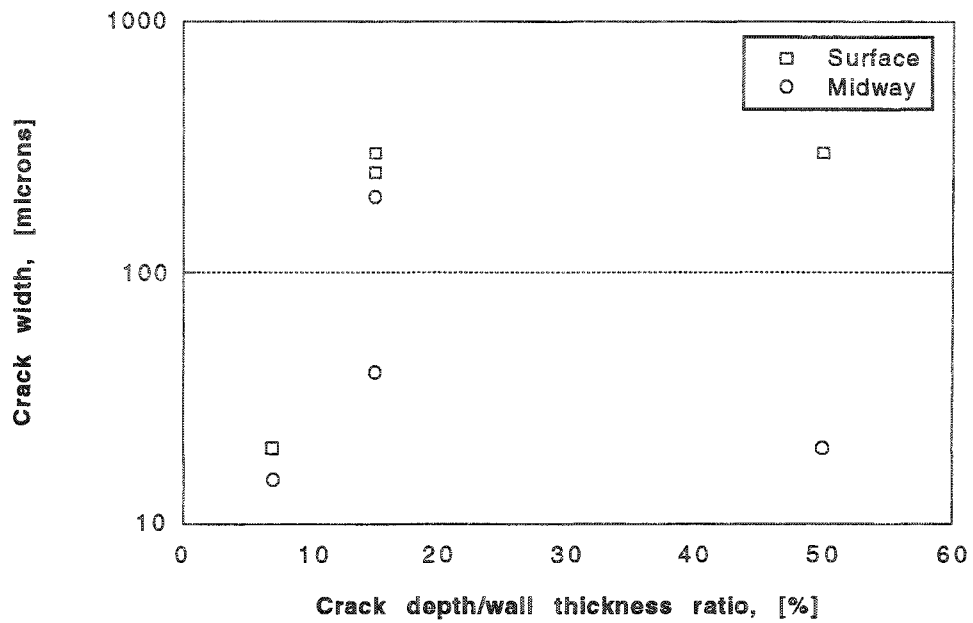
Fig. 30, Crack width at surface and midway for 4 TGSCC cracks versus crack depth/wall thickness ratio.

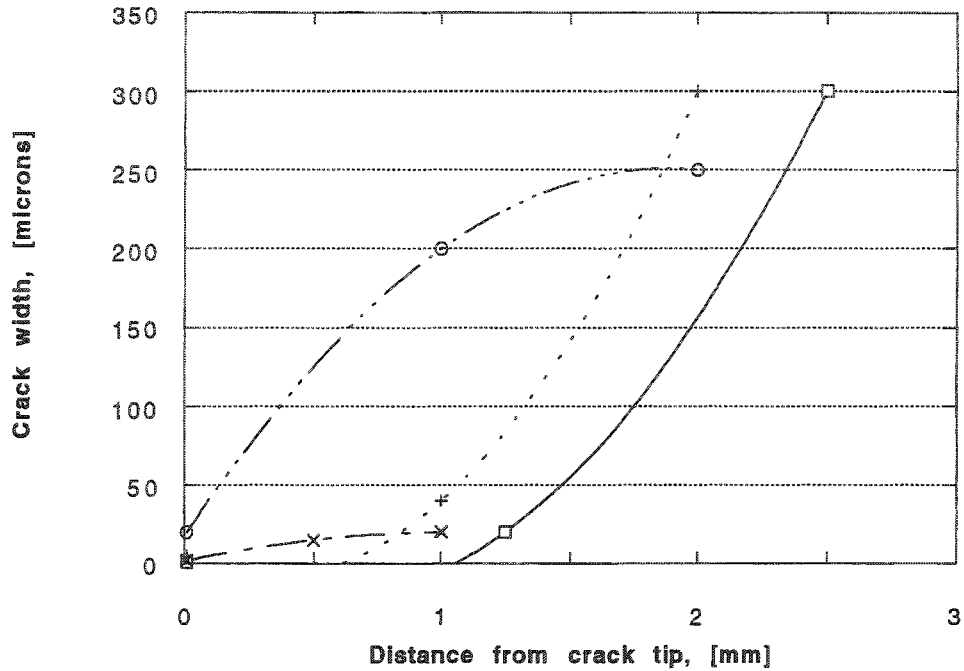
Fig. 32, Crack width at three locations for each crack versus distance from crack tip. Four TGSCC cracks with depths 1-2.5 mm, wall thickness 5-16 mm and crack depth/wall thickness ratio 7-50%.

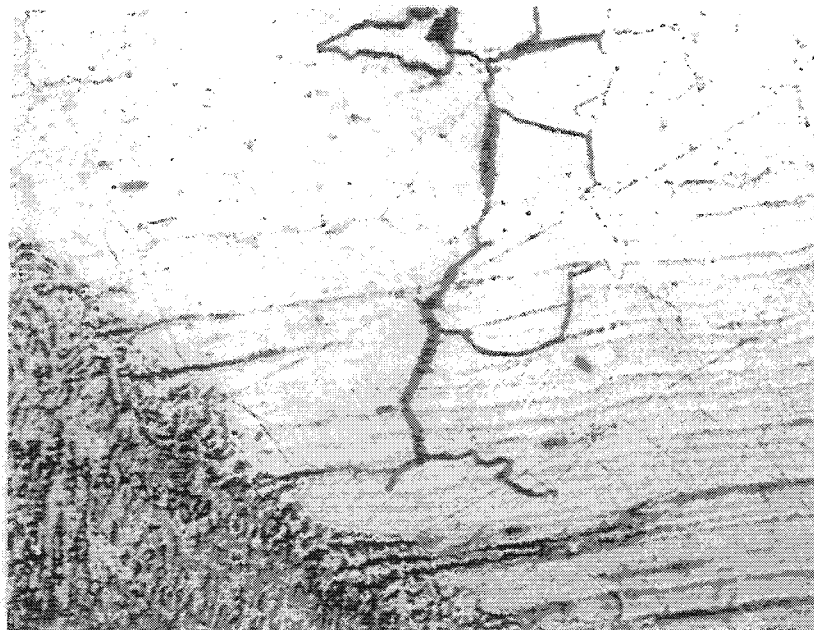
Micro graph 30 IGSCC crack tip region close to a weld in an austenitic stainless steel pipe, nuclear industry. Crack arrest at the fusion line. Note, the micro branching and the intergranular crack growth. Magnification 200 X.
