Strål
säkerhets
myndigheten

Quality Assurance Review of the Swedish Nuclear Fuel and Waste Management Company's LOT Experiment (Phase S2 and A3) at the Äspö Facility in Sweden

2021:06

Authors: T.W. Hicks¹, T.D. Baldwin¹ and J.R. Scully²

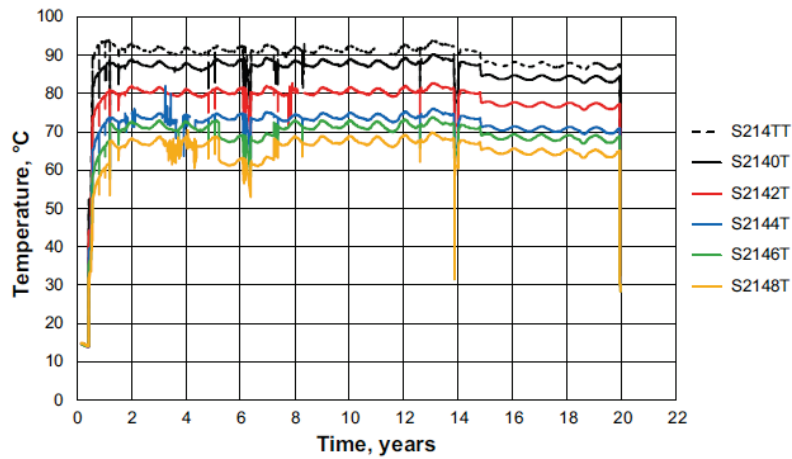
Figure 4 Temperature as a function of time and radial distance from the copper tube in block 14 of test parcel S2 [5]. The small drop in temperature after about 14 years is because of an exchange of power regulators.

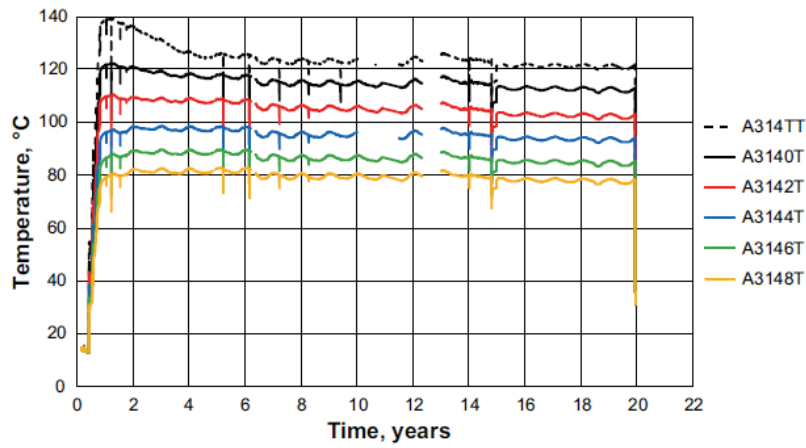
Figure 7 Temperature as a function of time and radial distance from the copper tube in block 14 of test parcel A3 [5]. Data gaps are a result of problems with data loggers.
