Hot-Cell Examination of a Defect Rod from IFA-597

Tord Jonsson

November 1998

Studsvik Nuclear AB
SE-611 82 Nyköping
Sweden

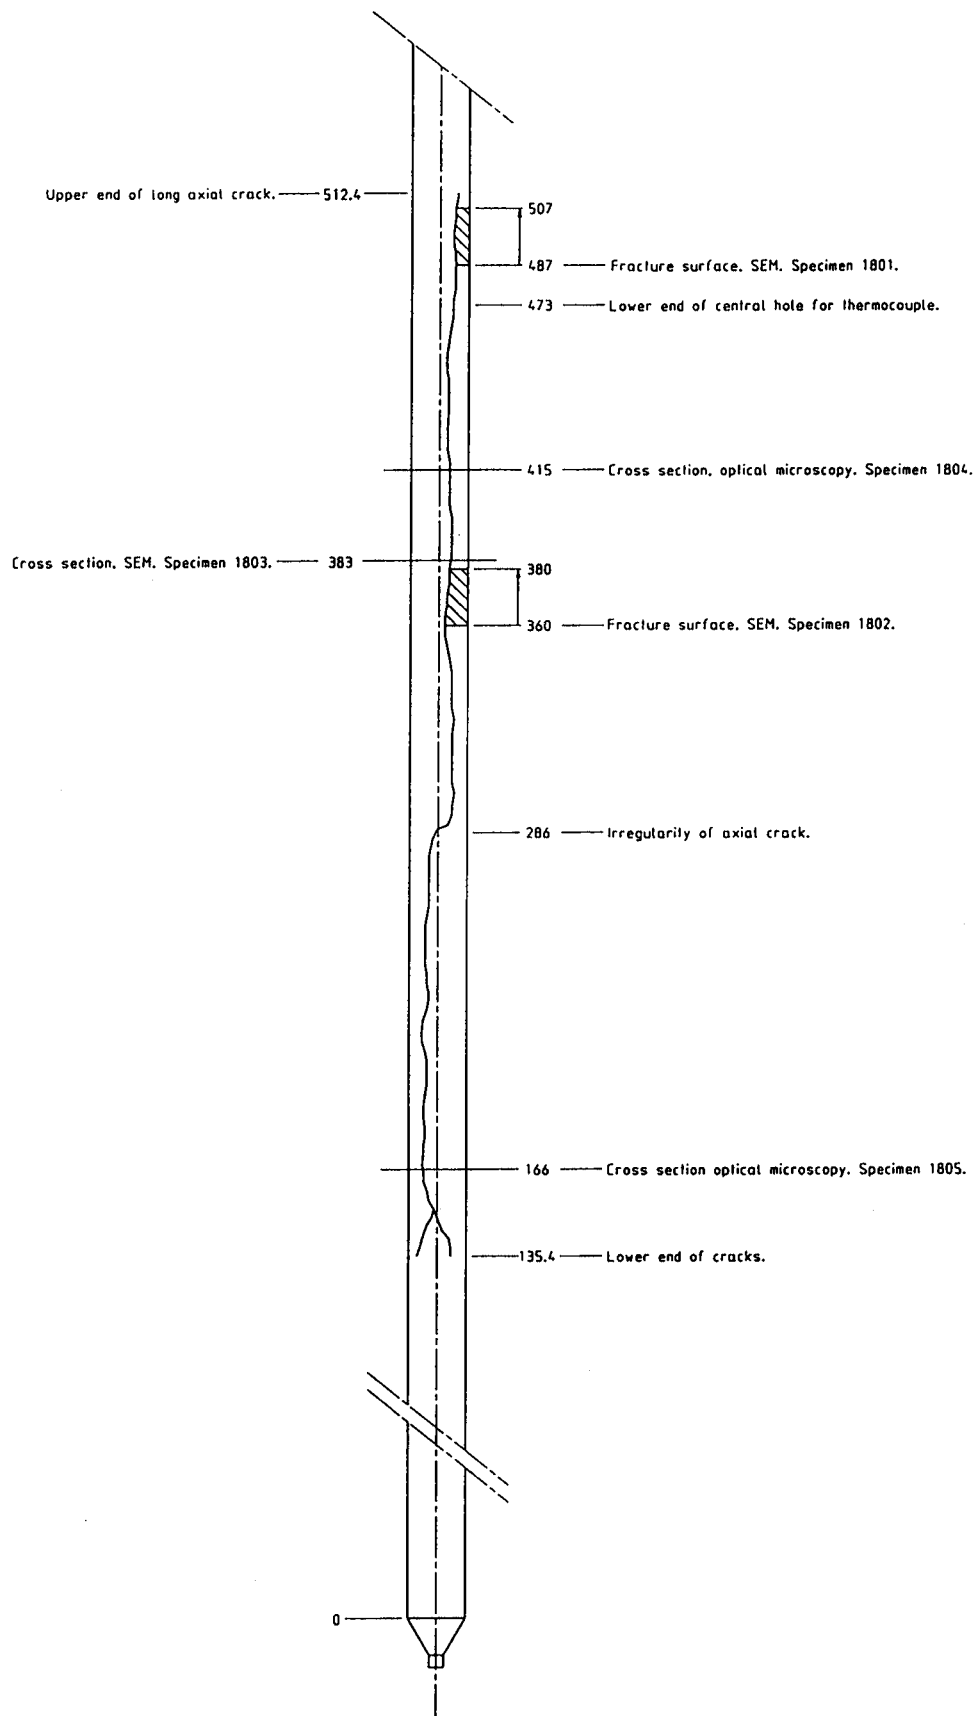
Appendix H1 Positions of specimens for destructive examinations.

Axial position (mm from lower end)	Specimen number	Type of examination or comment
135,4		Lower end of cracks
147		Lower end of fuel column
159-175		Part of cladding without oxide and crud
166	1805	Cross section, optical microscopy
~286		Irregularity of axial crack
360-380	1802	Fracture surface, SEM
383	1803	Cross section, SEM
415	1804	Cross section, optical microscopy
473		Lower end of central hole for thermocouple
587-507	1801	Fracture surface, SEM
508		Upper end of fuel column
512,4		Upper end of long axial crack
