Identification of Common Cause Initiating Events Using the NEA IRS Database

Maciej Kulig - Enconet Consulting

February 2007

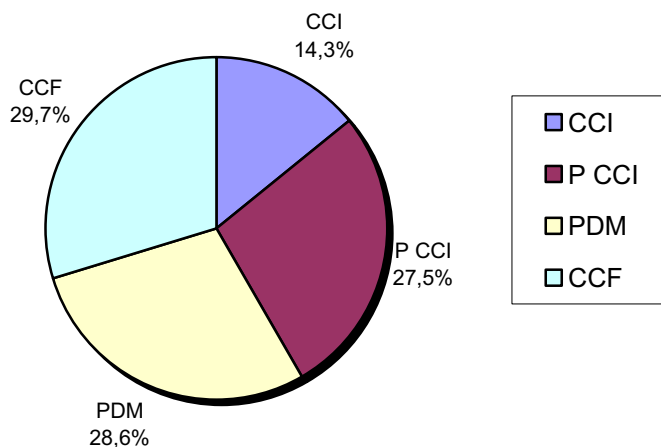
Figure 3-1. Events of interest identified in the IRS database in relation to CCIs.

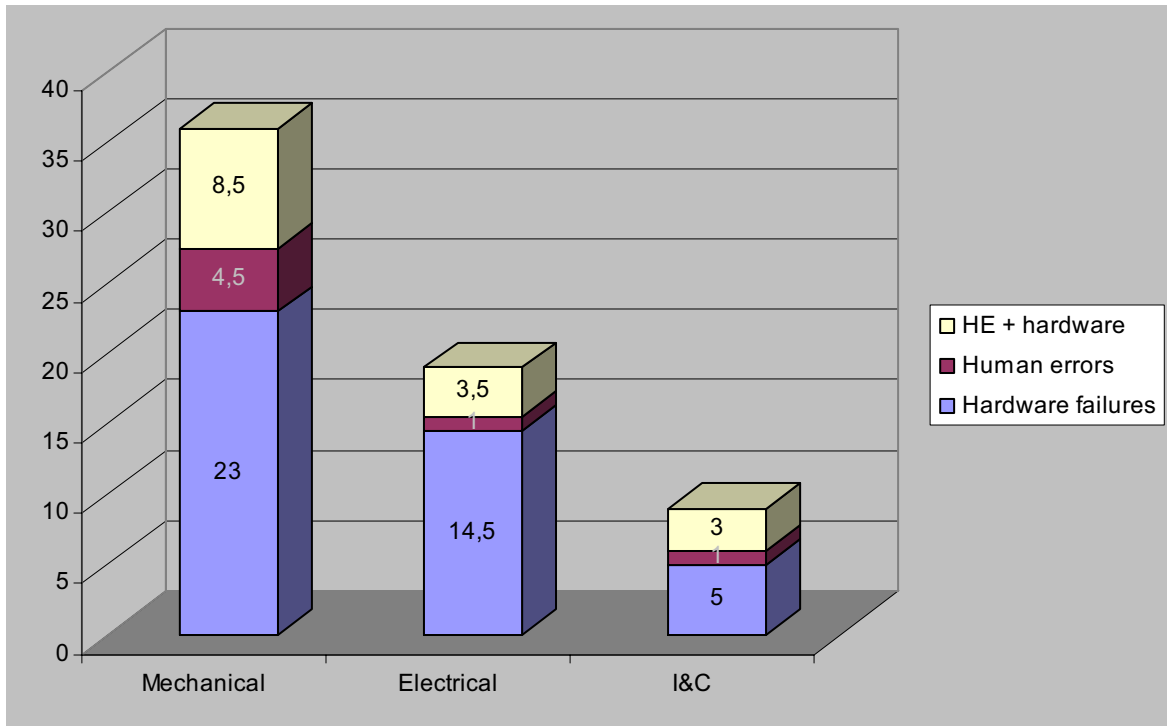
Figure 3-2. Systems and types of malfunctions involved in the direct cause of events (64 events of CCI, P CCI, PDM type reported to occur in the period of 1995-2006)

Fig. 3-2 shows a distribution of ‘direct cause’ occurrences among the three types of systems and contribution of hardware failures and human errors (and their combination, if applicable). This figure addresses only three groups of events: CCI, P CCI, and PDM. The CCF group was excluded since the related IRS reports address mostly degraded plant conditions (generic issues) for which the ‘direct cause’ concept is hardly applicable.

As shown in Fig 3-2 the distribution of events among system type categories is not uniform. About 56 % of direct cause occurrences involve the mechanical systems. Electrical systems contribute ~30 % and I&C systems 14 %. Contribution of hardware failures varies depending on the system type from ~76 % for the electrical systems to ~55 % for the I&C systems. The remaining contributors are human errors alone or in combination with hardware failures. The latter group includes also HEs made before the incident. As shown in Fig 3-3 failures of systems are dominated by failures of component of the same type – the mechanical systems by failures of mechanical components, the electrical systems by failures of electrical components, etc.

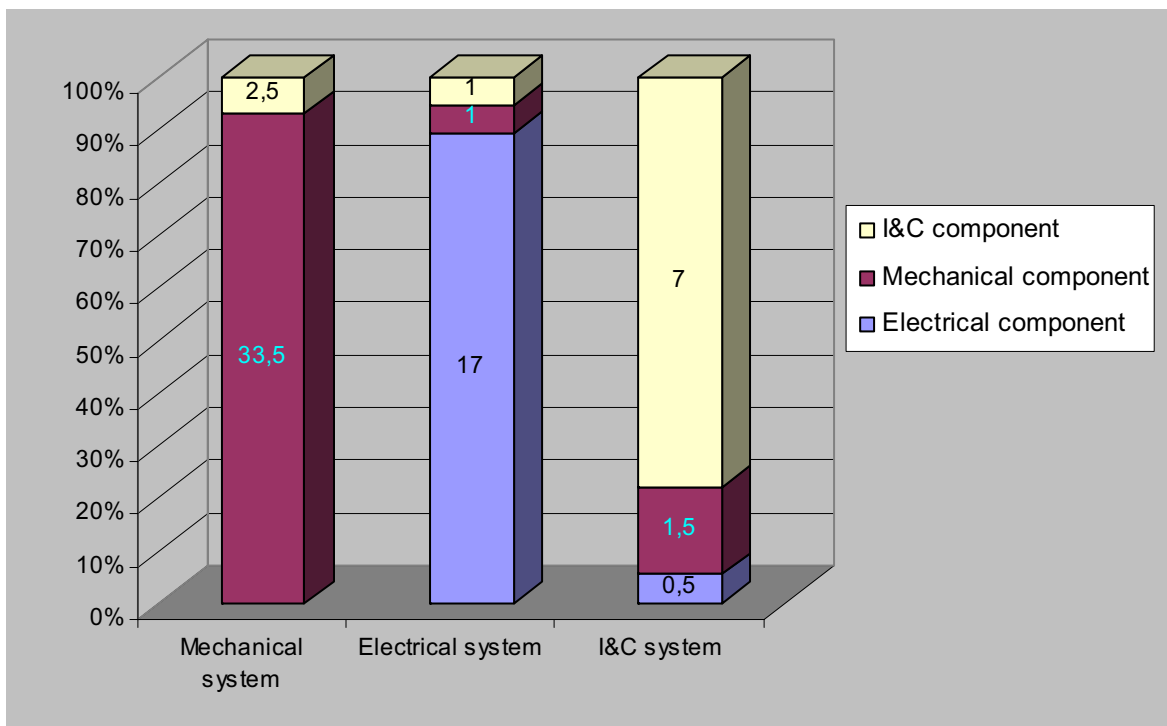
Figure 3-3. Components involved in the direct cause of events for system groups (64 events of CCI, P CCI, PDM type reported to occur in the period of 1995-2006)

Fig. 3-3 shows a distribution of ‘direct cause’ occurrences in terms of component types for each of the system categories.

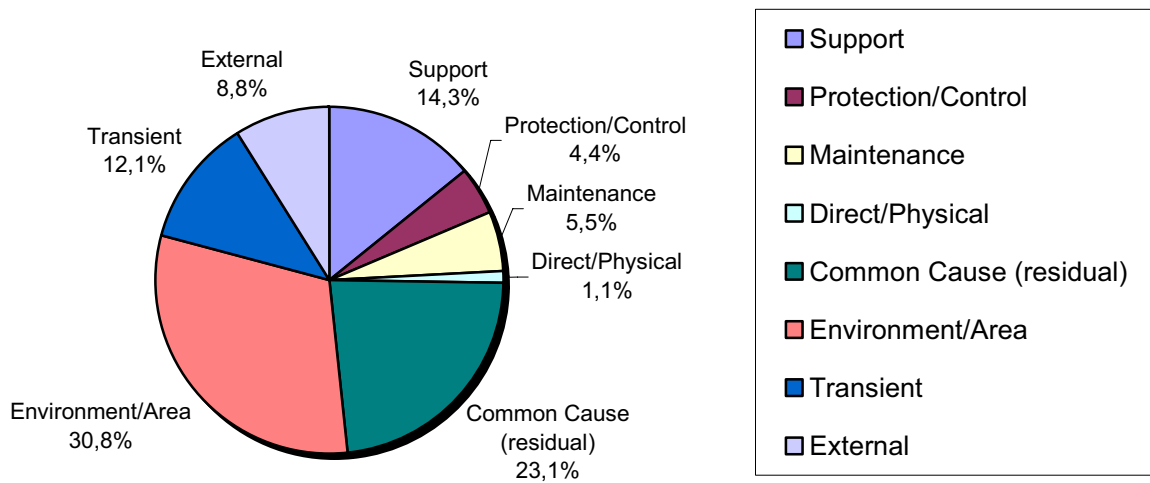
Figure 3-4. Various dependency mechanisms involved in CCI-related events – major types (91 events reported to occur in the period of 1995-2006)

Categorization of events with regard to 'dependency mechanism' was conducted for all events considered interesting from CCI point of view (91 events including CCI, P CCI, PDM and CCF type). Fig. 3-4 shows distribution of these events among the major categories:

- Support (power, ventilation, computer, air, etc.)
- Protection/control (signal, measurement, setpoints)
- Maintenance
- Direct /physical
- Common cause (residual)
- Environment/Area
- Transient (operational and accident-induced)
- External

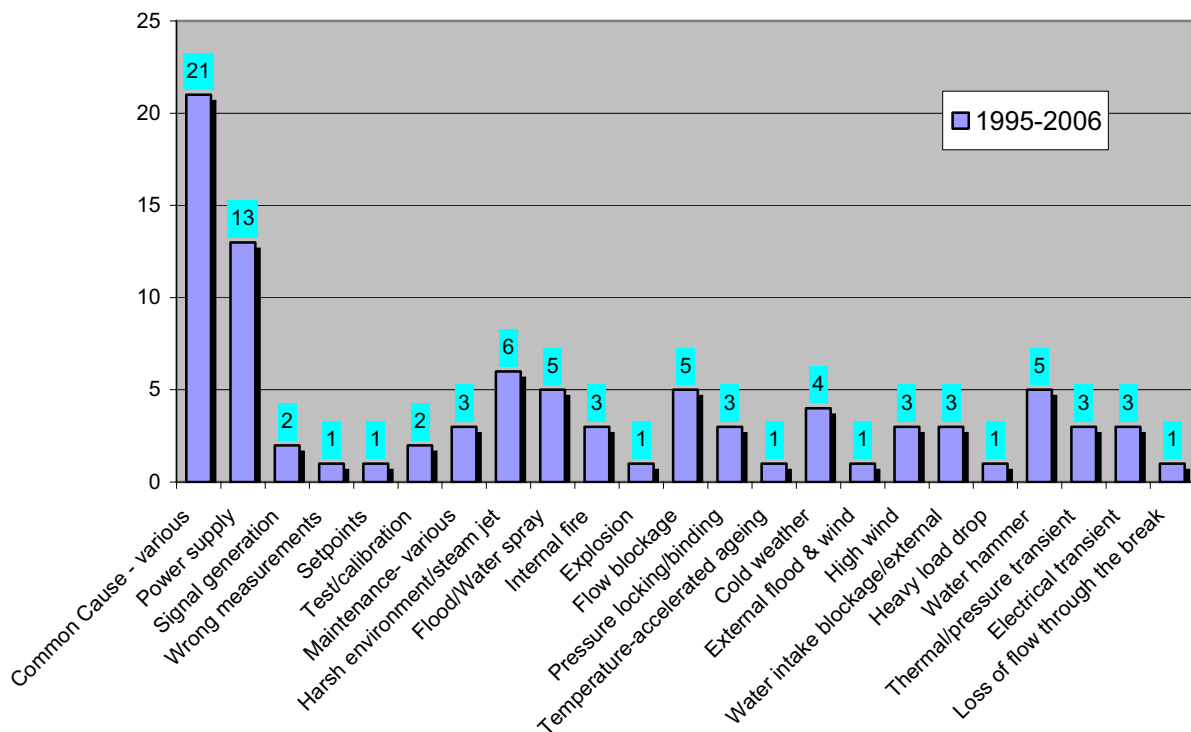
Figure 3-5. Various dependency mechanisms involved in CCI-related events – detailed categorization (91 events reported to occur in the period of 1995-2006)

More detailed categorization of the observed dependency mechanisms is shown in Figs 3-5 and 3-6.

The most relevant dependency mechanisms are related to environmental impact/area events, direct dependencies through support systems, and transients. Fig. 3-5 shows individual contributors in these major groups. The most frequent are power supply, harsh steam environment and steam jet impact, flood and water spray, flow blockage, water hammer, and cold weather.

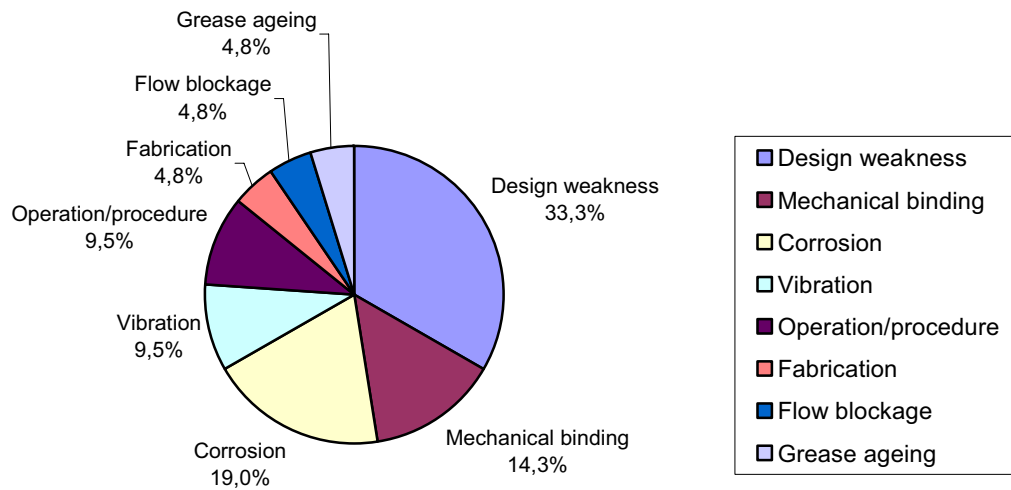
Figure 3-6. Coupling factors involved in Common Cause Failure events (residual) – (summary of 21 IRS reports issued in the period of 1995-2006)

In the group of CCF related events the ‘design’ is the most important coupling factor. Although this coupling factor is not likely to contribute to CCIs, there are other coupling factors that may be relevant from CCI point of view. It includes factors of environmental type (corrosion, vibration, mechanical binding).

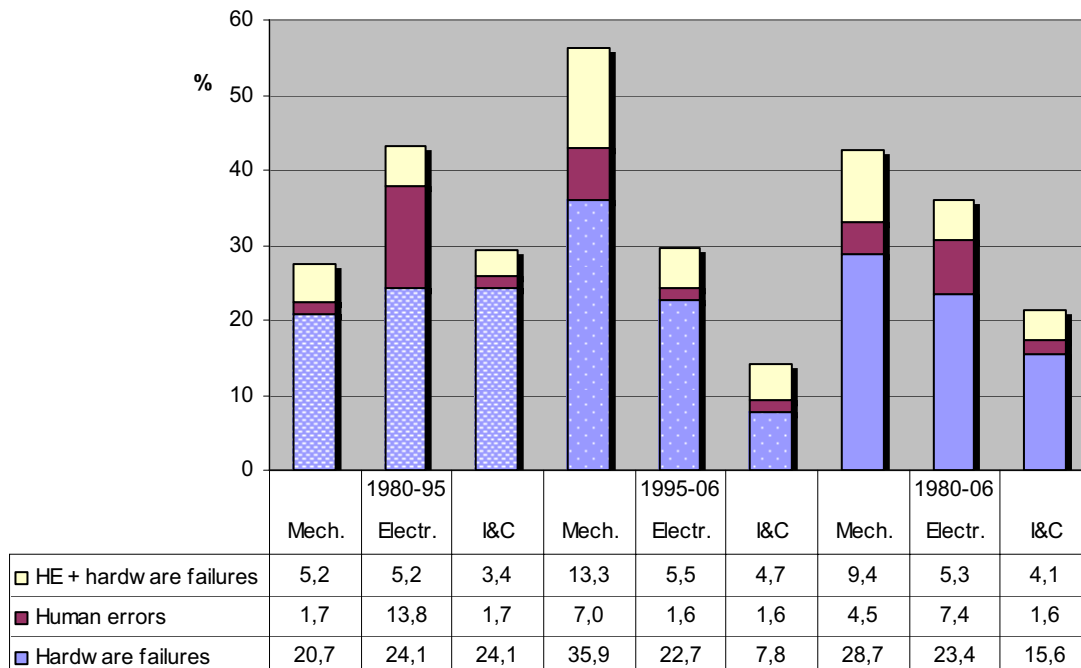
Figure 4-1. Systems and types of malfunctions involved in the direct cause of events – relative (%) contribution (based on events of CCI, P CCI, PDM type i.e. 58 and 64 events in the period of 1980-1995 and 1995-2006, respectively)

Distributions of systems and types of malfunctions involved in the direct cause of events are shown in Fig. 4-1 for the three events samples - 1980-1995, 1995-2006, and 1980-2006.

As can be noticed, the systems contributing to the ‘direct cause’ are different in the current project as compared to the earlier results. In the period 1995-2006 contribution of systems of the mechanical type is higher than the electrical and I&C systems.

the factors that result in a lower contribution of ‘electrical’ and ‘I&C’ systems involved in the direct cause (as shown in Fig. 4-1).

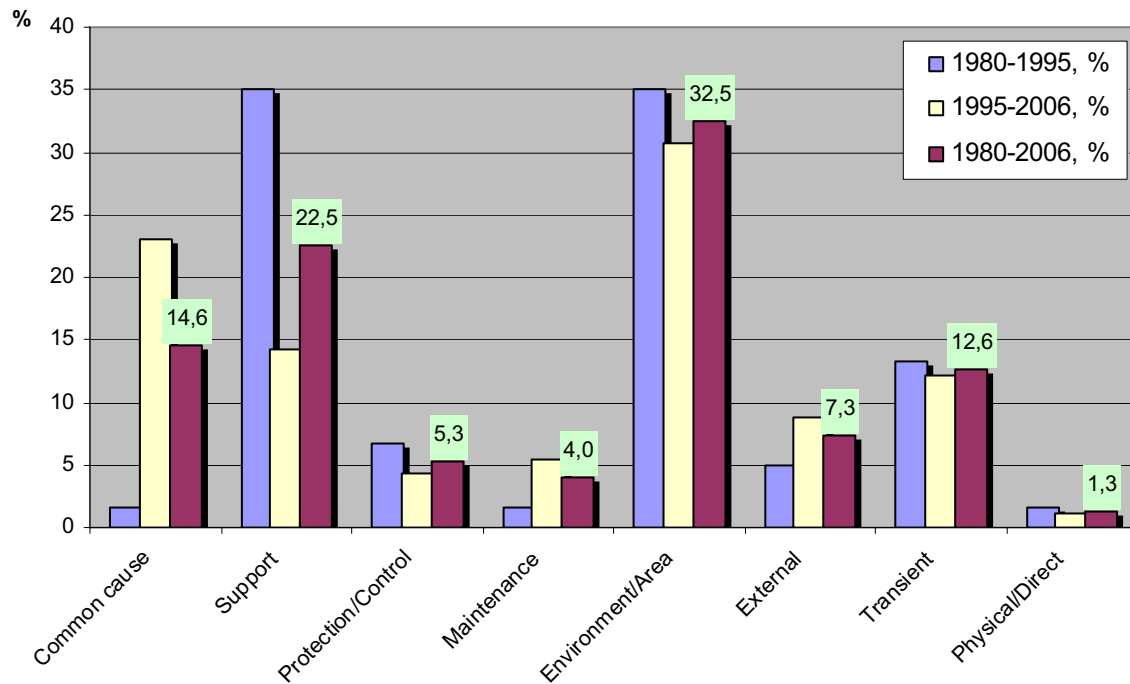
Figure 4-2. Relative contribution (%) of various dependency mechanisms involved in CCI-related events – major categories; (all types of events (CCI, PCCI, PDM, CCF) i.e. 60 and 91 events in the period of 1980-1995 and 1995-2006, respectively).

Distributions of events in terms of various dependency mechanisms are shown in Figs 4-2 and 5-3 for the three events samples (1980-1995, 1995-2006, and 1980-2006).

The 3 most significant dependency categories identified in the earlier study (power supply, harsh environment, internal hazards (flood and fire), water hammer, and cold weather) are also clearly noticeable in the current event sample.

The current review identified the dependency mechanisms that were not observed in the earlier event sample (1980-1995) or contributed very little. These include the maintenance, flow blockage, pressure locking / binding, and external events (wind).

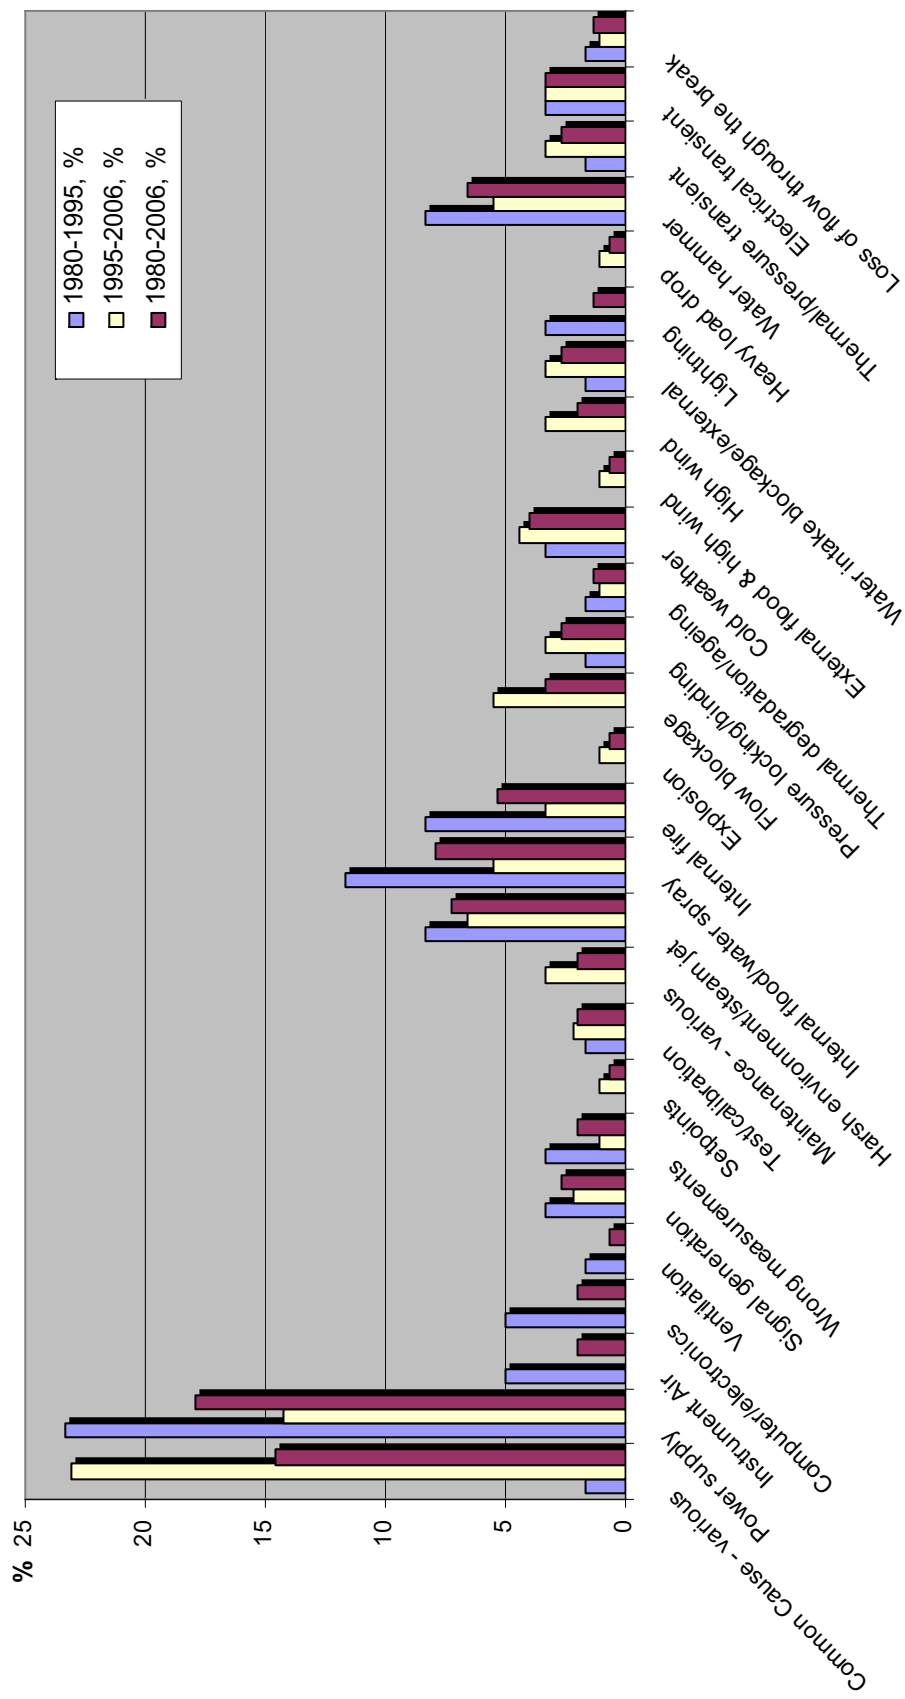
Figure 4-3. Relative contribution (%) of various dependency mechanisms involved in CCI-related events –detailed categories (all types of events (CCI, PCCEI, PDM, CCF) i.e. 60 and 91 events in the period of 1980-1995 and 1995-2006, respectively).

The dependency mechanisms related to maintenance, flow blockage (internal and external causes), and pressure locking in mechanical systems (e.g. valves) are addressed in several generic reports that refer to multiple events of this type. The same observation applies to the cold weather dependency mechanism. Therefore, the importance of these factors is even higher than it looks like based on the current statistics.
