# **Characterization of the Microstructure in Recrystallized Zircaloy-2 Cladding Irradiated to a High Neutron Dose**

Kjell Pettersson

April 2003

Characterization of the microstructure in recrystallized Zircaloy-2 cladding irradiated to a high neutron dose. SKI-project 14.6-011209:01257.

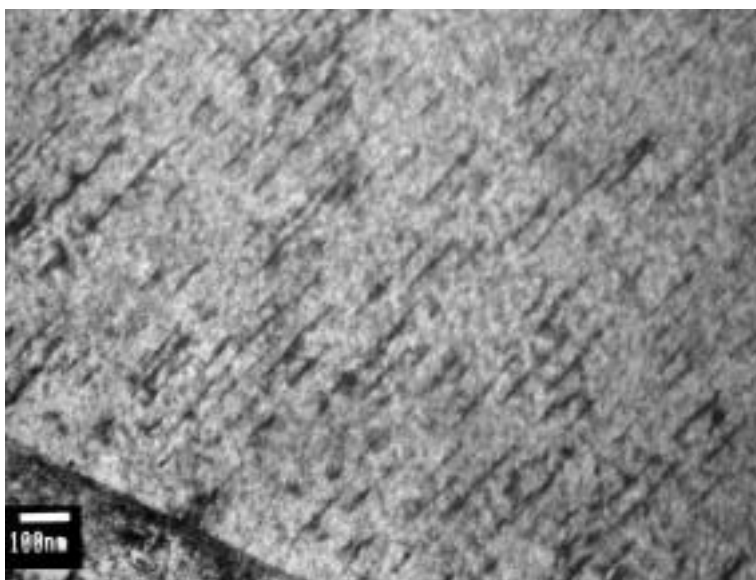
Figure 6 shows the *c* component damage in the low-burnup specimen. It seems to consist of short dislocation segments directed perpendicular to the *c*-axis of the material. The picture was taken with the (000*x*) row of systematic reflections activated. By tilting around the *c*-axis another picture was taken in order to get a stereo pair. The purpose of

of using stereo in this case was to see if the line segments go from the top of the foil to the bottom of the foil. However this did not seem to be the case so probably the segments are several small loops which when observed edge on appear as a segment.

Figure 6. **c** component damage in the low burnup specimen. The **c**-axis is perpendicular to the direction of the apparent line segments. 65000x.
