# **SKI Report 98:09**

## **Identification of Common Cause Initiators in IRS Database**

**Ralph Nyman  
Maciej Kulig  
Bojan Tomic**

Februari 1998

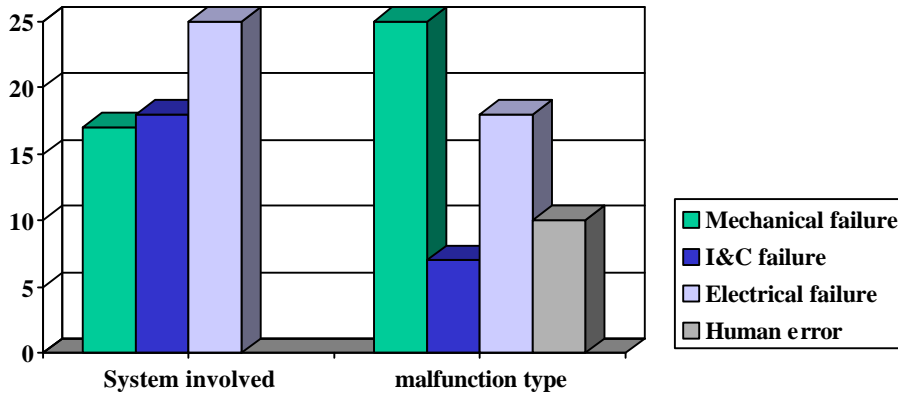
FIG. 2. Systems and types of malfunctions involved in direct cause of events.

Fig. 2 shows distribution of direct causes among the above mentioned categories. As shown the distribution of events among system type categories (mechanical, electrical, I&C) is almost uniform. With regard to malfunction type involved about 80% of direct causes are hardware failures (sometimes in combination with human errors) and 20% human errors alone.

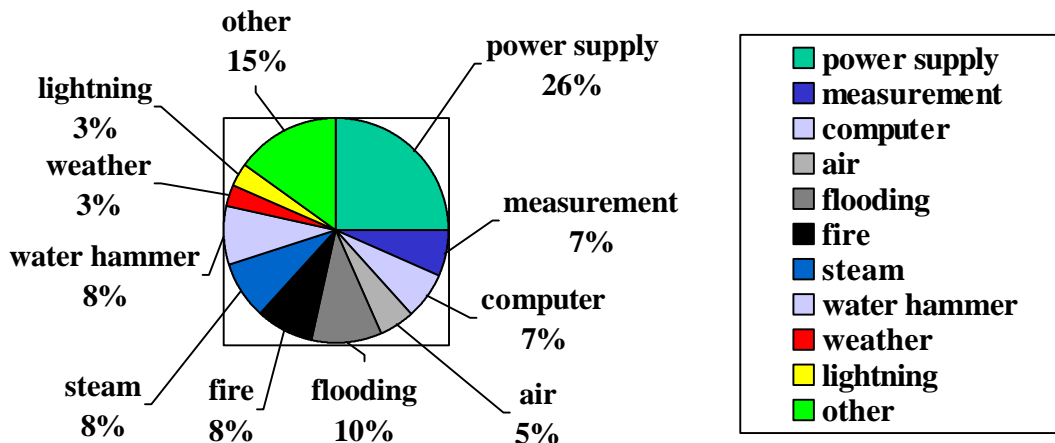
Distribution of various dependency mechanisms among the events is shown in Fig. 3.

FIG. 3. Various dependency mechanisms involved in CCI related events (60 events).

Among direct causes the dominating dependency mechanisms include electrical power supply and I&C (measurement/signal, computer support, instrument air) support functions. Among indirect mechanisms dominating mechanism include environmental area related dependencies (fire, flood, steam) and transients (water hammer).
