UNDETECTED LATENT FAILURES OF SAFETY-RELATED SYSTEMS

**Preliminary Survey of Events in
Nuclear Power Plants 1980-1997**

Bengt Lydell

March 1998

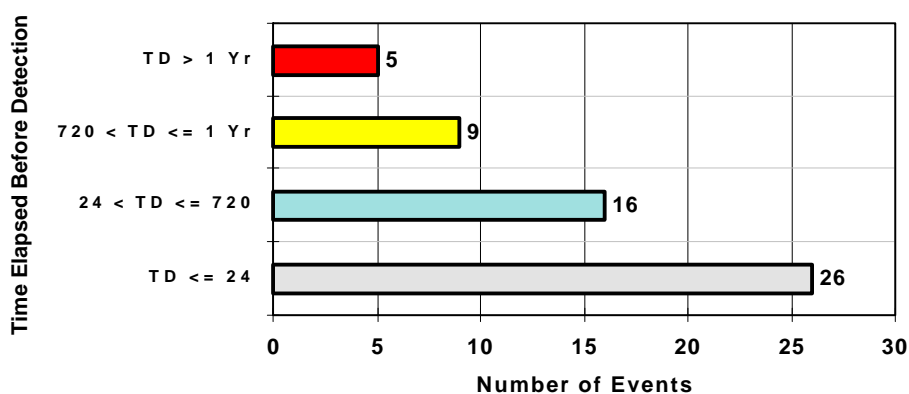
Figure 2-1: *Time to Detection of Latent Errors Summarized in Tables 2-2 & 2-3.*

The events selected for review are summarized in Table 2-2 and Table 2-3. This summary resulted from a limited review of selected operational events. All of these events involved multiple personnel errors in following procedures, inadequate procedures, and inadequate post maintenance and surveillance activities. The anatomy⁵ of the events that occurred 10 or more years ago remains applicable to the recent events. This observation points to inadequacies of root cause analyses practices, and lack of feedback of operating experience. It also points to the complexity of unraveling the root causes of latent errors. Typically, the detection of unavailable standby systems was the fortuitous result of some control room or ex-control room activity soon after occurrence rather than a deficiency that was revealed via a planned or scheduled action; *c.f.* Figure 2-1.
