SKI Report 2004:16
SSI-report 2004:04

Statement of the Situation Concerning Safety and Radiation Protection at Swedish Nuclear Plants in 2003

Safety and Radiation Protection at Swedish Nuclear Power Plants 2003

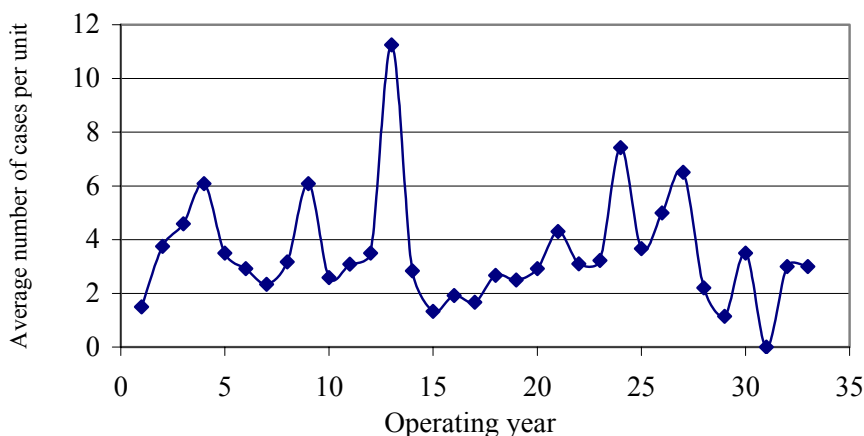
Diagram 2. The uppermost of the two diagrams shows the average number of reported cases of damage per unit and operating year for all Swedish nuclear power plants. The diagram comprises damage to pressure vessels, pipelines and other mechanical devices apart from steam generator tubes. The diagram below shows the number of operating years for the different units.

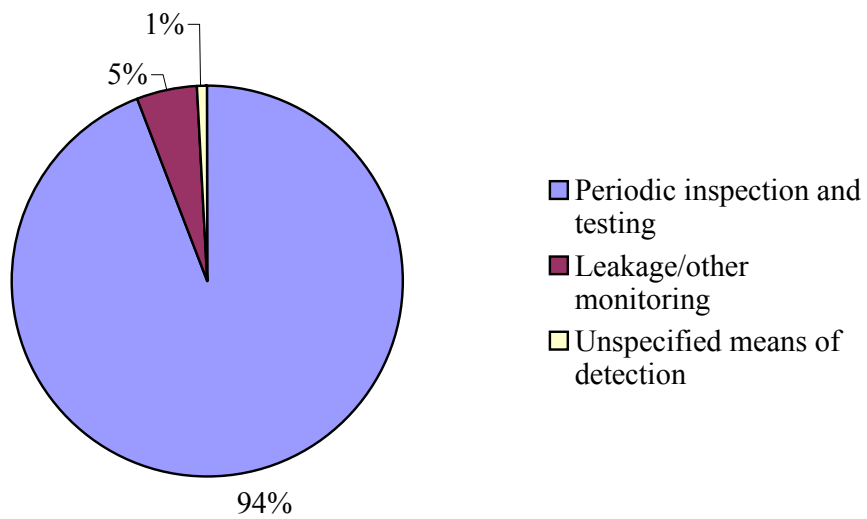
Diagram 3. The number of cases of damage detected through periodic in-service inspection and testing and the number of instances of damage that have resulted in leakage or that have been detected in some other way.
