Strål
säkerhets
myndigheten

2015:07

TEM-lamella lift-out from the crack tip
region of Alloy 600 for high resolution
electron microscopy examination

This report contributes to the development of a method for high-quality TEM lamella preparation from crack tip regions of nuclear materials. A standard compact tension (CT) specimen of Alloy 600 previously tested for stress corrosion crack growth in simulated PWR primary water was used to demonstrate the benefit of the proposed method. This report describes the procedure for cutting the CT specimen in order to access the crack tip region, and how TEM lamellas including crack tips were extracted with the use of Focused Ion Beam. Some high quality TEM images of crack tip regions were presented.

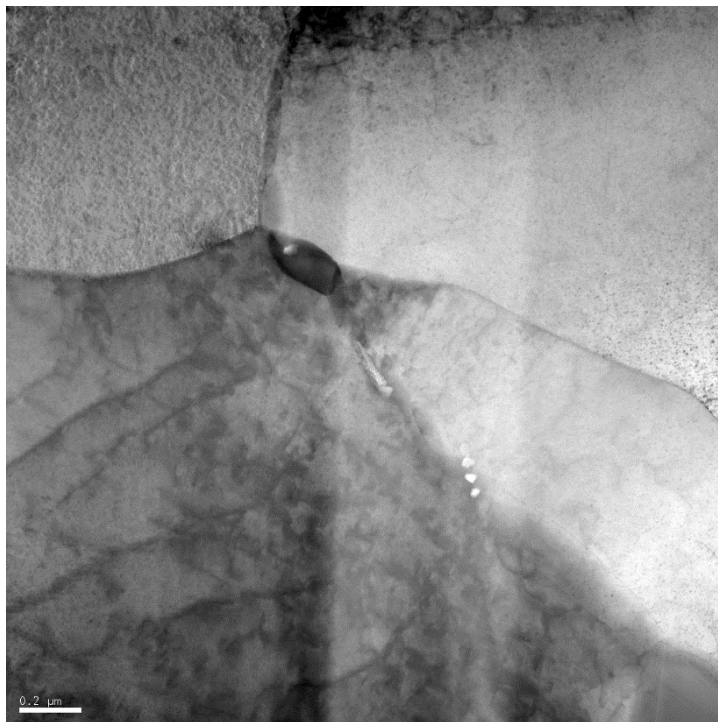
Figure 24
TEM bright field image of an area including precipitates in the grain boundaries.

Figure 21 shows a TEM bright field image of a part of the TEM-lamella prepared. The top part of the lamella was about 50 nm or thinner in thickness. At the top region of the lamella one can see a layer of recrystallized metal. This was likely a result of the Ga^+ milling in this area during the crack tip hunting before Pt was deposited. In this lamella, one can see Me-Me grain boundaries in which there were a number of chromium carbide precipitates. An EELS measurement showed an atomic ratio of Cr to C of ~ 2 , suggesting that the carbide was Cr_7C_3 (orthorhombic, $a = 7.014 \text{ \AA}$, $b = 12.15$ and $c = 4.532 \text{ \AA}$). Figure 22 through Figure 24 show some TEM bright field images of some locations of the TEM lamella. Figure 25 is a high resolution TEM image of a chromium carbide precipitate.
