SKI Rapport 2007:31 eng. version  
SSI Rapport 2007:09 eng. version

# Safety and Radiation Protection at Swedish Nuclear Power Plants 2006

May 2007

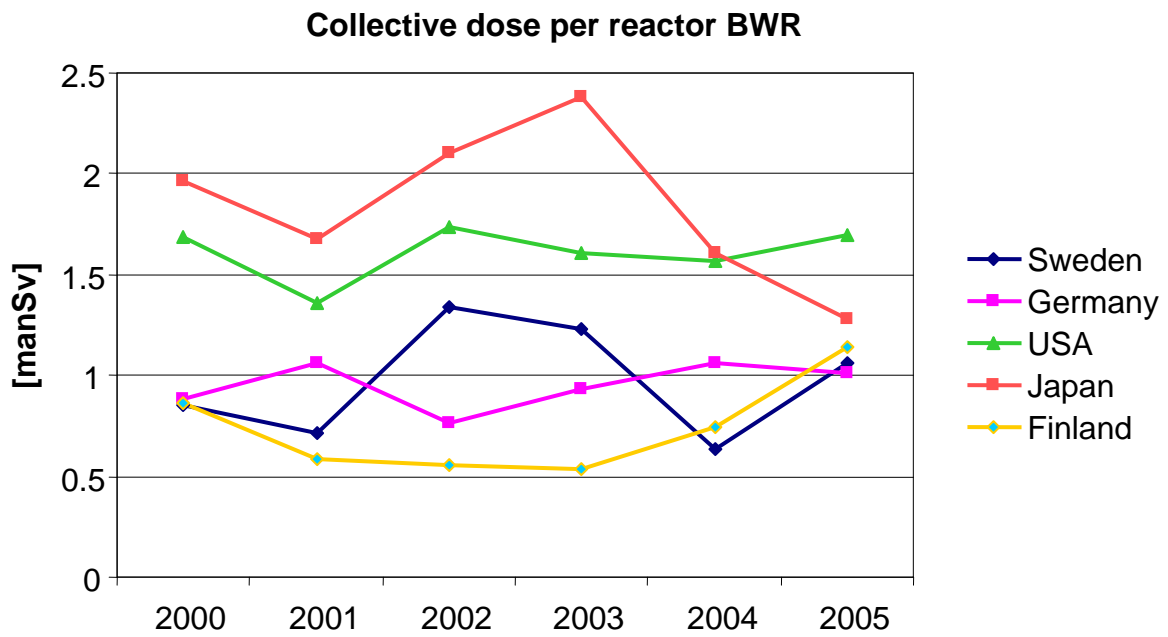
Diagram 4: Swedish collective doses for BWR (boiling water reactors) in an international comparison. Source: OECD/NEA, Information System of Occupational Exposure.

During 2006 the total collective dose (effective dose to personnel, including contractors) at the Swedish nuclear power plants was 9.3 manSv. The dose is the same order of magnitude as the average for the past five years (9.7 manSv). Diagrams 4 and 5 show the collective doses at the Swedish nuclear power plants and an international comparison for BWR and PWR plants. The choice of countries has been made taking into consideration reactors comparable to the Swedish plants with respect to design and age. Diagram 6 shows the dose trend for occupational exposure at the nuclear power plants over the period 1996 – 2006.

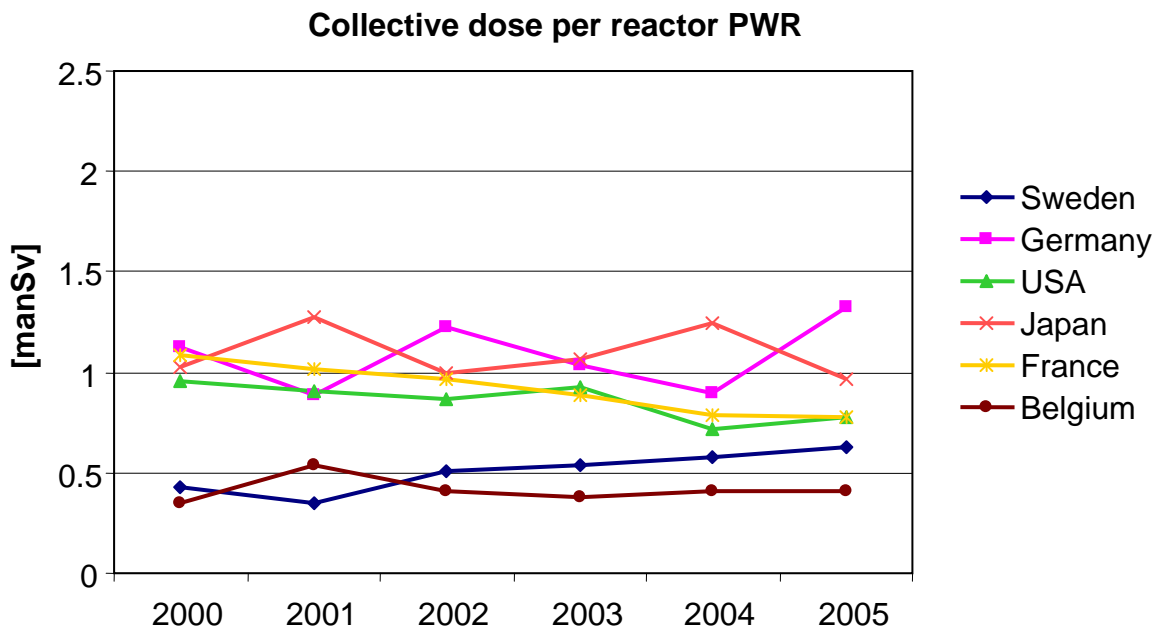
Diagram 5: Swedish collective doses for PWR (pressurized water reactors) in an international comparison. Source: OECD/NEA, Information System of Occupational Exposure.

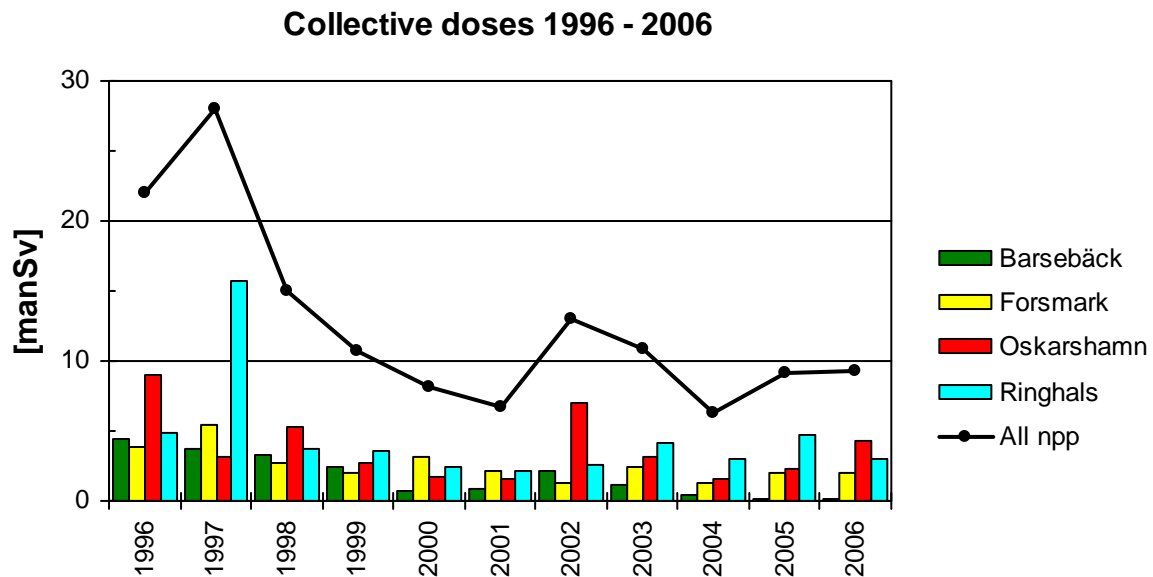
Diagram 6: Annual total collective doses (manSv) to personnel at the Swedish nuclear power plants.

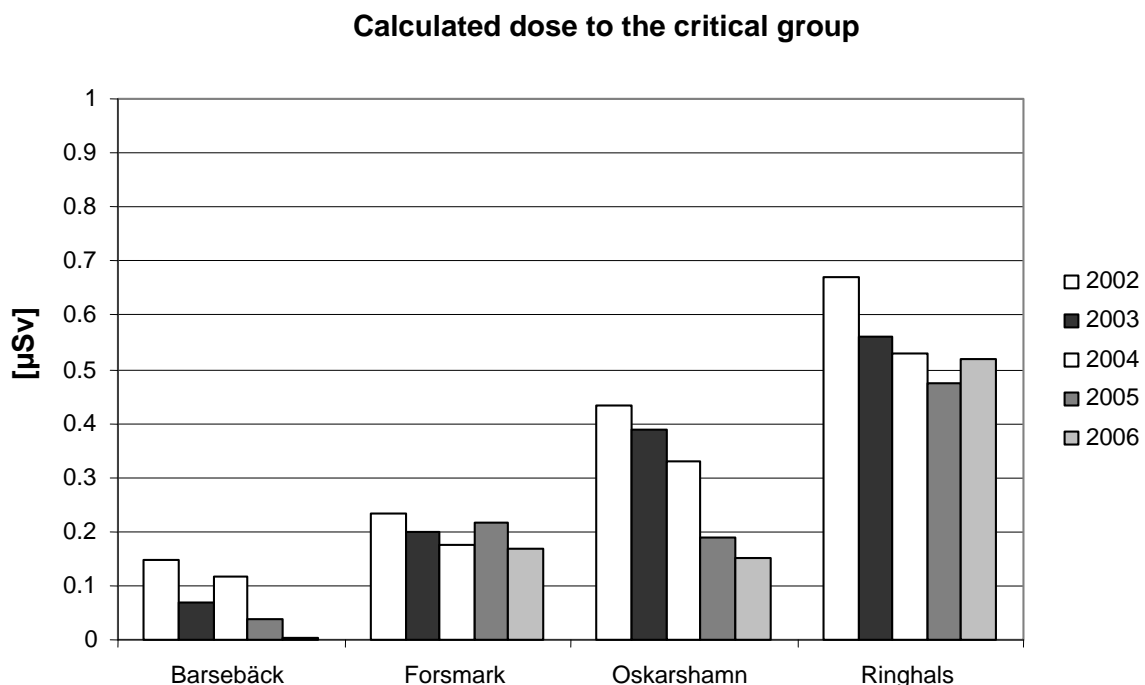
*Diagram 7: Release of radioactive substances to the atmosphere and water from nuclear power plants 2002 – 2006 shown as the dose to the critical group. The results from Forsmark are not corrected for the measurement error detected in December 2006.*

Diagram 7 shows the radiation doses calculated from the release of radioactive substances from nuclear power plants in 2006. The radiation doses (quoted in Sv) are for people living close to a nuclear power plant and who are expected to receive the highest doses, *the critical group*. The permissible dose to a person the critical group is 0.1 mSv per annum (100 Sv). The doses were in all cases less than one hundredth of the permissible dose, and also show a decreasing trend over the years covered in the diagram.
